Service Bulletin Number: 5467306

Cylinder Head Reuse Guidelines

- ISX12N CM2380 X120B
- ISX12 G CM2180 EJ

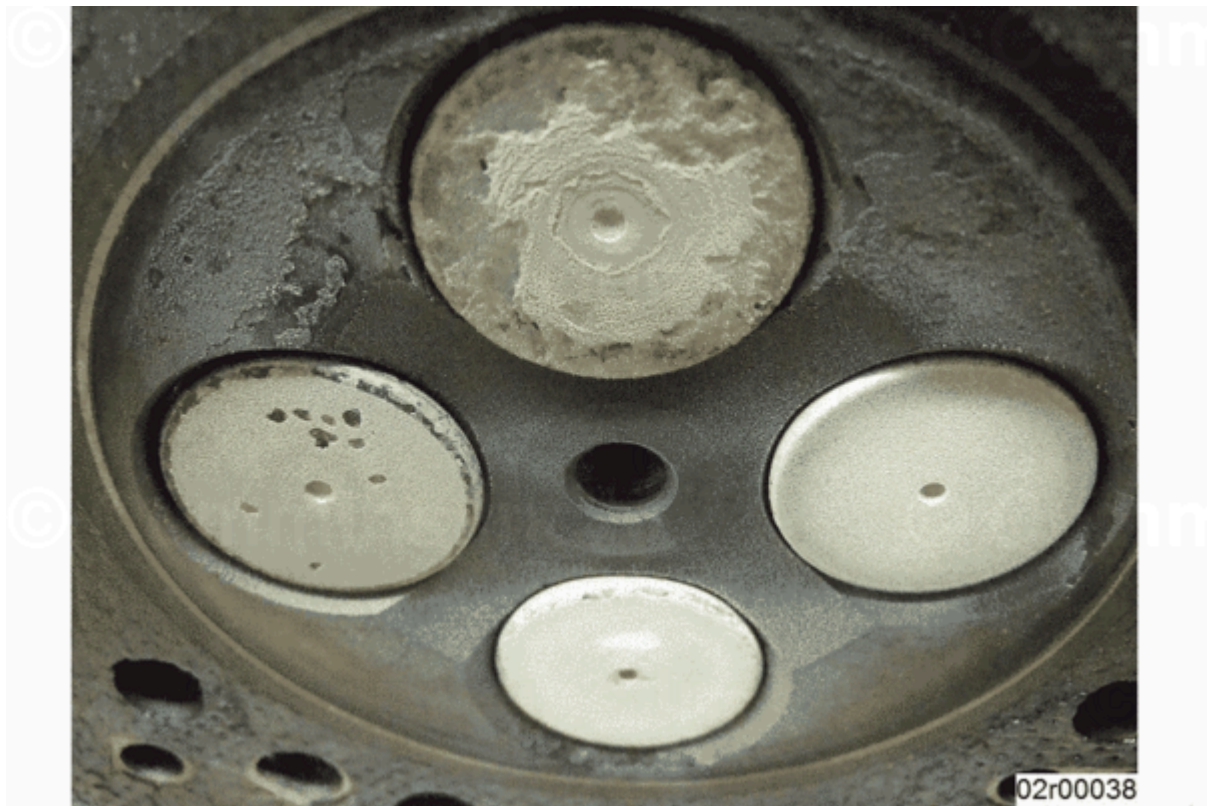
Figure 5, Combustion Face Deposits – Moderate.

| Appearance | Moderate deposits. |
| Cause | Deposits from combustion and acceptable oil consumption. |

| Action | Conditional Reuse. Clean, inspect, and reuse. Do <b>not</b> remove valves for cleaning. See corresponding Service Manual. Reference Procedure 002-004 in Section 2. |

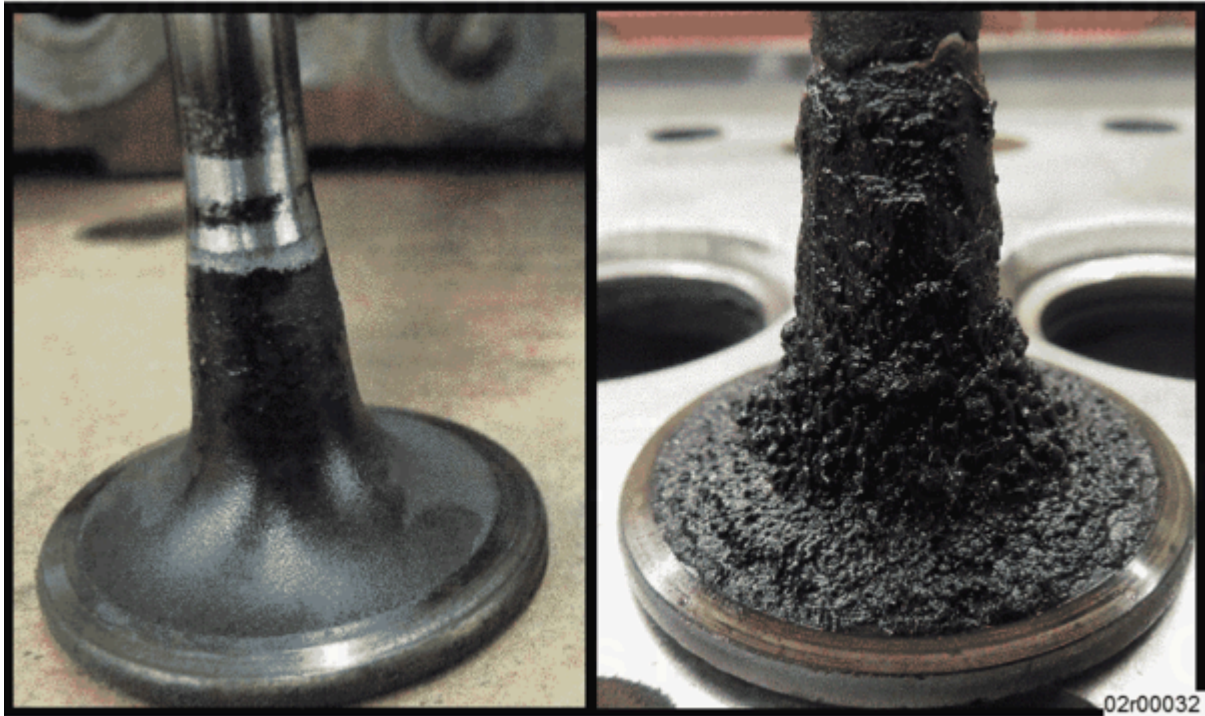
Figure 12, Left: Oil Buildup Least Severe. Right: Oil Buildup Most Severe.

| Appearance | Coated with black, oily sludge or deposits. |
| Cause | <ul style="list-style-type: none"> <li>• All Cylinders: Formation of deposits is dependent on duty cycle. Duty cycles with increased idle are more likely to produce heavier valve fillet deposits.</li> <li>• Single cylinder: Power cylinder issue or leaking valve stem seal.</li> </ul> |

| Action | <ul style="list-style-type: none"> <li>• Unconditional reuse.</li> <li>• Clean valve with brake clean, abrasive wheel is <b>not</b> to be used.</li> </ul> |

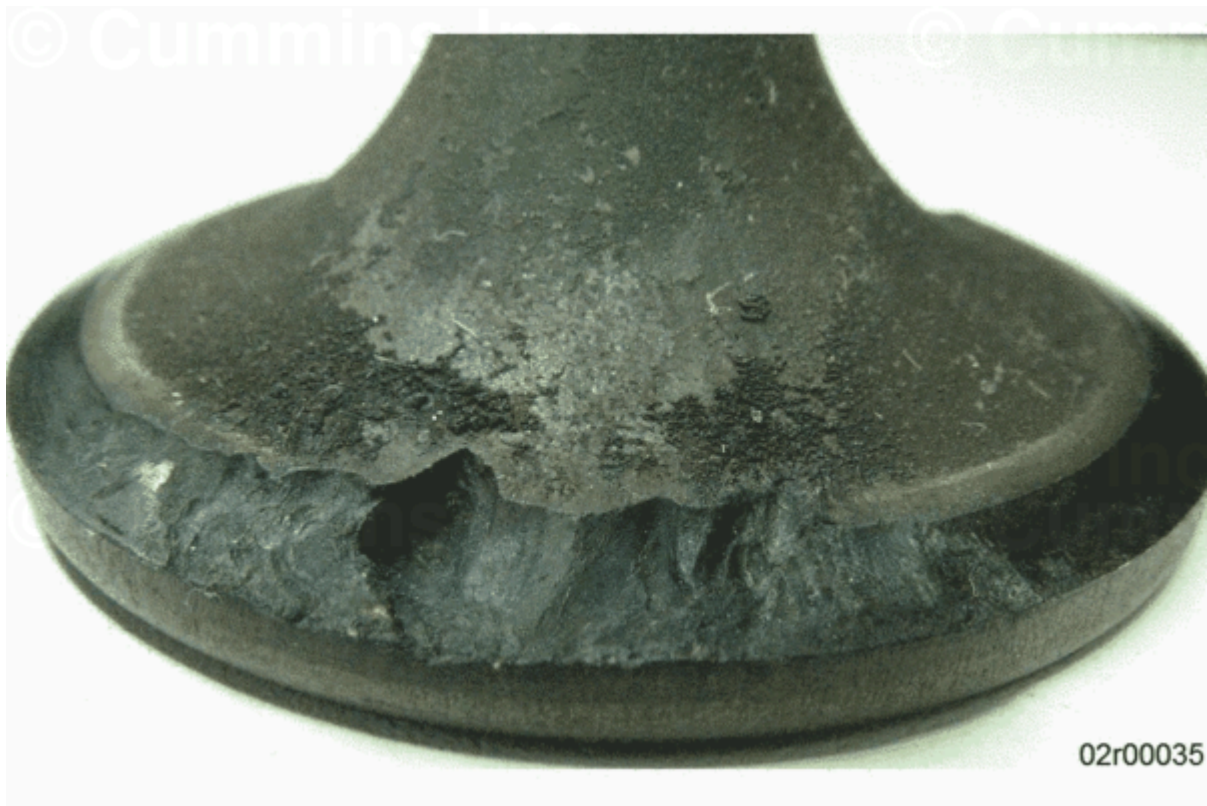
Figure 15, Torched Exhaust Valve.

| Appearance | Damaged valve with torch-like cutting appearance. |
| Cause | Prolonged engine knock. |

| Action | Replace cylinder head and inspect pistons for excessive deposits. See corresponding Service Manual. Reference Procedure 002-004 in Section 2. |

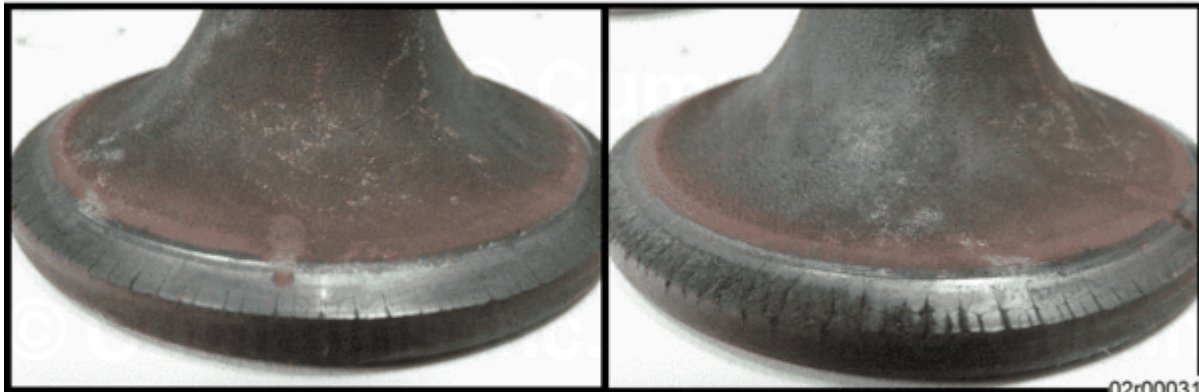
Figure 16, Left: Burnt Intake Valve Least Severe. Right: Burnt Intake Valve Most Severe.

| Appearance | Cracking on valve seat face |
| Cause | Thermal fatigue: cylinder head with improved valve and seat materials released 31 March 2015. |

| Action | Replace cylinder head. See corresponding Service Manual. Reference Procedure 002-004 in Section 2. |

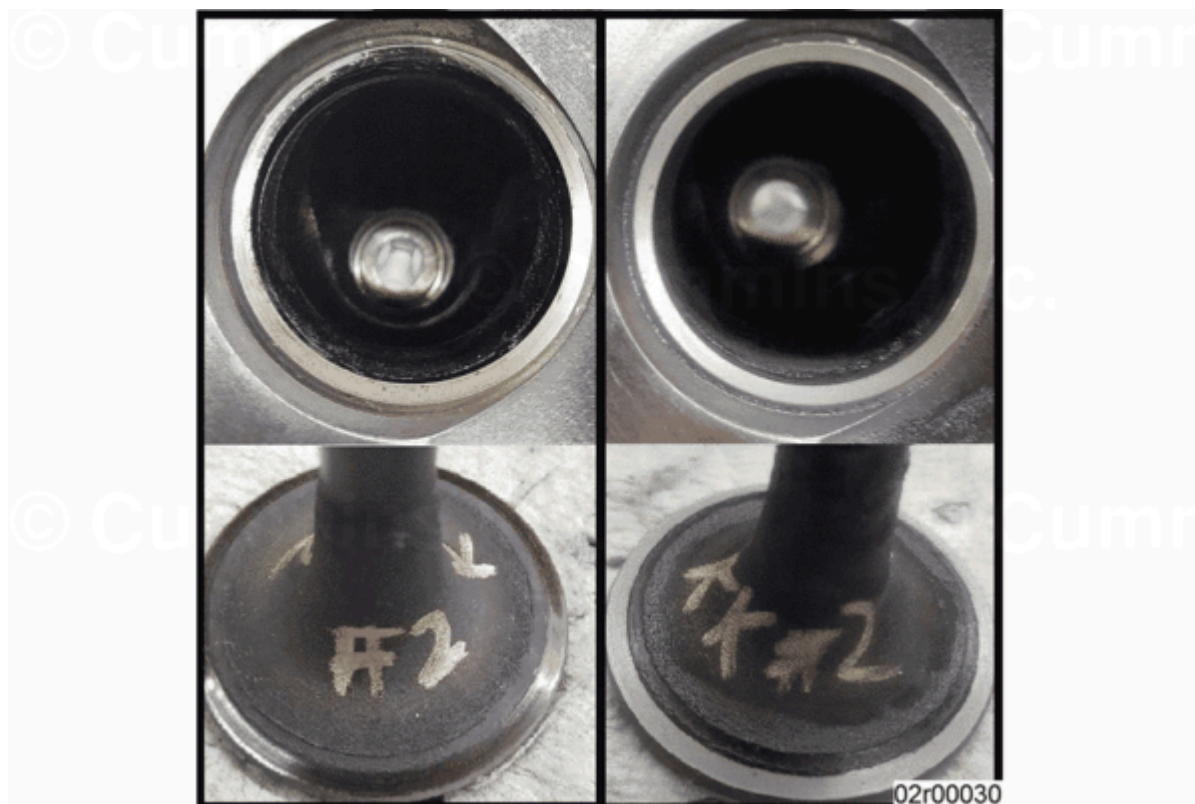
Figure 18, Left: Valve Seat and Valve Before Lapping. Right: Valve Seat and Valve After Lapping.

| Conditions for Valve Lapping | <p><b>Only</b> lap valves as directed. Lapping will correct all valve leakage except for burning, torching, and chordal malfunction conditions. Lapping will repair sealing surface and clear any debris or imperfections from between valve and valve seat.</p> |

| Action | <ul style="list-style-type: none"> <li>Lap all four valves of <b>only</b> cylinders that did <b>not</b> pass procedure in corresponding Service Manual. Reference Procedure 002-004 in Section 2.</li> <li>Number all valves and remove all four valves from only cylinder that did <b>not</b> pass valve leak test. Use valve spring compressor tool, Part Number 5298756, to remove valves. See corresponding Service Manual. Reference Procedure 002-004 in Section 2.</li> </ul> |
