Service Bulletin Number: 5676975

Cylinder Liner Reuse Guidelines

- ISL G CM2180
- ISX12 G CM2180 EJ
- ISX12N CM2380 X12B
- L9N CM2380 L124B/L9N CM2380 L130B
- L9N CM2380 L142B

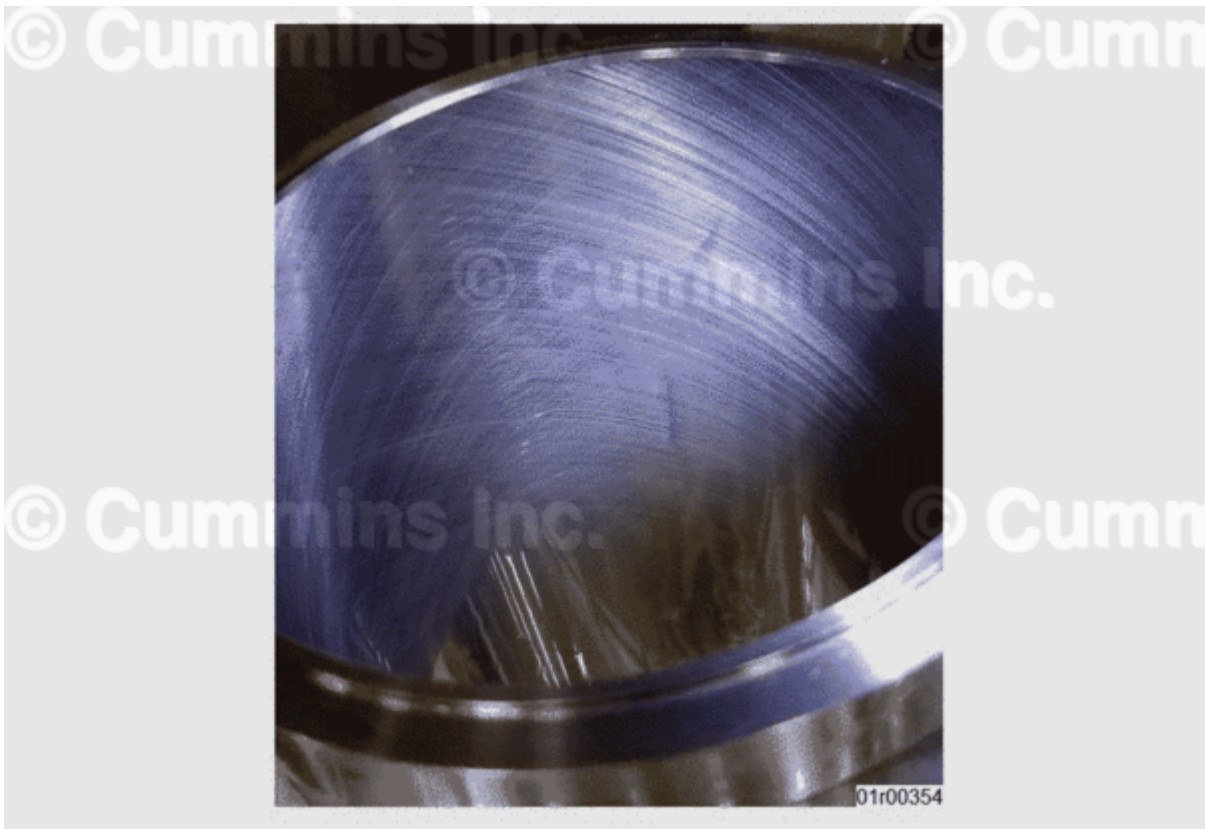
Figure 1

| Figure 1, New Cylinder Liner – No Surface Wear Present | |
| Appearance: | Cross hatching clearly visible in region of proper lighting. No wear present on any part of the machined surface. Notice that cross hatching has a mirrored appearance in lower region due to lack of proper lighting. |
| Cause: | - |

| Figure 1, New Cylinder Liner – No Surface Wear Present | |
|---|---|
| Action: | None |

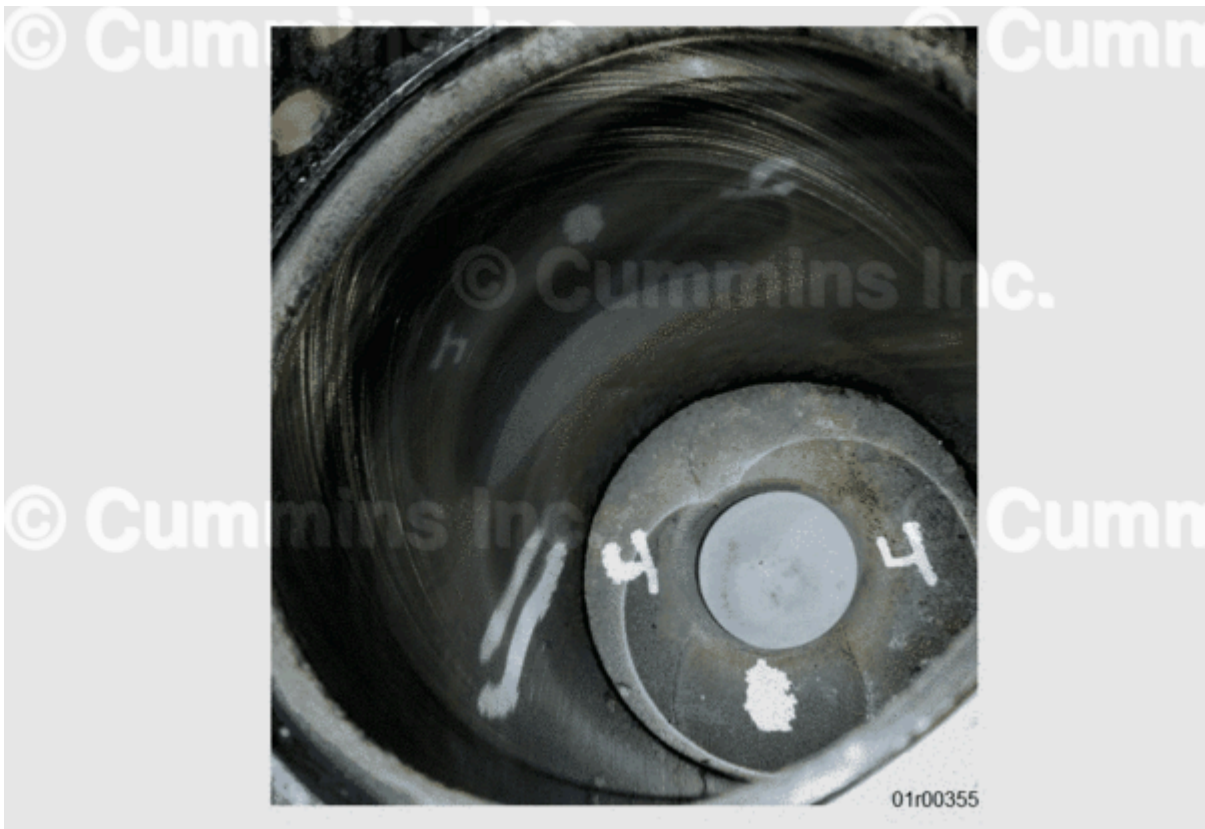
Figure 2

**Figure 2, Used Cylinder Liner – No Surface Wear Present**

| Appearance: | Crosshatching clearly visible in region of proper lighting. Cross hatching difficult to see in regions without proper lighting. No wear present on any part of the machined surface. Notice cross hatching has a mirrored appearance in lower region due to lack of proper lighting. There is not any polishing present. |
| Cause: | - |

| Action: | Unconditional Reuse |

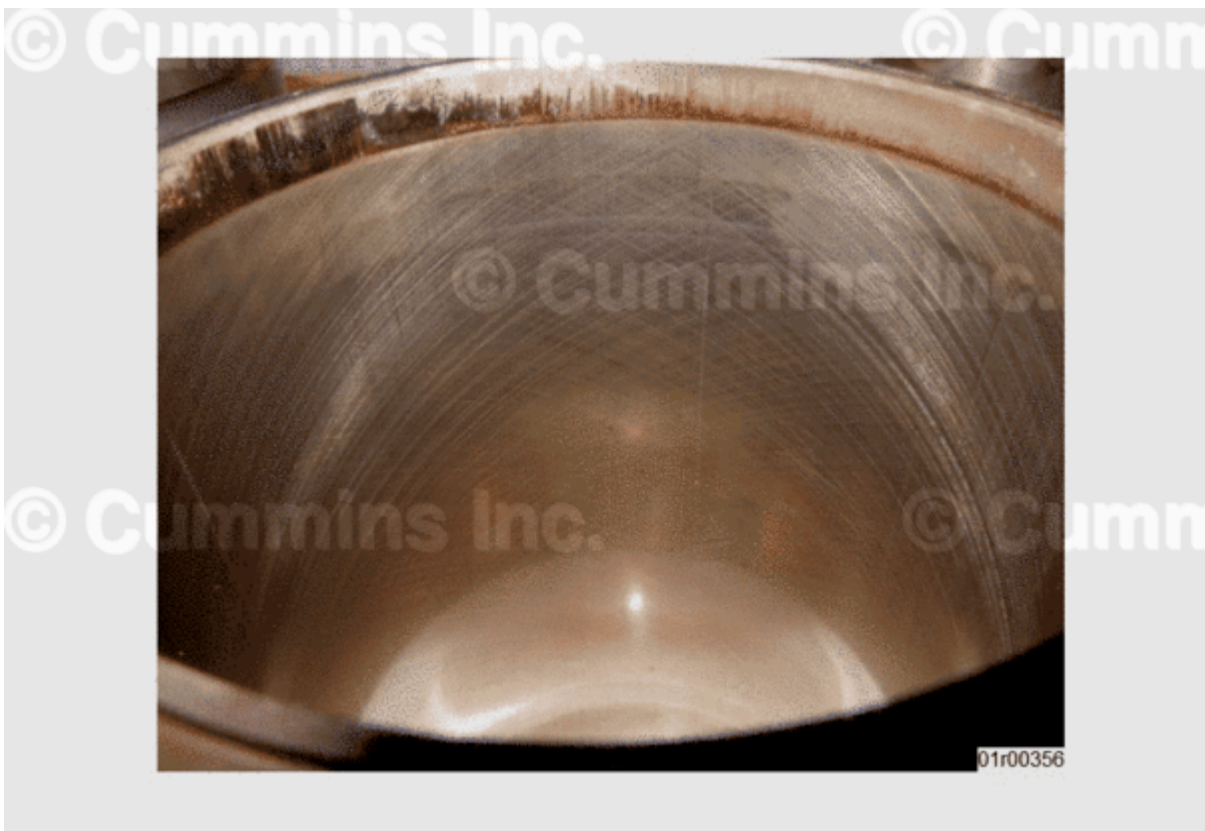
Figure 3

**Figure 3, Used Cylinder Liner – Light Vertical Streaking**

| Appearance: | Narrow lines of vertical discoloration along path of piston travel. Only visible, cannot be felt with a fingernail. Crosshatching completely intact throughout. |
| Cause: | Can occur during break-in as piston rings seat to cylinder liners. |

| Action: | Unconditional Reuse |

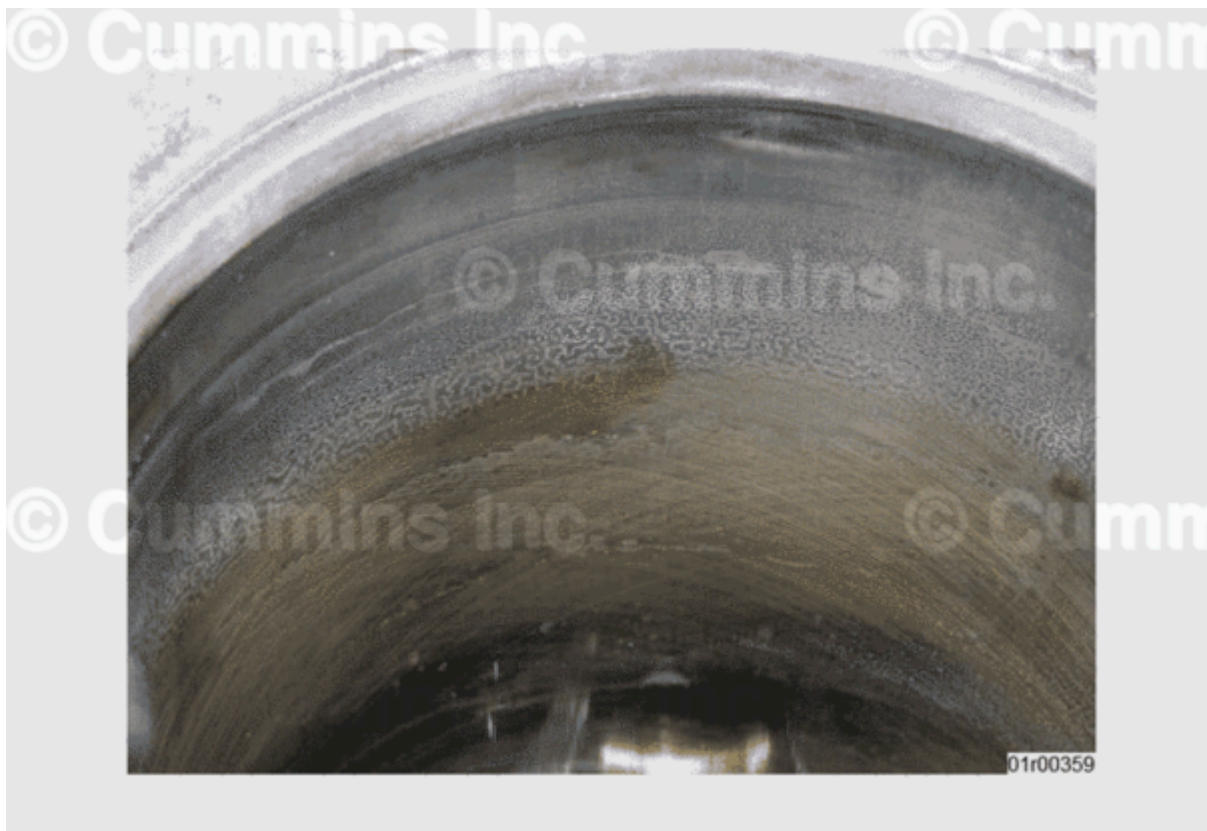
Figure 6

**Figure 6, Used Cylinder Liner – Discoloration/Stain**

| Appearance: | Superficial discoloration resembling rust or hammered pattern. Not able to be felt with a fingernail. Crosshatching is difficult to see but is completely intact. |
| Cause: | Condensation in cylinder for prolonged period. Normal for natural gas engines. |

| Action: | Unconditional Reuse |

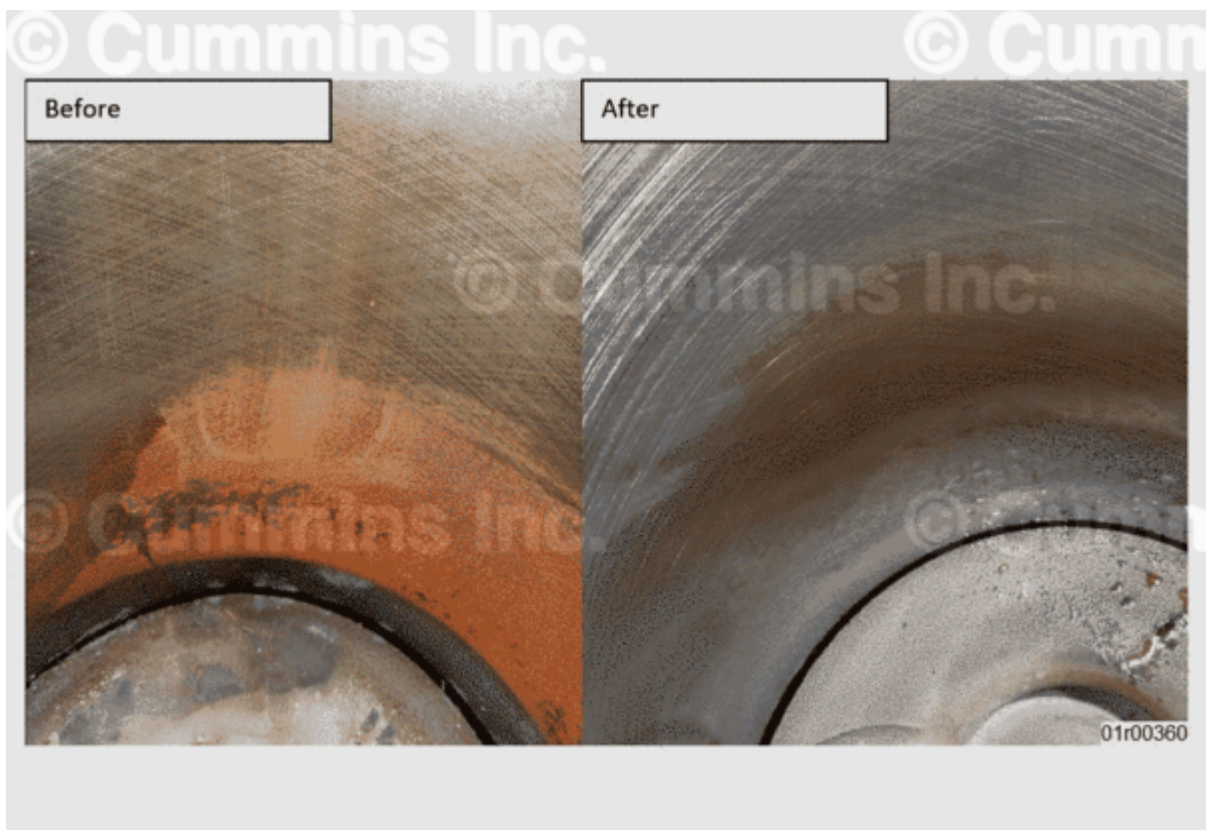
Figure 7

**Figure 7, New or Used Cylinder Liner – Rust Before and After Running In**

| Appearance: | Rust colored patches. Before running in they may be felt with a fingernail, but will clean up with lubrication and run in. Not able to be felt with fingernail after run in. Cross hatching is difficult to see but is completely intact throughout discolored patch. |
| Cause: | Condensation in cylinder for prolonged period. Normal for natural gas engines. |

| Action: | Unconditional Reuse |

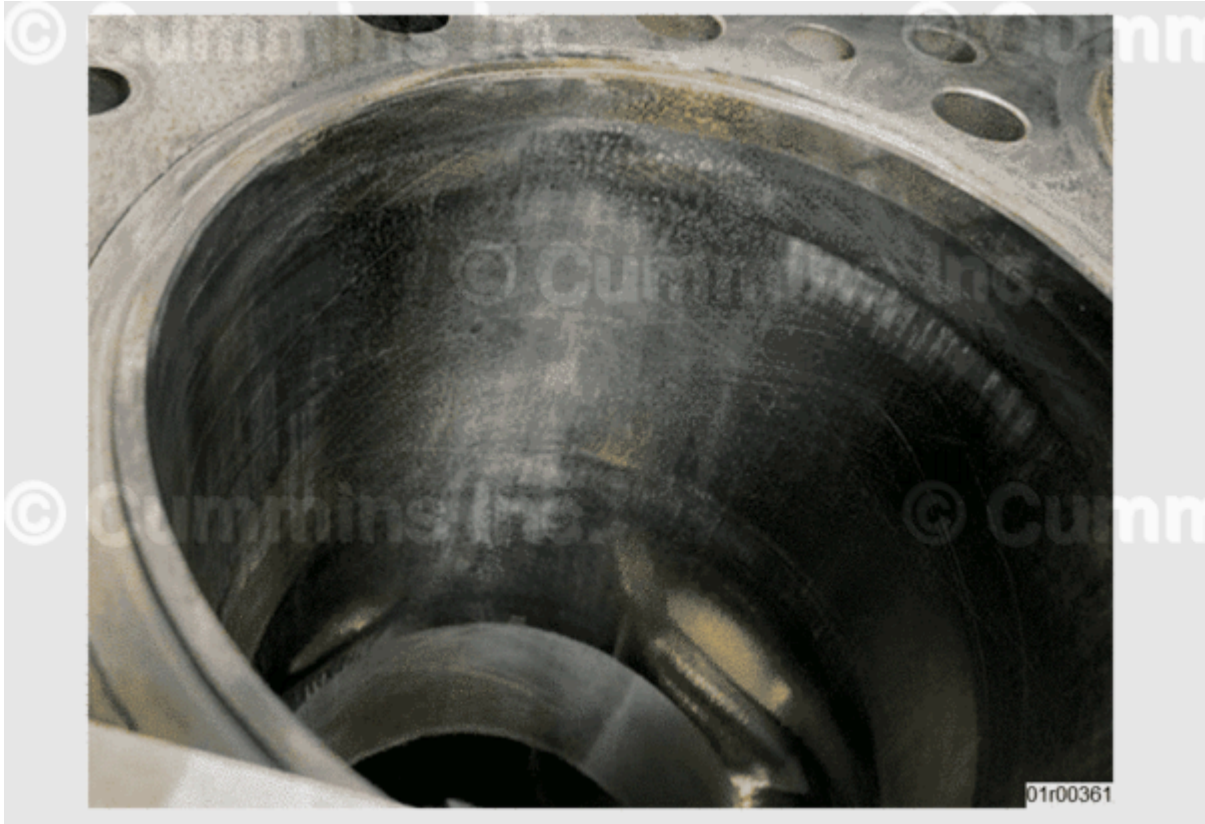
Figure 8

**Figure 8, Used Cylinder Liner – Combination of Visual Anomalies**

| Appearance: | Bright spots on thrust side, staining, visible ring reversal area. No imperfections can be felt with a fingernail. Cross hatch is visible throughout with proper lighting. Notice lower region appears to have a mirrored finish due to poor lighting. |
| Cause: | Condensation in cylinder for prolonged period. Normal for natural gas engines. |

| Action: | Unconditional Reuse |

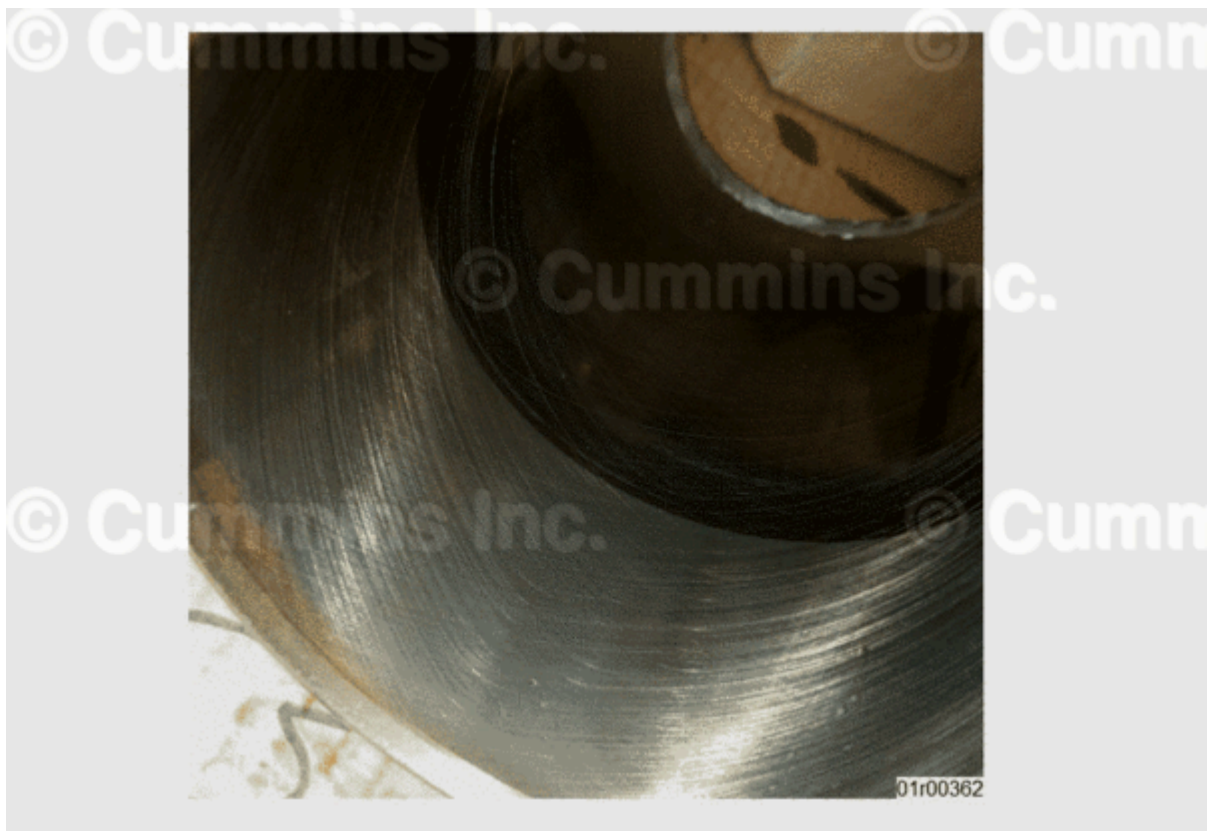
Figure 9

**Figure 9, Used Cylinder Liner – Color Variation Top to Bottom**

| Appearance: | Shown from bottom side of a removed cylinder liner for reference. Visual difference in coloring of cylinder liner from top to bottom. The darker color is not an indication of excessive wear or polishing. Cross hatching is present in all regions. Any mirrored appearance is caused by poor lighting. |
| Cause: | Normal piston ring and cylinder liner seating. |

| Action: | Unconditional Reuse |
