Service Bulletin Number: 6508353

Water In the Fuel System and Corrosion on Fuel System Components

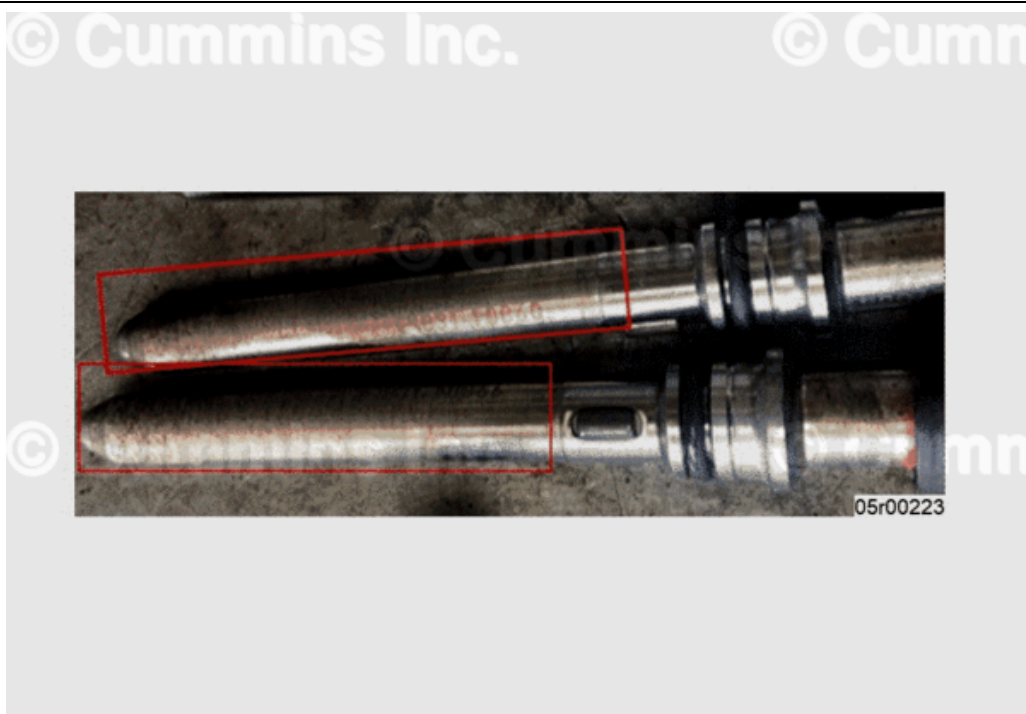
- b. Parts to inspect for corrosion if directed to remove according to published troubleshooting:
    - i. Injector fuel supply connector (For example of corrosion, see Figure 2)

Figure 2, Abnormal and Unacceptable Corrosion on Injector Connector Below O ring

- v. Fuel pump pressure regulator. (For example of corrosion, see Figures 12 and 13)
- **Only** If corrosion is found on any of the components listed above, proceed to inspect the fuel tank and see Service Bulletin, Water in Fuel Contamination, Bulletin 5659823 for restoring the fuel system.

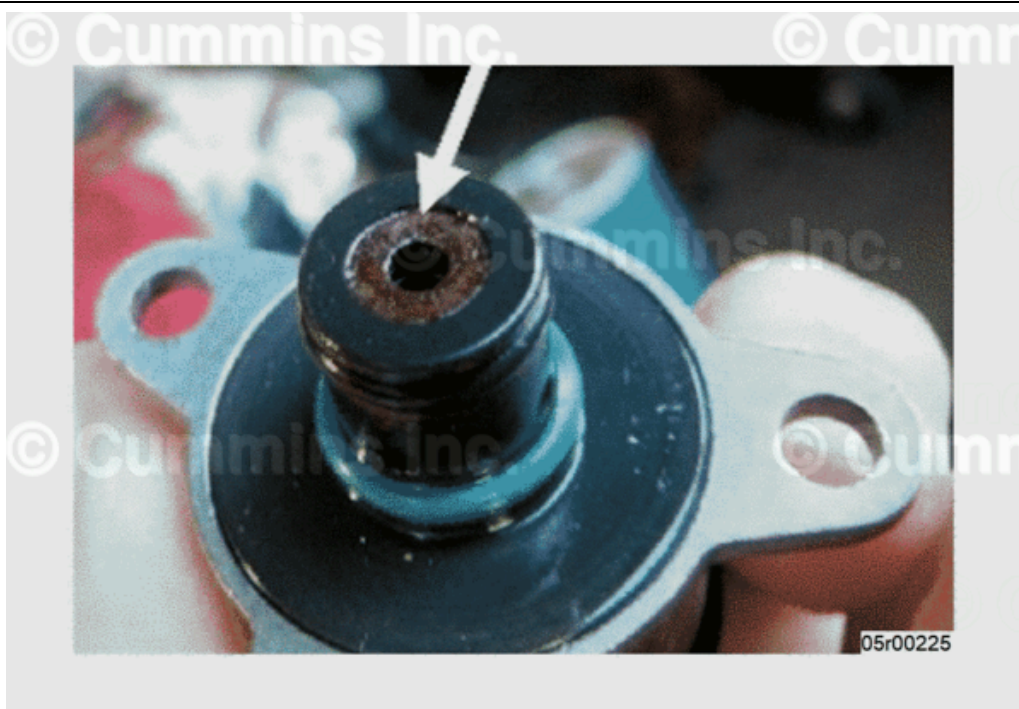
- ii. Fuel Injector
    - iii. Fuel pump electronic fuel control actuator (For example of corrosion, see Figure 4)
    - iv. Fuel rail pressure relief valve (For example of corrosion, see Figure 6)

Figure 4, Corroded and Unacceptable Fuel Pump Electronic Fuel Control Actuator

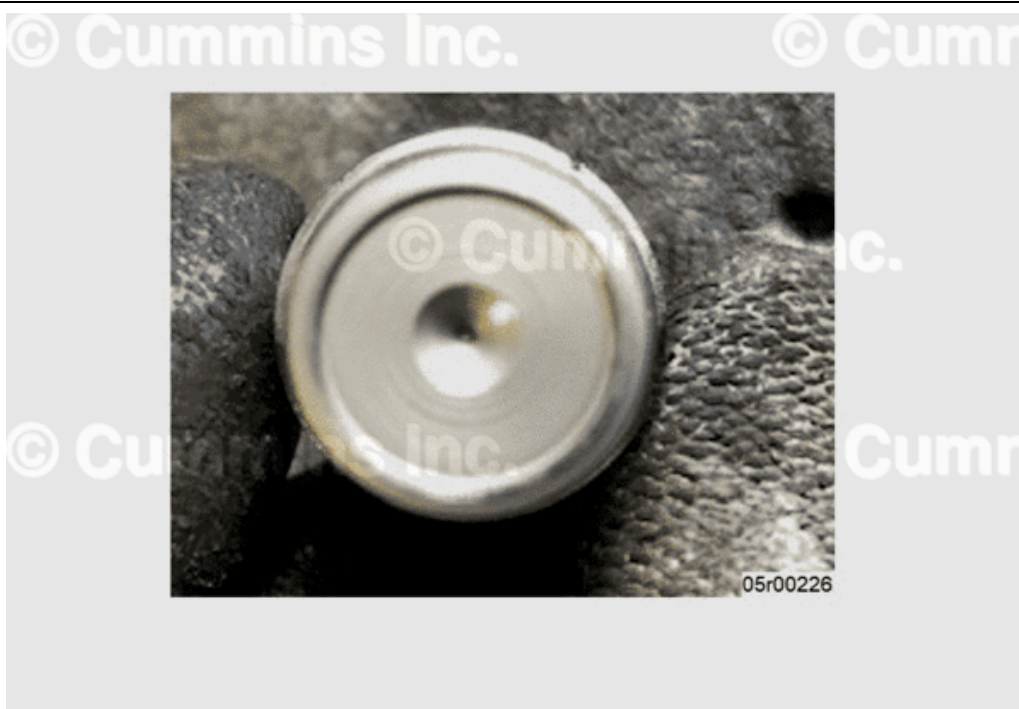
Figure 5, Clean and Acceptable Fuel Rail Pressure Relief Valve Corrosion

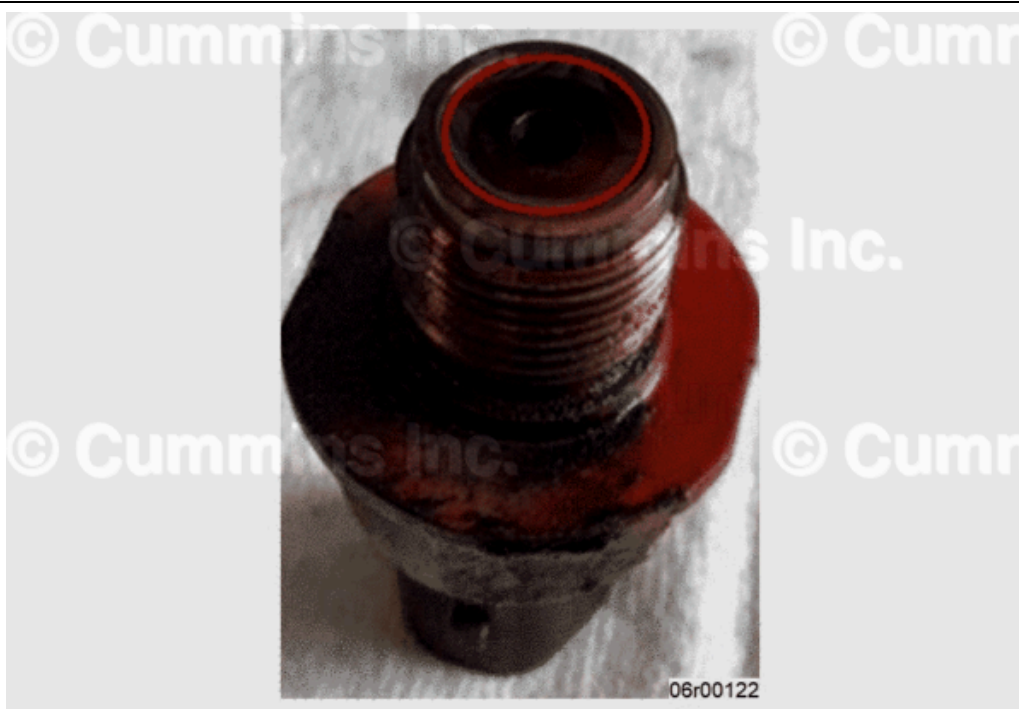
Figure 6, Corroded and Unacceptable Fuel Rail Pressure Relief Valve Corrosion

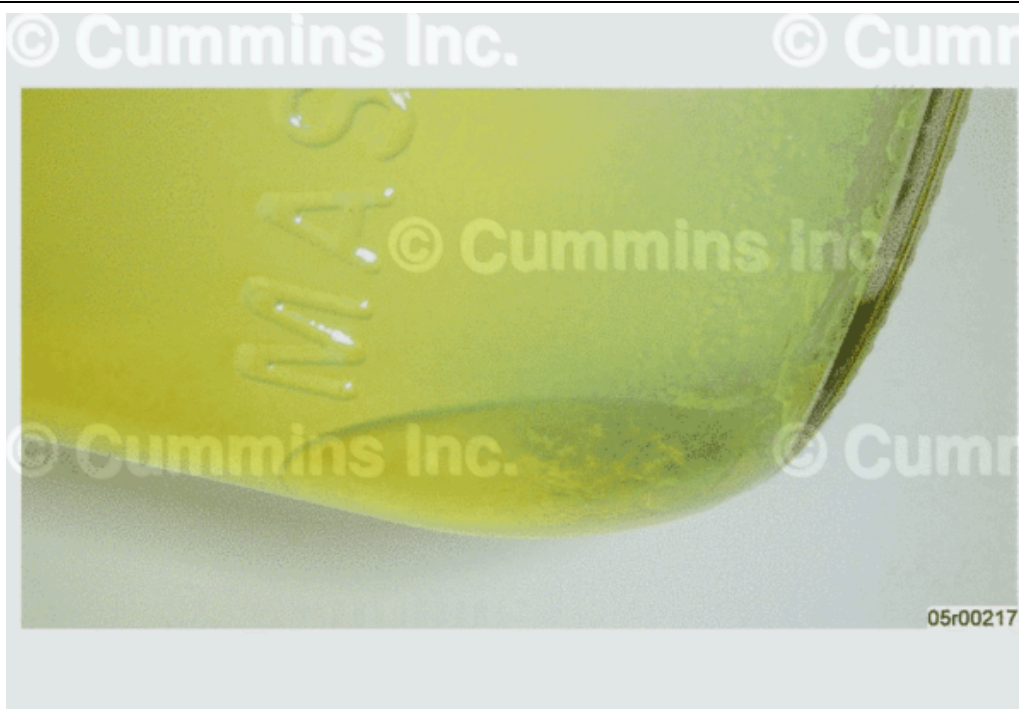
Figure 7, Free Standing Water in Diesel Fuel.

- c. Let the fuel sit for 5 minutes.
- Check fuel sample for signs of water in the clear container.
  - a. If free-standing water is found in the bottom of the clear container (See Figure 7), see Service Bulletin, Water in Fuel Contamination, Bulletin 5659823 for repair.
  - b. If no free-standing water is found at the bottom of the container:
    - i. Print fuel bar chart. Select hyperlink below for fuel bar chart.

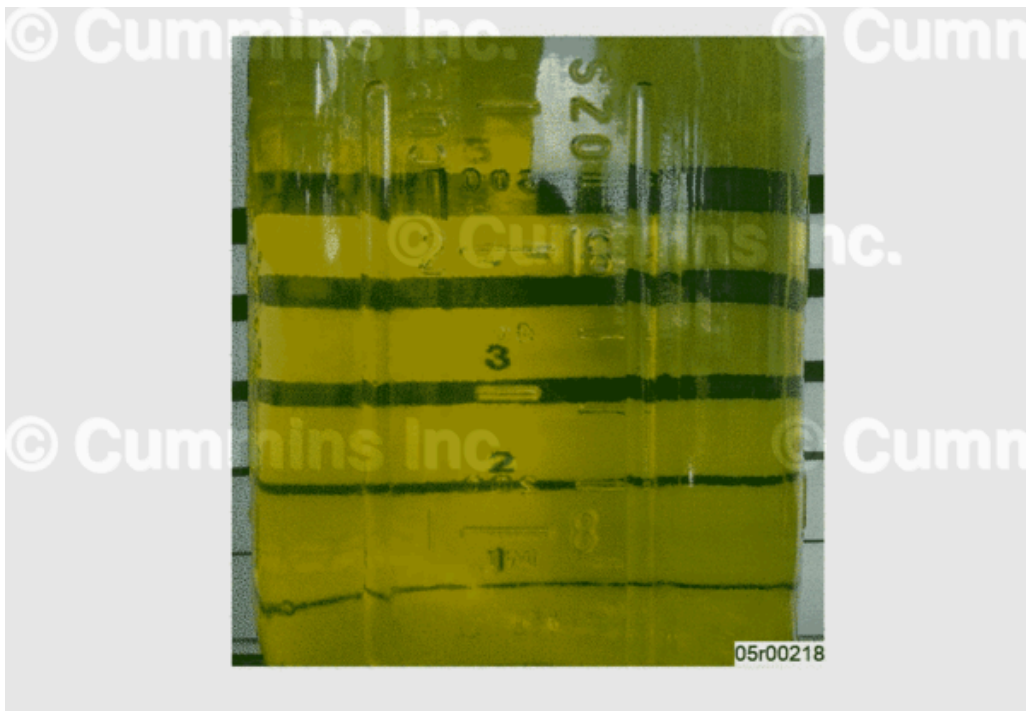
Figure 8, 0 ml of Water Added to Diesel Fuel

- ii. Place fuel bar chart behind the fuel sample and compare with examples in Figure 8-10.
- iii. If Line 1 on fuel bar chart is **not** visible while looking through fuel sample, see Service Bulletin, Water in Fuel Contamination, Bulletin 5659823 for restoring the fuel system.

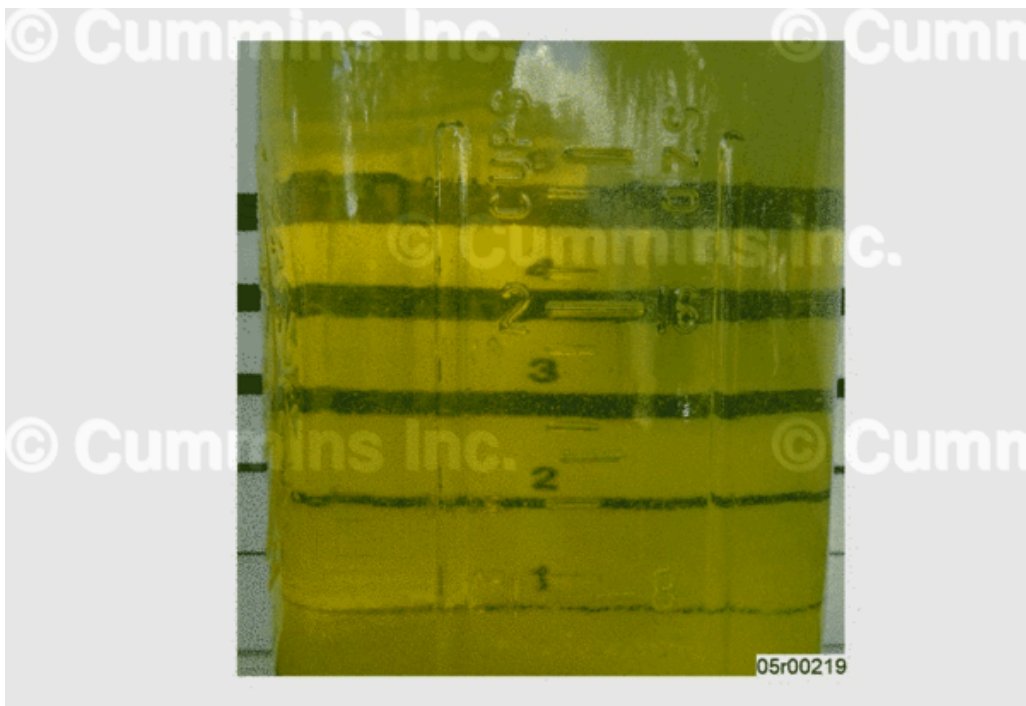
Figure 9, 1 ml [ .0 fl-oz ] Water Added to Diesel Fuel

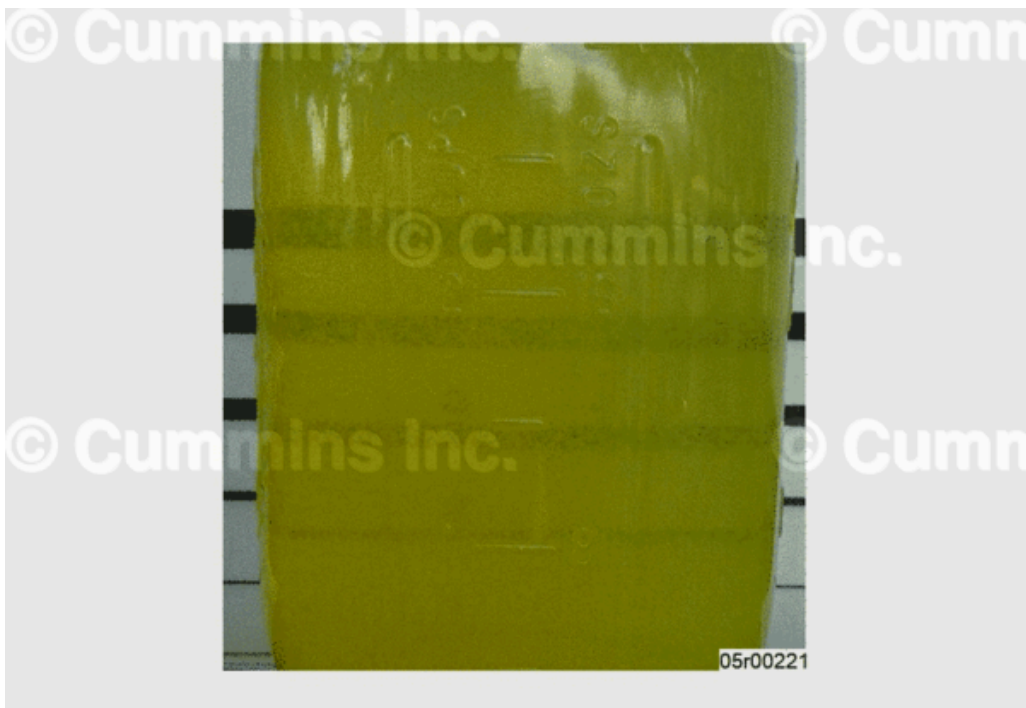
Figure 11, 5 ml [ .17 fl-oz ] Water Added to Diesel Fuel

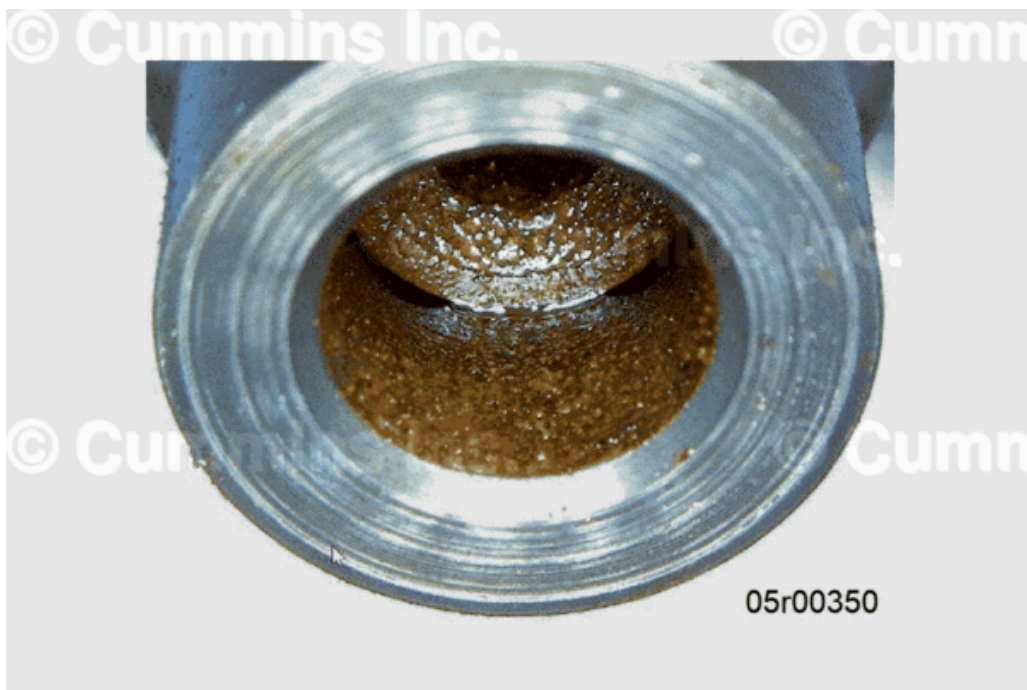
Figure 12, Example of Corrosion in Fuel Pump Pressure Regulator

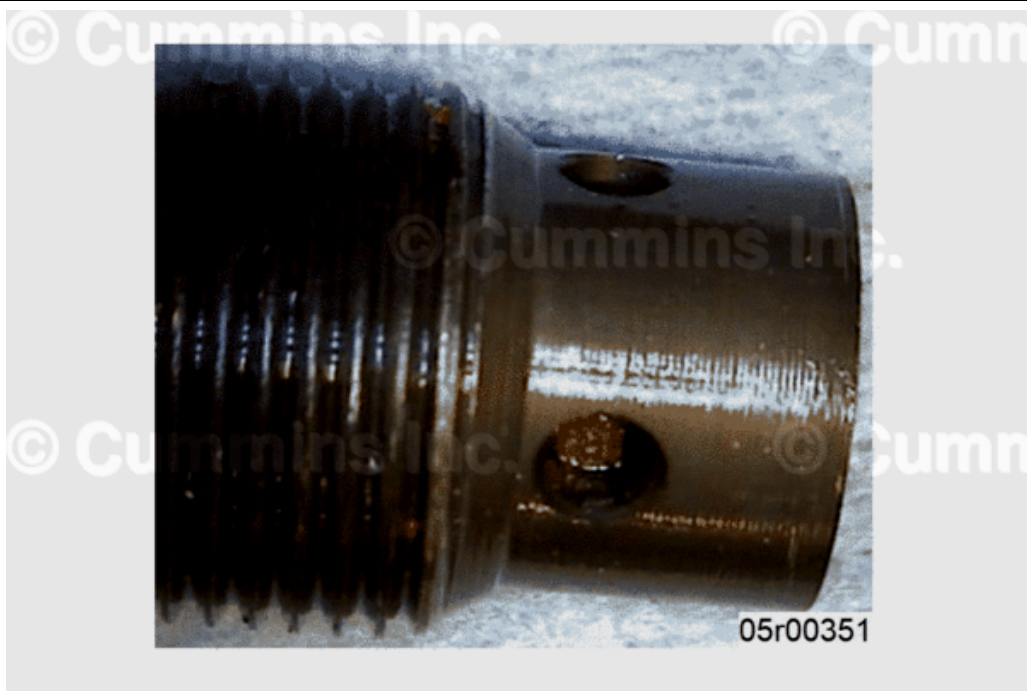
Figure 13, Example of Corrosion in Fuel Pump Pressure Regulator

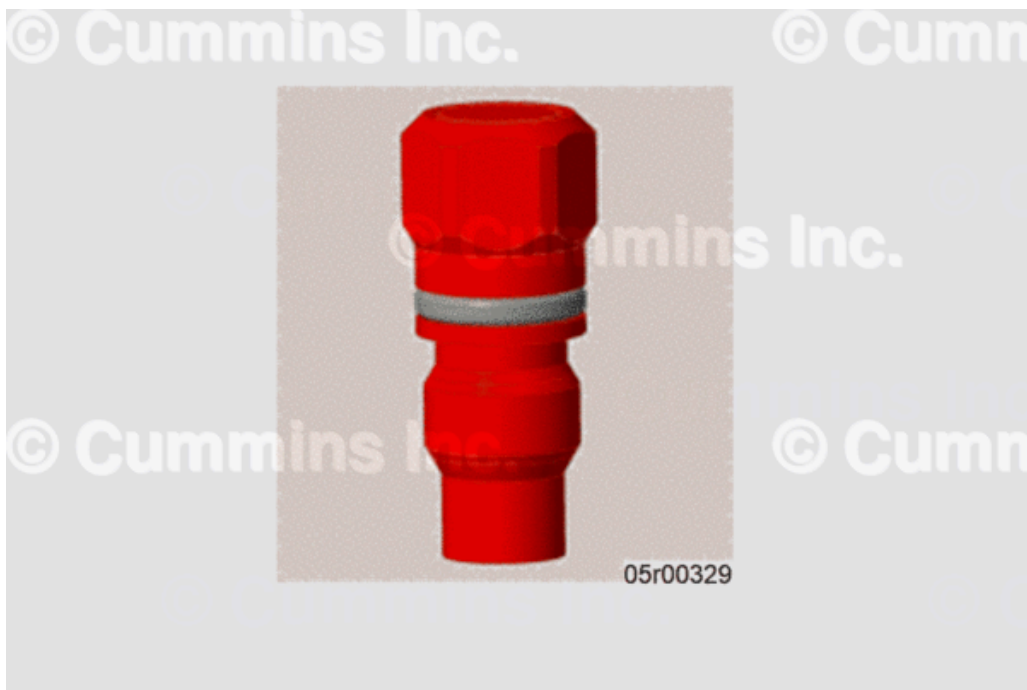
Figure 14, Fuel Pump Pressure Regulator

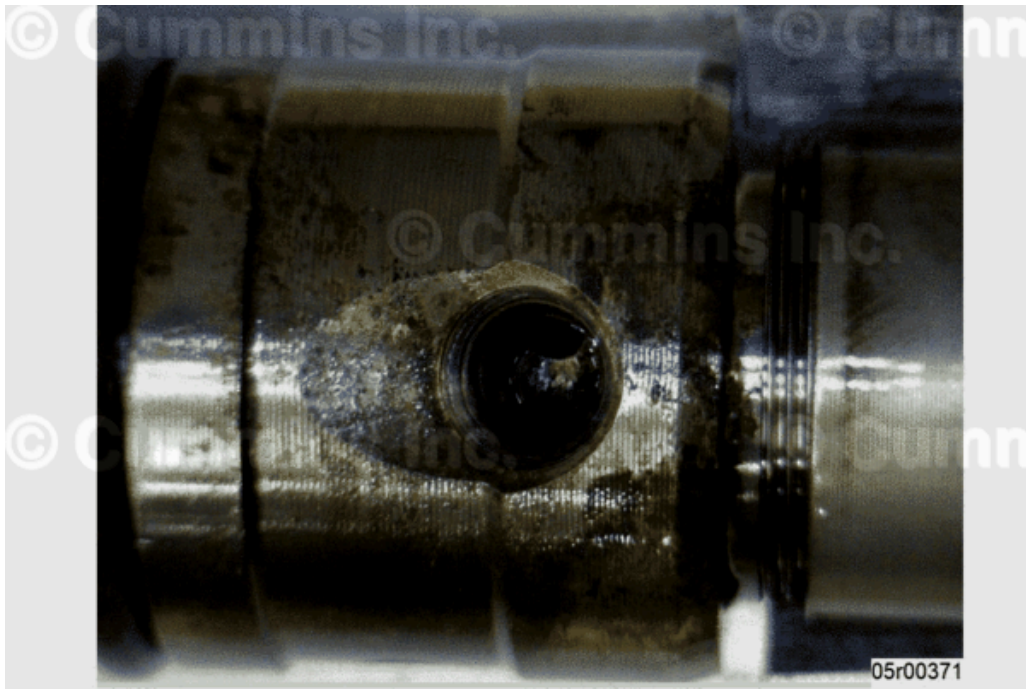
Figure 16, Example of Corrosion on Injector

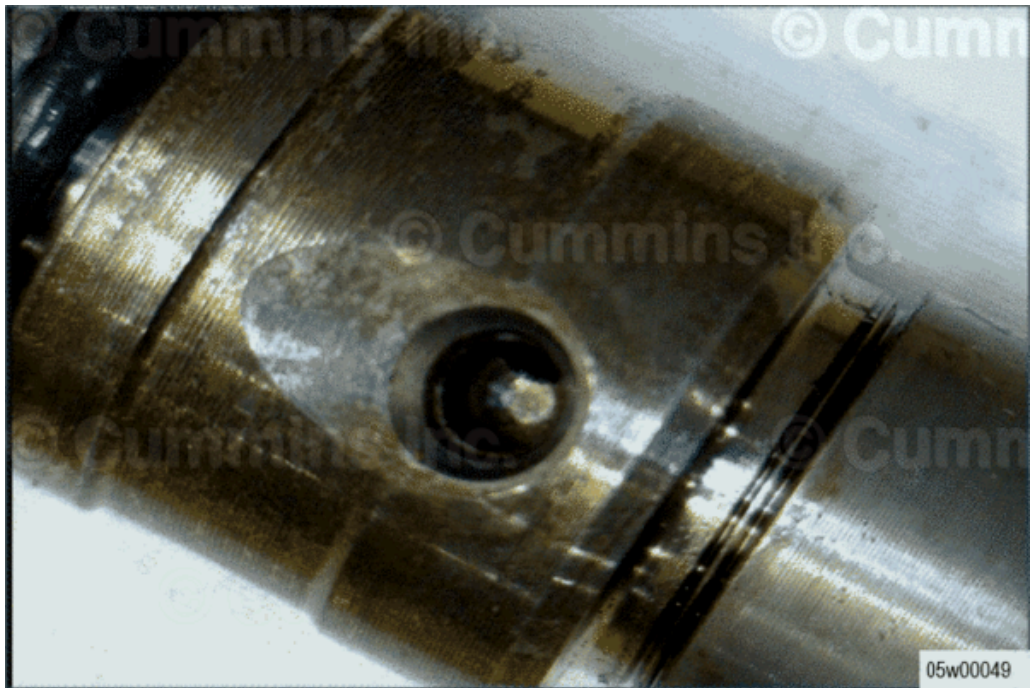
Figure 19, Example of Corrosion on Injector
