# Fault Code: 231

## Coolant Pressure Sensor Circuit

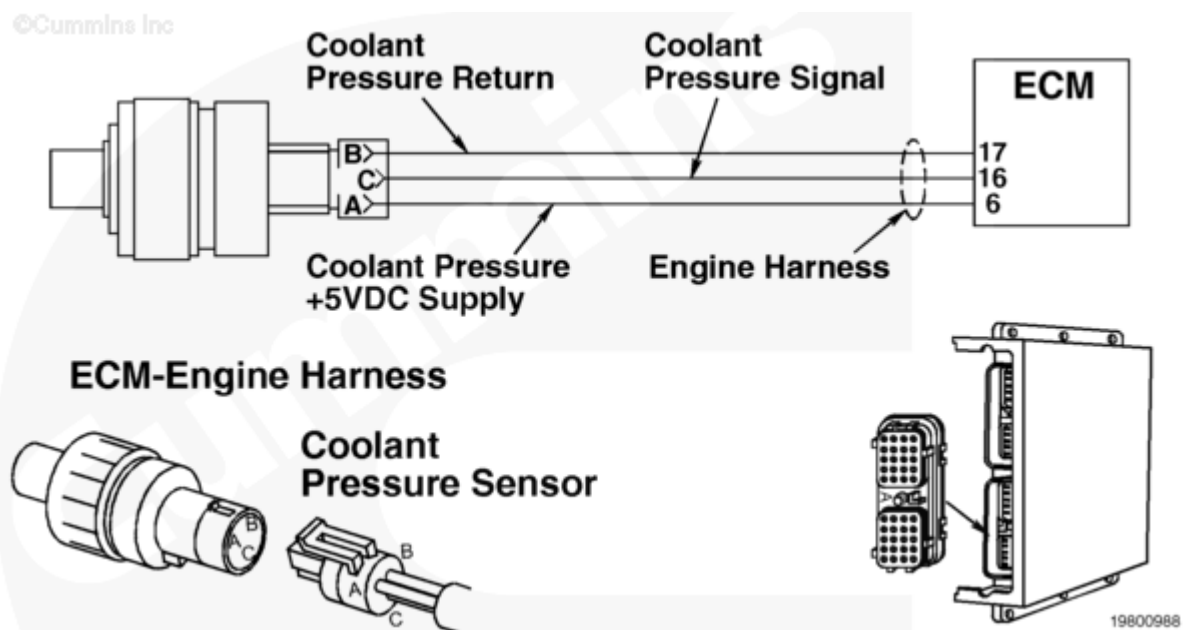
Coolant Pressure Sensor Circuit

The coolant pressure sensor monitors coolant pressure and passes information to the ECM through pin 16 of the engine harness. The ECM monitors the voltage on pin 16 and expects to see the voltage vary between 0.5 and 4.5-VDC during normal operation. Voltage above 4.72-VDC on pin 16 will trip Fault Code 231 and can be caused by shorts in the supply, signal, or return wires, an open in the return wire, or a failed sensor.

Refer to Troubleshooting Fault Code t05-231 (</qs3/pubsys2/xml/en/procedures/19/19-t05-231.html>)
