## Fault Code: 232

### Coolant Pressure Sensor Circuit

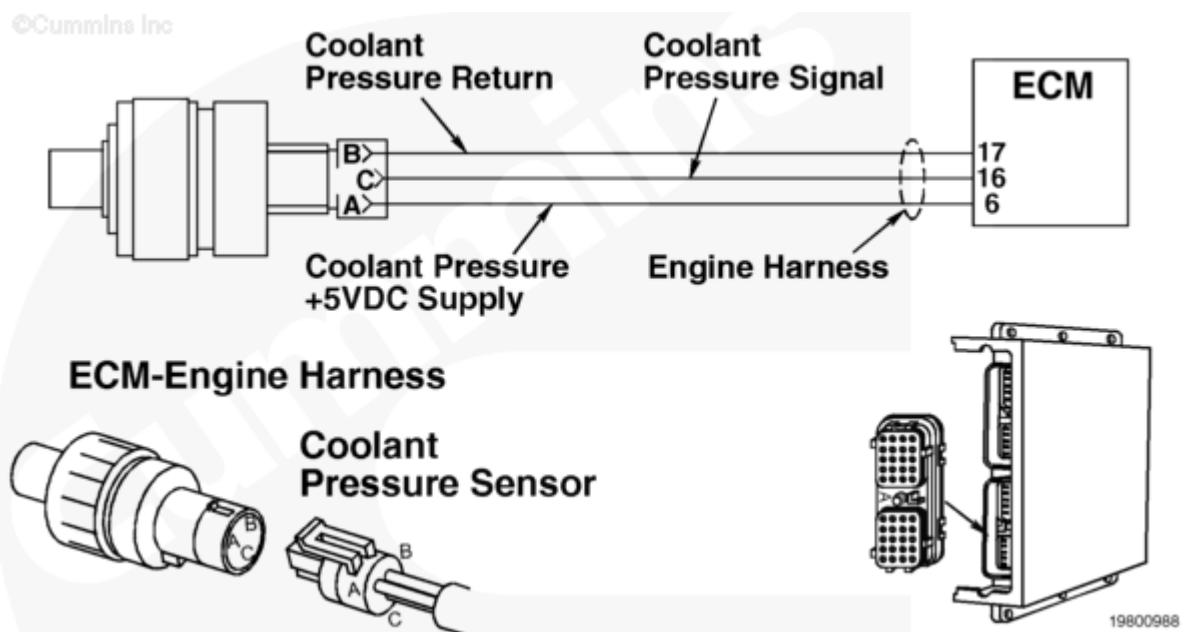
Coolant Pressure Sensor Circuit

The coolant pressure sensor monitors coolant pressure and passes information to the ECM through pin 16 of the engine harness. The ECM monitors the voltage on pin 16 and expects to see voltage vary between 0.5 and 4.5 VDC during normal operation. Voltage below 0.33-VDC on pin 16 will trip Fault Code 232 and can be caused by shorts in the supply, signal, or return wires, an open in the return wire, or a failed sensor.
