# Fault Code: 422

## Coolant Level Sensor Circuit

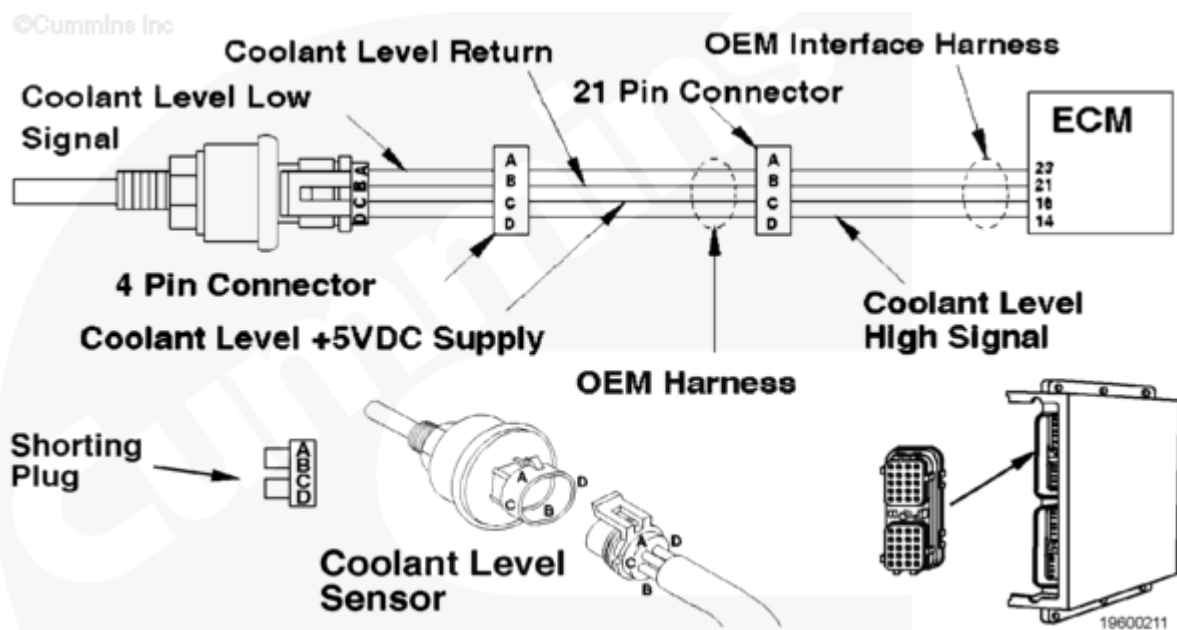
Coolant Level Sensor Circuit

| Codes | Reason | Effect |
|---|---|---|
| Fault Code: 422<br><br>PID(P): P111<br>SPN: 111<br>FMI: 2<br>Lamp: Yellow<br>SRT: 00-368 | Voltage detected simultaneously on both the coolant level high and low signal pins 14 and 23 of the OEM interface harness, or no voltage detected on either pin. | No engine protection for coolant level. |

There is an optional configuration of the coolant level sensor circuit that includes a water-in-fuel sensor. This optional configuration is illustrated above.

- If a shorting plug is used in the coolant level circuit, verify that it is wired correctly.
- Inspect the wiring harness between the Weather-Pack four-way connector and the coolant level sensor for damage.
- Make sure the coolant level sensor is located in the middle of the tank rather than off to one side where the coolant level can change when the vehicle makes a turn.
