# Fault Code: 156

## Intake Manifold 2 Temperature Sensor Circuit - Voltage Above Normal or Shorted to High Source

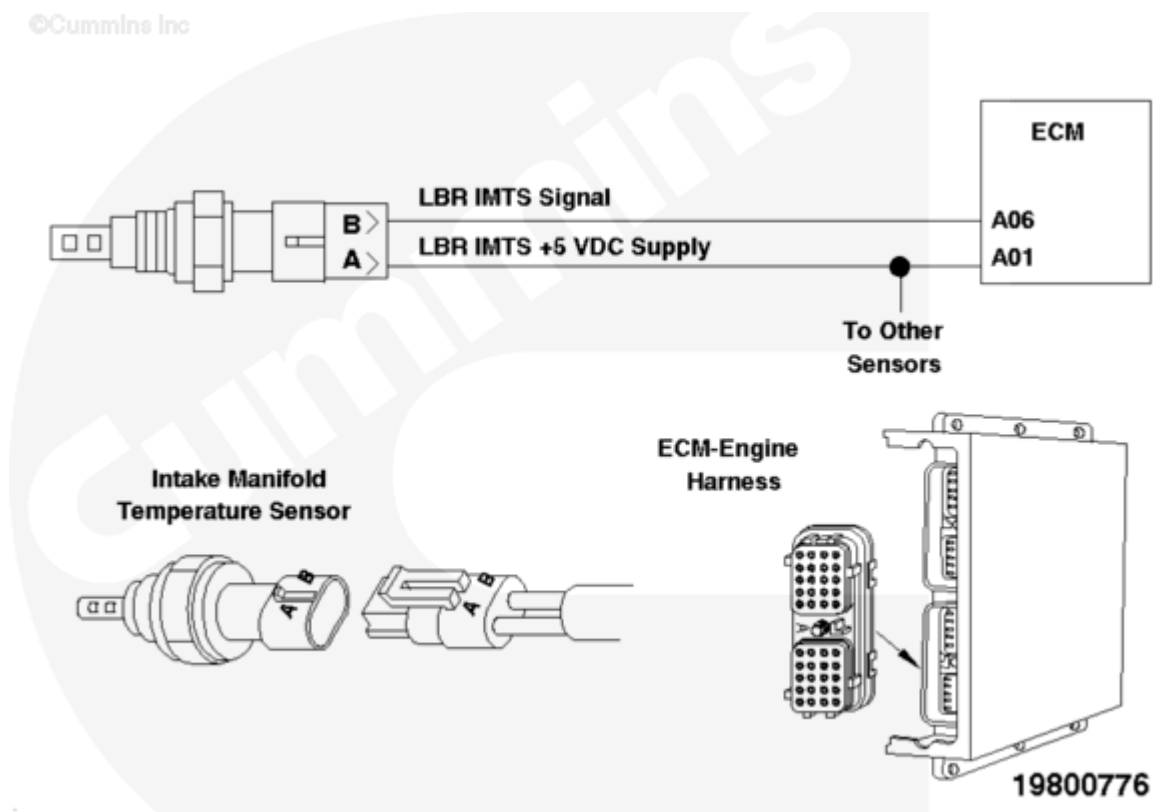
Left Bank Rear Intake Manifold Temperature Sensor Circuit

| Codes | Reason | Effect |
|---|---|---|
| <p>Fault Code: 156</p> <p>PID(P): 105</p> <p>SPN: 1131</p> <p>FMI: 3</p> <p>Lamp: Yellow</p> <p>SRT: 00-696</p> | <p>Intake Manifold 2 Temperature Sensor Circuit - Voltage Above Normal or Shorted to High Source.</p> <p>High voltage detected on SIGNAL pin 06 of the main harness A ECM connector.</p> | <p>Fault Code 158 is disabled.</p> |

The left bank rear intake manifold temperature sensor provides the left bank rear intake manifold air temperature signal to the CENSE™ ECM.

The left bank rear intake manifold temperature sensor is located on the left bank rear intake manifold. The sensor is located downstream of the aftercooler.

Refer to Troubleshooting Fault Code t05-156 (</qs3/pubsys2/xml/en/procedures/81/81-t05-156.html>)
