# Fault Code: 624

## Exhaust Gas Temperature Deviation Low for Cylinder 7 - Data Valid But Below Normal Operating Range - Least Severe Level

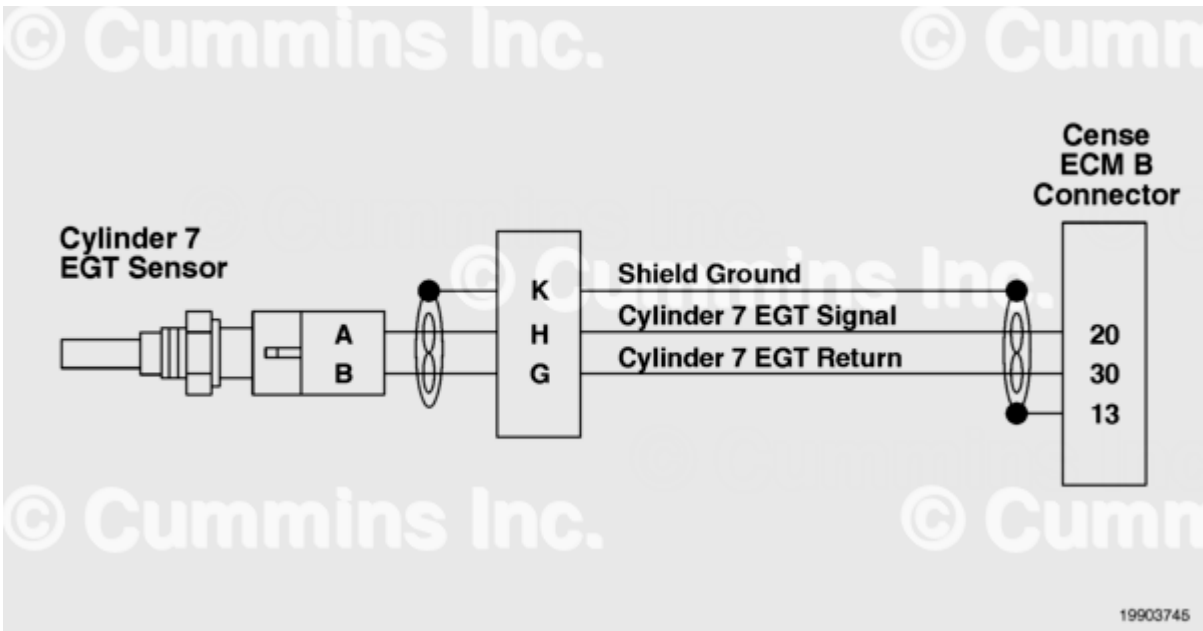
Exhaust Gas Temperature Sensor Circuit Cylinder 7 - QSK45 and QSK60 Engines

The exhaust gas temperature sensor circuit cylinder 7 monitors exhaust gas temperature and passes information to the engine control module (ECM) through the engine harness.

The exhaust gas temperature sensor circuit cylinder 7 for this fault code is located in the exhaust manifold at the cylinder head 7 to exhaust manifold interface.
