# Fault Code: 626

## Exhaust Gas Temperature Deviation Low for Cylinder 11 - Data Valid But Below Normal Operating Range - Least Severe Level

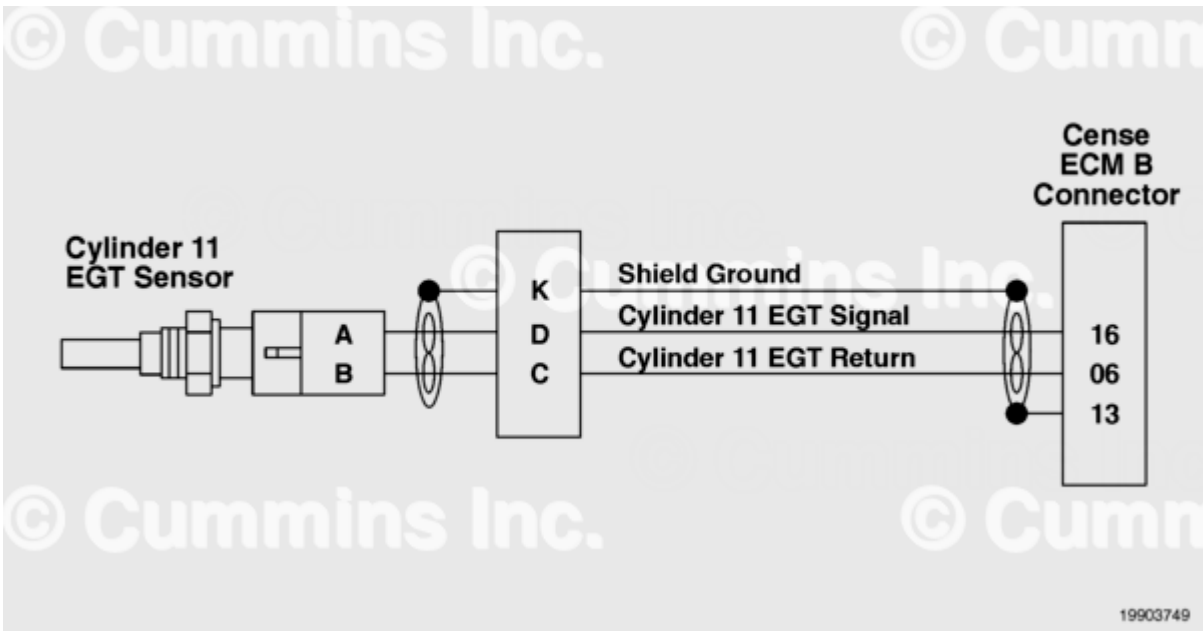
Exhaust Gas Temperature Sensor Circuit Cylinder 11 - QSK45 and QSK60 Engines

The exhaust gas temperature sensor circuit cylinder 11 monitors exhaust gas temperature and passes information to the engine control module (ECM) through the engine harness.

The exhaust gas temperature sensor circuit cylinder 11 for this fault code is located in the exhaust manifold at the cylinder head 11 to exhaust manifold interface.
