Technical Service Bulletin: tsb090070

Released Date: 12-Nov-2021

Diesel Exhaust Fluid (DEF) Exhaust Blockage (Crystallization/Polymerization) and Fault Codes 1682, 2973, 2772, 2773, 3548, 3538, 3568, 3582, and 5655

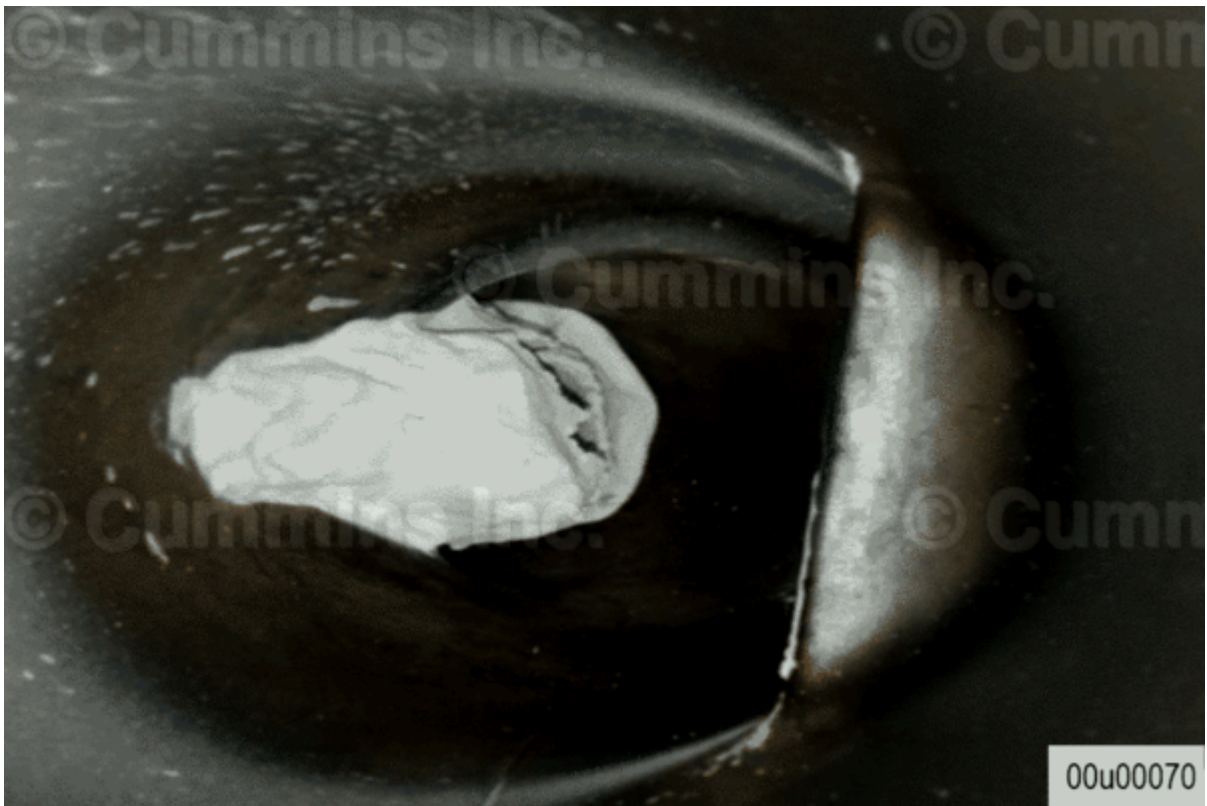
1. Less than 20% DEF Accumulation (See Figure 1 below)
  - Minor tracking marks can be seen in the decomposition tube.
  - This is normal and will burn off in normal operating conditions during an active regeneration.
  - Vehicle performance **not** impacted.
  - No further action required.
2. 20 to 40 % DEF accumulation (See Figure 2 below)
  - This is normal and will burn off in normal operating conditions during an active regeneration.

- Vehicle performance **not** impacted.
  - No further action required.
3. 40 to 50 % DEF Accumulation (See Figure 3 below)
- Soft Crystal Buildup - White in color.

Figure 2, 20% to 40% DEF Accumulation.

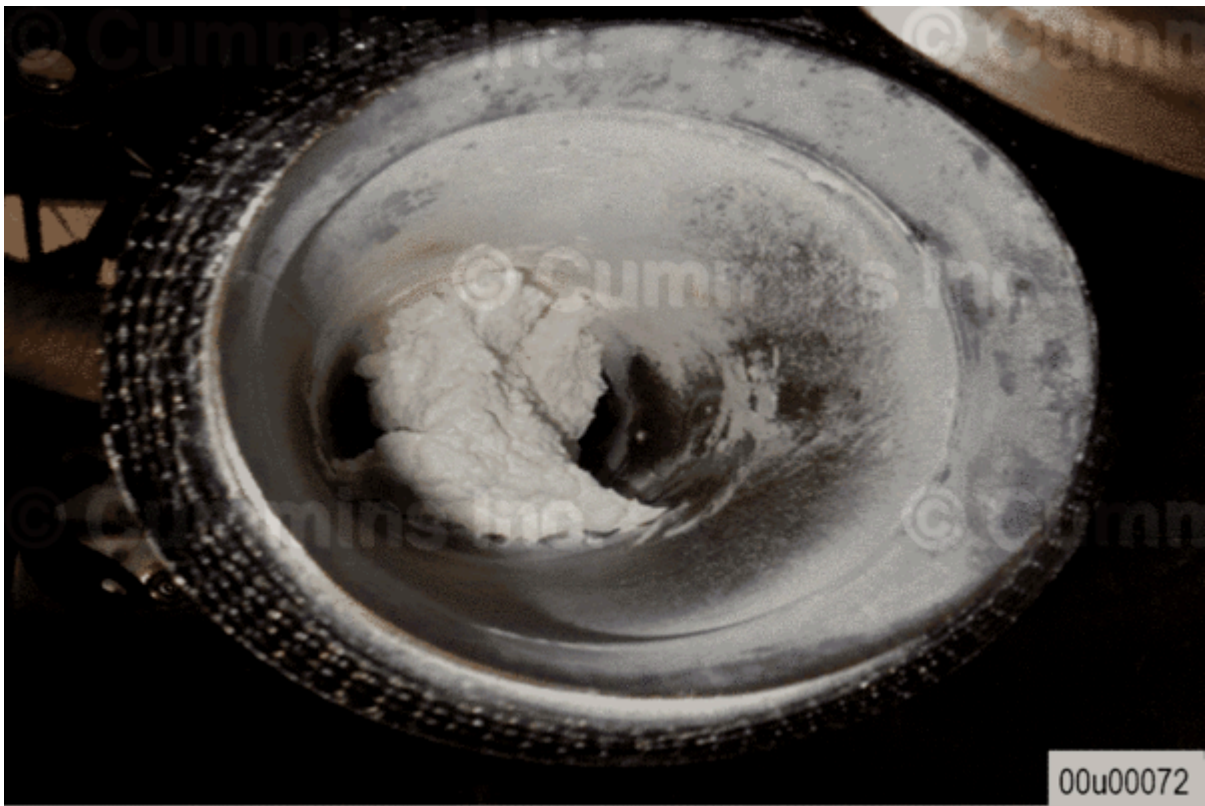
4. 50 to 80 % DEF Accumulation (See Figure 4 below)
- Polymerization occurs when crystals are heated for prolonged periods of time at temperatures below 290°C [554°F].

- White in color.
  - **Not** able to be dissolved using warm water.
  - Decomp tube will need to be removed and cleaned out.
  - Check aftertreatment system gaskets and clamps for leaks and replace as required.

- Duty cycle will need to be assessed and potential stationery regeneration schedule implemented.
  - Hard and difficult to remove.
  - Covering 50 to 80 percent of exhaust cross section.

- Usually forms at nozzle location, at point where injection spray touches the exhaust wall.
  - Can be made more severe by exhaust system design violation.

Figure 4, 50% to 80% DEF Accumulation.

- DEF accumulation covering less than 50% of cross sectional area does **not** need to be removed.
- DEF accumulation above 50% **must** be removed. See corresponding Service Manual. Reference Procedure 011-062 in Section 11.
- For any instances of reoccurring DEF accumulation where a resolution is **not** found using above information, a Technical Service Request (TSR) is to be raised.

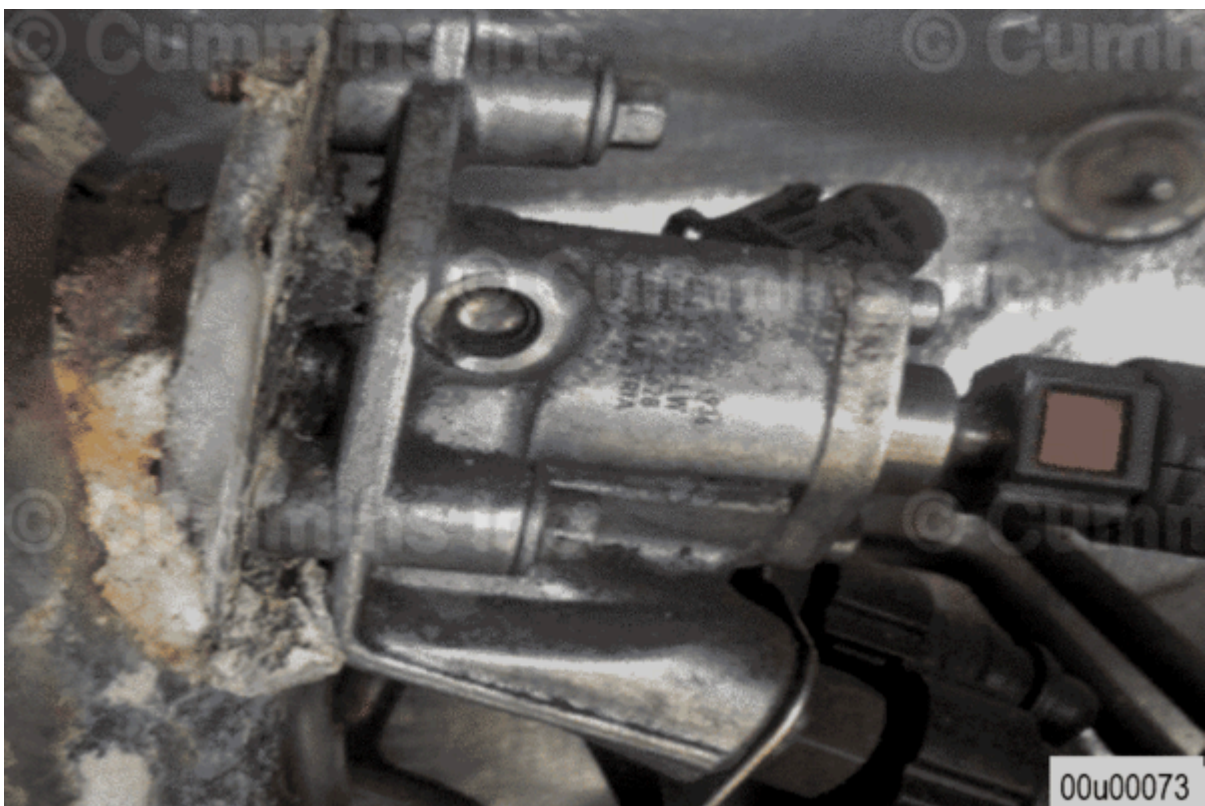
- External Buildup
  - Indication an exhaust malfunction exists that will also cause internal DEF buildup
- Internal Decomposition Pipe Cleaning when crystallization leak is witnessed externally (DEF Injector Gasket). (See Figure 6 below).

- External Crystal growth can be witnessed from the DEF Injector gasket.
  - There is no detriment to the performance of the system when this is witnessed, no additional repairs are required other than to change the Injector Gasket.

Figure 5, External Buildup.

- New gasket has been released to remedy these leaks.
  - Cummins Part Number 5508734.
  - CES Part Number A063J608.
- DEF injector changes, Injectors seen to be “wet” or with a “drip” during system prime.

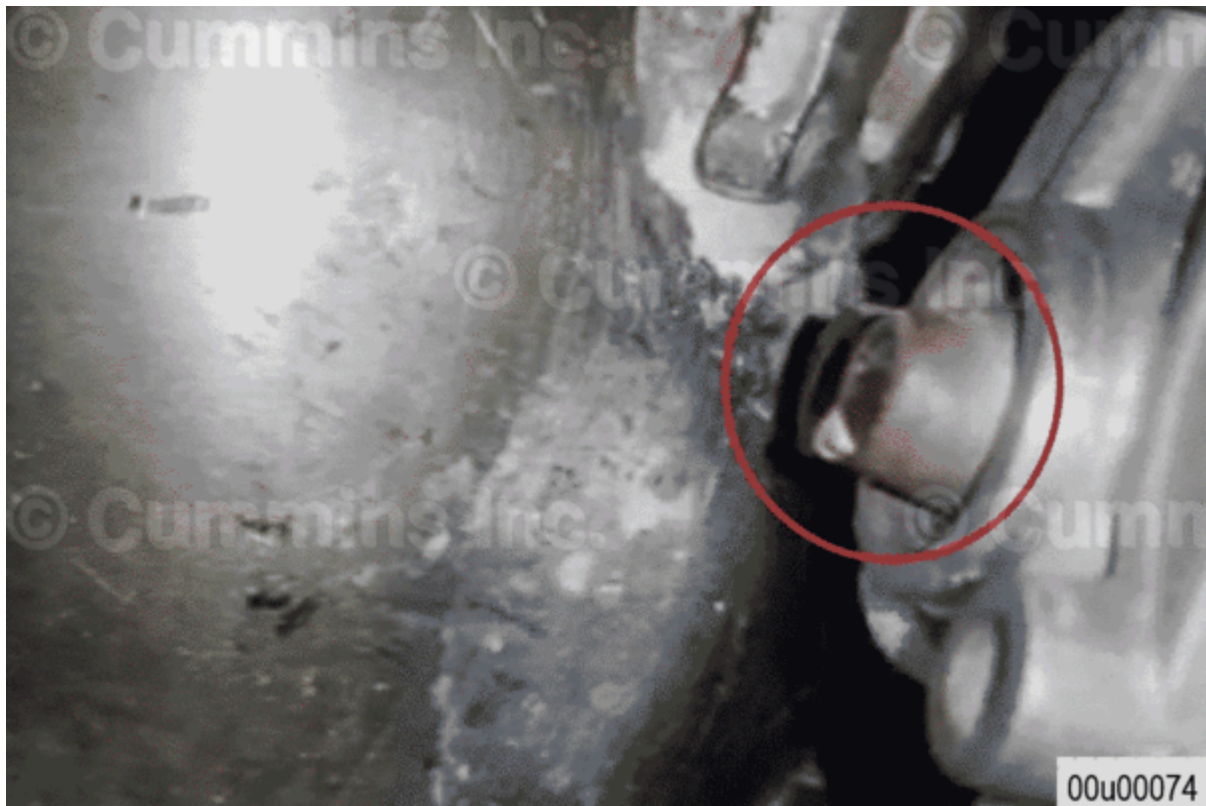
- During the prime procedure a build-up of fluid will be noted from the DEF injector nozzle – as seen in Figure 7.
  - This is a normal condition and does **not** point to a potential injector issue.

- The injector tip is a “wet tip”, Small amounts of fluid are released to allow any crystal build up to be dissolved. During the priming of the system.

Figure 6, Buildup of Fluid Noted from the DEF Injector Nozzle.
