# Technical Service Bulletin

| Technical Service Bulletin: tsb101016 | Released Date: 03-Dec-2009 |
| Optimized Lubricating Oil Filter | |

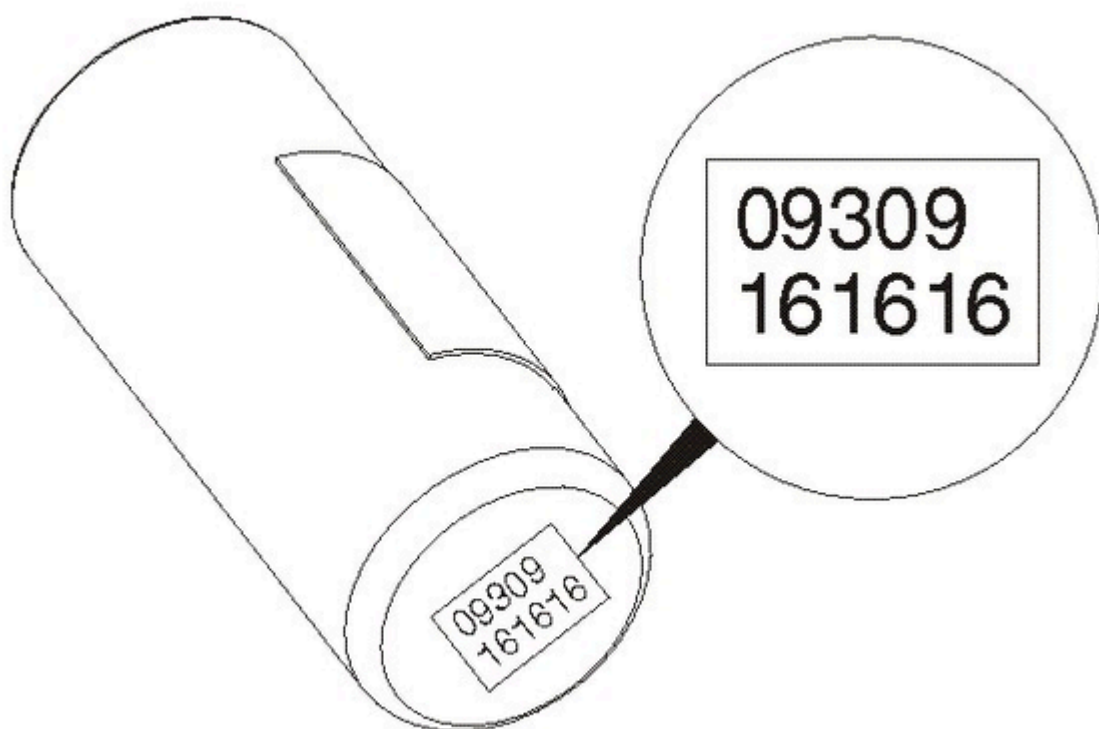
07c00651

Optimized LF9000 and LF9001 filters were manufactured beginning November 5, 2009. The filters will display a date code – inkjet printed on the bottom of the filter – in the format shown in the photograph in the Repair Instruction section.

The top line reflects the filter manufacturing code. Filters with the modification will read: 09309 and higher. The products could also reflect code 10001 and higher. The bottom line of the filter code is **not** necessary for filter identification in this instance.

When troubleshooting an ISX engine for low oil pressure, be sure to follow the published symptom trees appropriate for the problem, such as t105, Lubricating Oil Pressure Low, and if necessary, t103-56, Lubricating Oil Filter Plugged. If the engine is ready to be returned to operation and the root cause is unclear, compare the date code of the used filter to the date code listed above. If the filter was manufactured before the date above, make sure the new filter is manufactured after this date. If the used filter date code is after the change date and the root cause is unclear, then contact your appropriate Cummins® technical assistance resource.
