Technical Service Bulletin: TSB101032

Boost Pressure Sensor Adapter Harness Resulting in Fault Codes 122/123

- QSK23 CM500

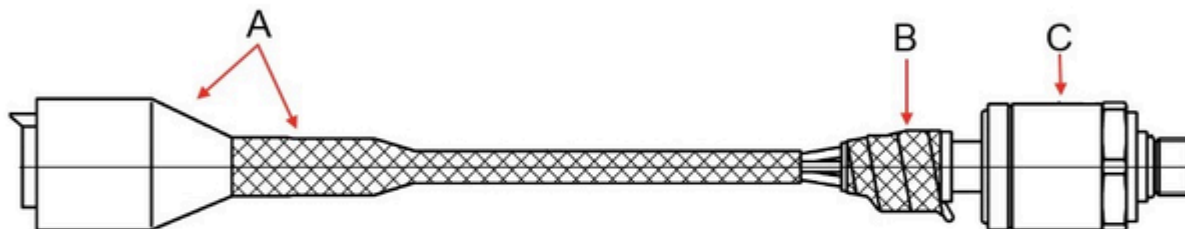
Figure 1, Boost Pressure Sensor and Adapter Harness Assembly, Part Number 4096902

Engines with a build date after 29 July 2010 are less likely to experience the issue highlighted above because these engines have the following parts that were released into production to prevent boost pressure sensor fault codes.

- A. 3 pin Deutsch™ Connector and harness.
- B. Tape location between adapter harness and boost pressure sensor.
- C. Boost pressure sensor, Part Number 3408589.

For field service, it is possible to avoid replacing the engine wiring harness by cutting off the current Packard™ connector on the engine harness and splicing a new male Deutsch™ connector in its place. For this solution, the parts in Table 3 should be used.

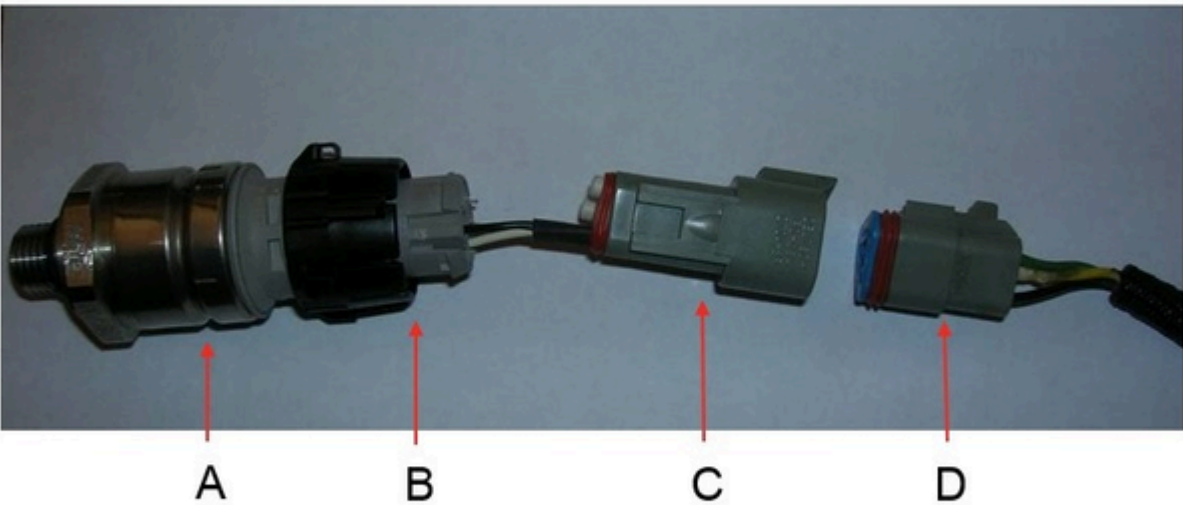
Figure 3, Jumper Harness and Boost Pressure Sensor

If the boost pressure sensor and adapter harness assembly, Part Number 4096902, is **not** available, the parts in Table 4 can be used to assemble a jumper harness to connect to boost pressure sensor, Part Number 3408589.

- Attach 3 pin Deutsch™ female connector (Figure 3, Item C) to the 3 pin Packard™ connector (Figure 3, Item B).
- Insert the 3 pin Packard™ connector into boost pressure sensor (Figure 3, Item A).
- Heat shrink **must** be applied around the harness and sensor connection to prevent movement.
