Technical Service Bulletin: tsb101596

Released Date: 26-Apr-2016

Cylinder Head and Main Bearing Capscrew Thread Repair

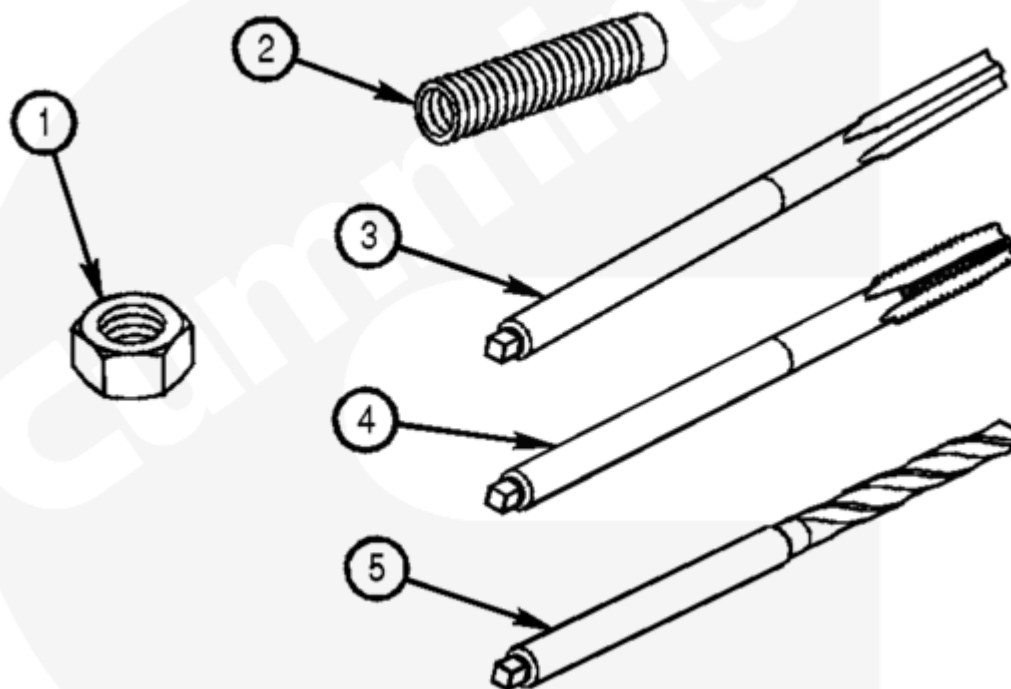
Figure 1, Items Purchased Separately.

This document introduces the required components to salvage damaged cylinder head and main bearing capscrew hole threads on the ISX and QSX15 series engines.

The illustration and table below show the items required in addition to the thread salvage kit, Part Number 3164021.
