| Technical Service Bulletin: TSB120004 | Released Date: 18-Jan-2012 |

## External Oil Leaks at Rocker Housing Gasket Reduced by Loctite™ 243 Applied to the Intake Port Capscrews

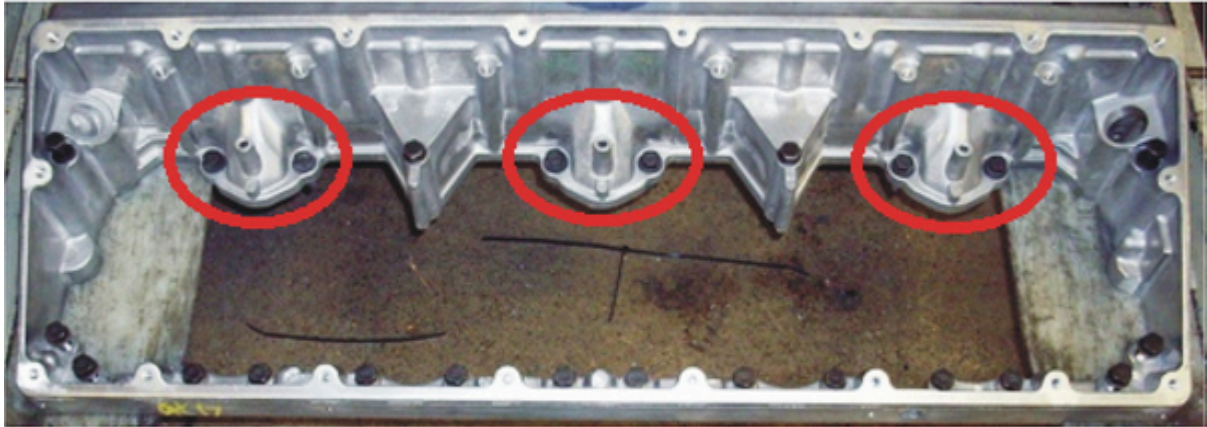
03z00005

External oil leaks at the ISM rocker housing gasket are partially caused by loss of capscrew load. Cyclic thermal expansion of the aluminum housing can cause the capscrews to rotate and eventually “ratchet” loose. The six short capscrews located at the intake ports are at risk for this issue.

External oil leakage from the rocker housing gasket, especially around the intake ports.

If the rocker housing is removed during any repair, oil resistant medium strength thread locker, such as Loctite™ 243 or equivalent, should be used when assembling the six short capscrews located on both sides of the three intake ports. Reference the photograph below.
