Technical Service Bulletin: TSB120227

Piston Cooling Gallery Plate Inspections on Heavy Duty Engines

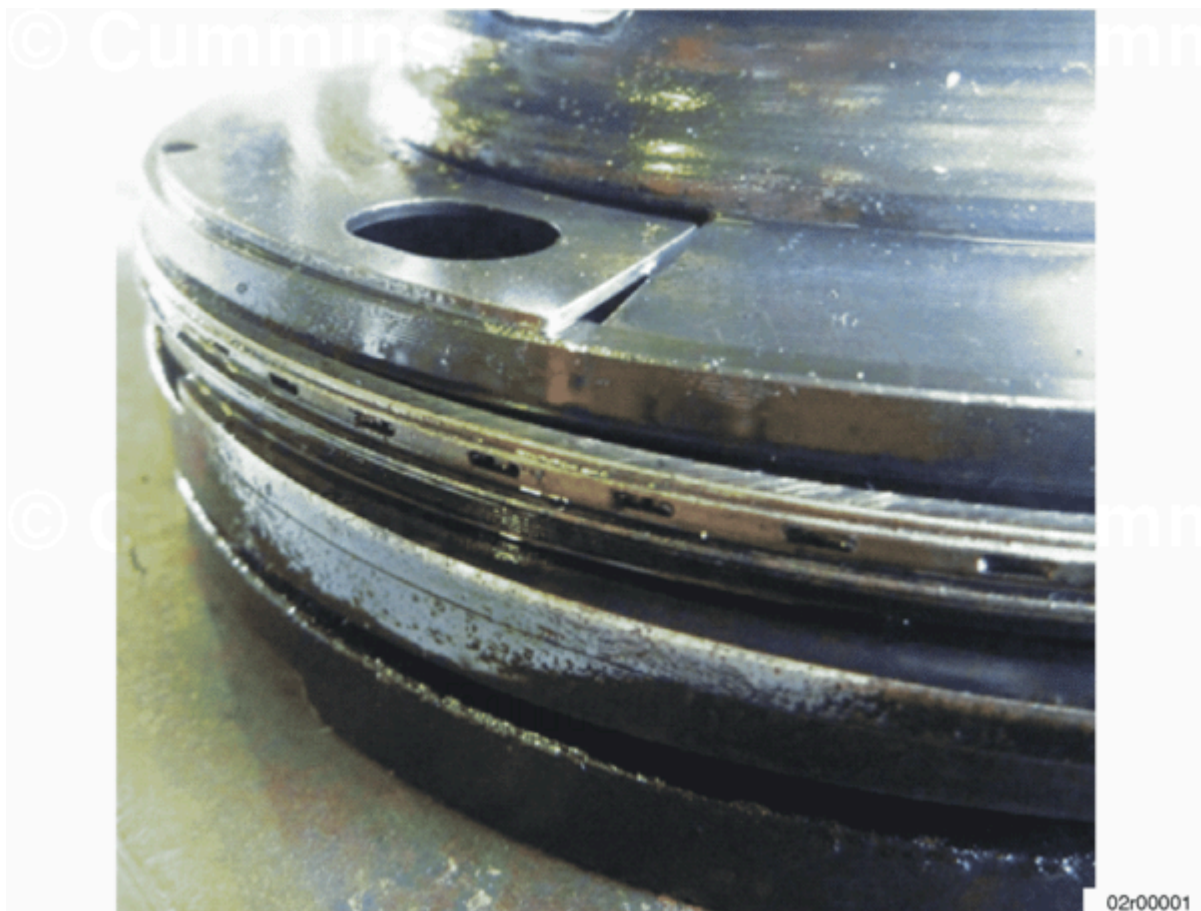
02r00001

Before installing new or used pistons, inspect the condition of the piston oil cooling gallery plates. Pistons have been found with loose, broken, and missing plates. In all, cases, the piston is to be replaced and the new piston inspected.

Piston crown cooling and oil retention will be impacted by loose, broken, or missing cooling plates. In some cases progressive damage could occur such as scuffing, accelerated ring wear, accelerated liner polishing, etc.
