Technical Service Bulletin: TSB140019

Fuel Pump - Plunger and Tappet Roller Inspection and Repair

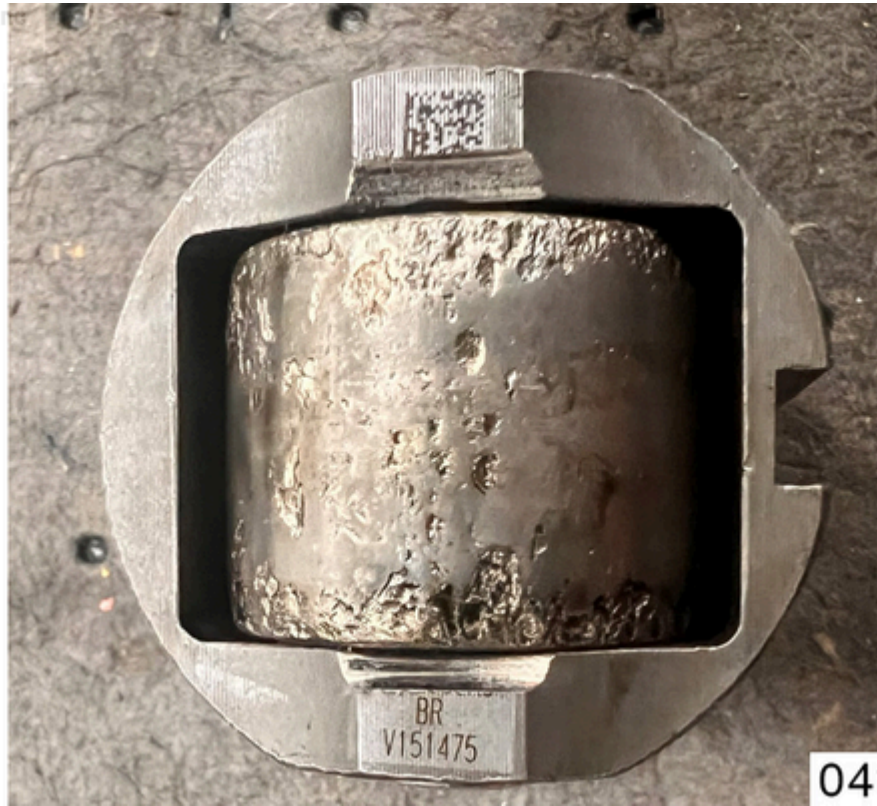
04v00001

Figure 1, Damaged Fuel Pump Tappet Roller Assembly.

Scenario 1: The fuel pump tappet rollers are damaged or pumping plunger damage is found:

- Remove, cut open, and inspect the lubricating oil filter for debris. See Procedure 007-083 in Table 2.
- Connect INSITE™ electronic service tool to the service tool data link and review any logged fault codes.
- Reference Table 1 below for repair direction.
