| Technical Service Bulletin: TSB140030 | Released Date: 14-Mar-2016 |
| ISX15 and QSX15 Early Life Oil Consumption Caused by Vertical Liner Lobing | |

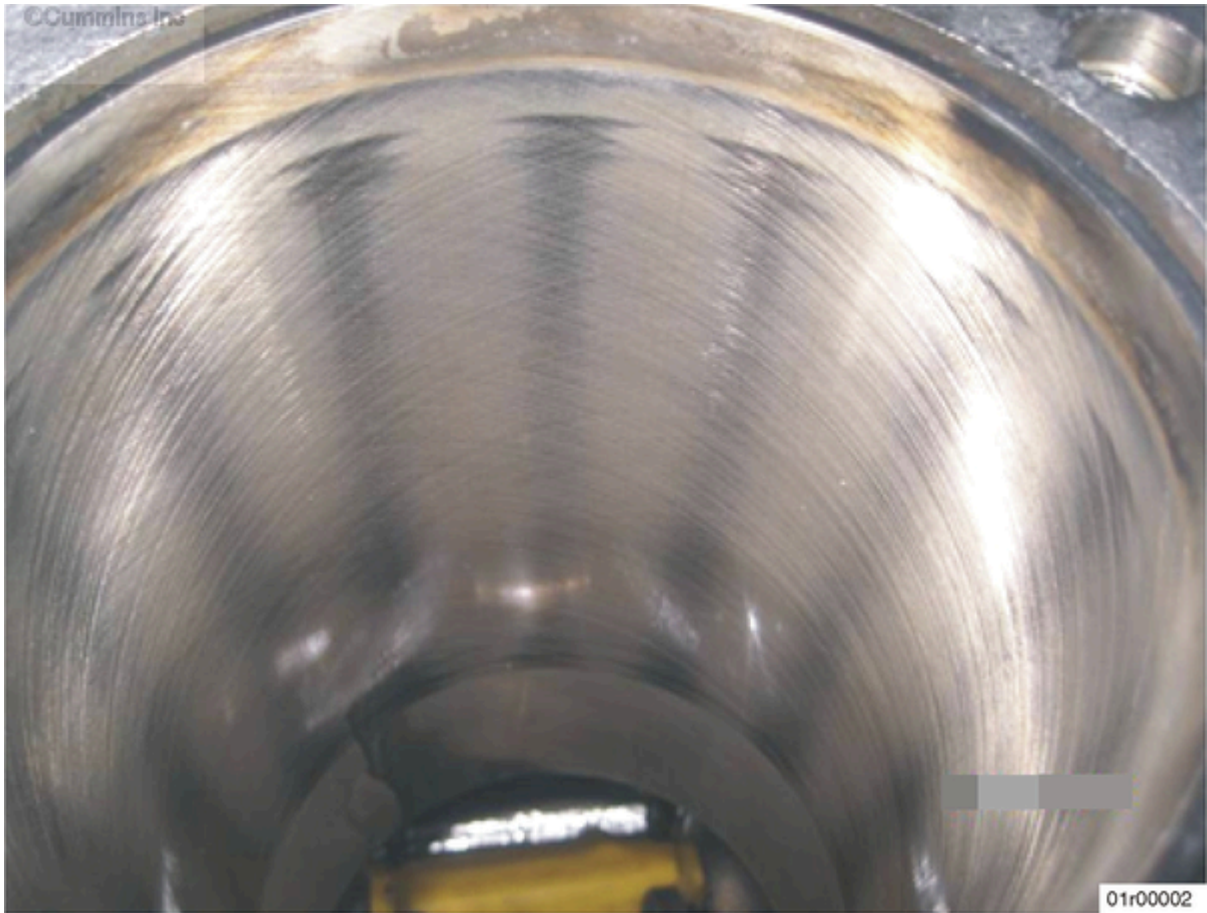
A vertical lobing pattern located on the inside diameter of the cylinder liner has been linked to early life internal oil consumption and/or frequent regen/aftertreatment fault codes. This lobing pattern prevents the piston rings from conforming to the liner, allowing oil to by-pass, resulting in elevated internal oil consumption and the formation of carbon deposits. Most of these early life complaints will surface at less than 120,000 miles [2000 hrs] on the engine.

Suspect used liners may show visual evidence of the 13 equally spaced vertical lobing pattern, as seen in Figures 1 and 2.

Figure 1 is a worst-case example that shows a cylinder liner at 33,000 miles and 635 Miles per Quart (MPQ) oil consumption. Carbon packing has started on all pistons but bore polish in all liners has **not** become an issue yet.

Figure 1: Cylinder Liner with Obvious Evidence of Lobing

In most all cases, the pistons will have heavy carbon packing on the top lands. If these pistons are reduced diameter top land pistons with low rings (Reference TSB150069), the carbon can be cleaned and pistons reused. If they are **not** reduced diameter top land pistons, replacing the pistons with the new reduced diameter top land piston is recommended.

Lobed liners are considered non-reusable and need to be replaced. If this lobing pattern is identified, inspect all six cylinders and replace cylinder liners as necessary.

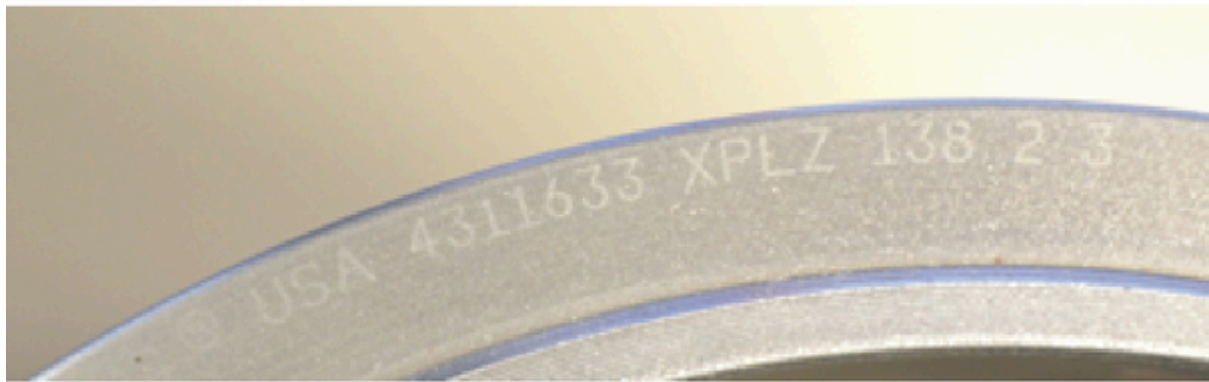
01r00004

The liner information and date codes are etched on the liner in one of the locations shown in Figures 3 and 4. The location of the markings is **not** an indicator of the XPLZ or ABDJV marking, since they have been found in both locations.

Figure 3: (Photograph for reference only.) The date code in the photograph above is suspect for liner lobing and would require inspection. The date code is formatted as Day, Year, and Shift. "138 2 3" translates to the 138th day of the year, the year 2012, and the third shift of the day or May 18th, 2012, Third Shift.
