Technical Service Bulletin: TSB140137

ISX 12/15 CM2250/CM2350 Variable Geometry Turbocharger (VGT) Turbocharger Bearing Housing Coolant Leak Test - Service Tool Leaks

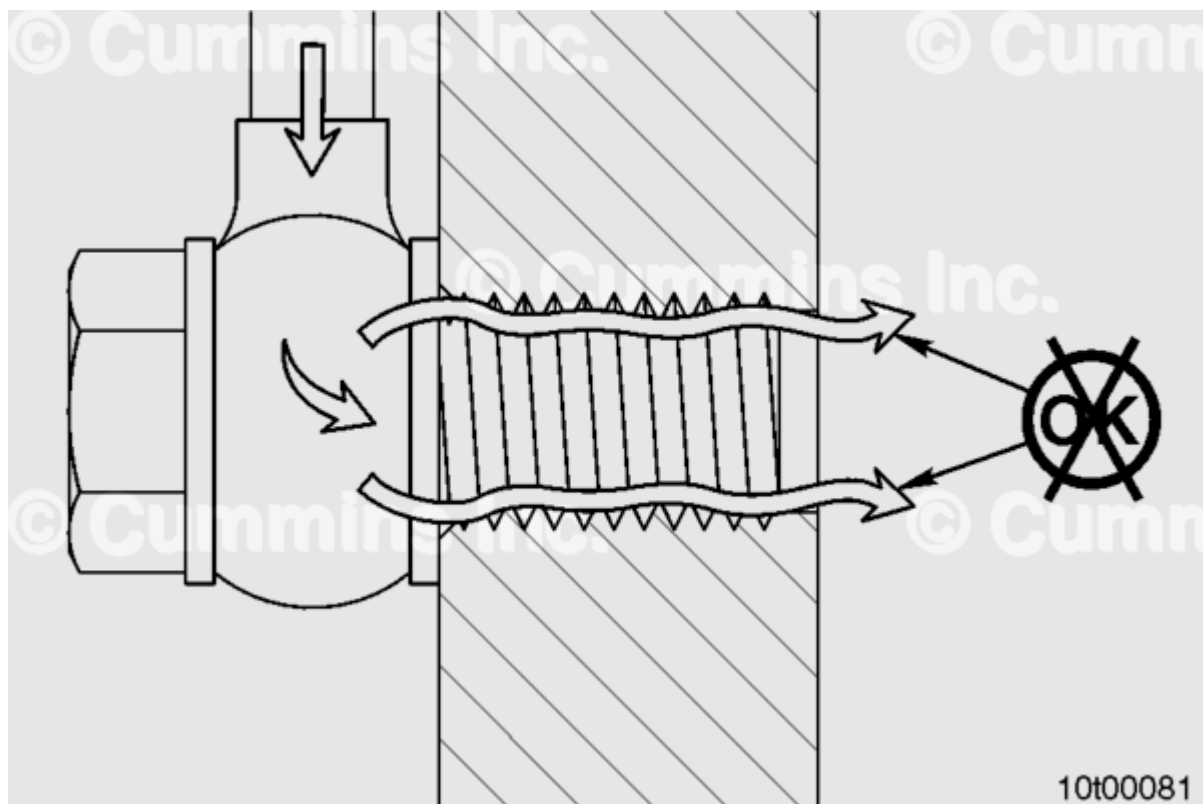
Figure 1

Turbochargers are being returned due to failing the bearing housing leak test when using Service Tool Kit, Part Number 2892101, as described in Procedure 010-033 (Turbocharger) in the service manual. It was found that the actual leak was caused by the service tool. The block off fittings do **not** provide enough shoulder for the inner seal of the banjo washer to seal properly, allowing air to leak down past the bolt and mating component threads. See Figure 1.
