Technical Service Bulletin: TSB150001

Incorrect Coolant Pre-Heater Installation Resulting in Piston Scuffing on QSK23 Engines

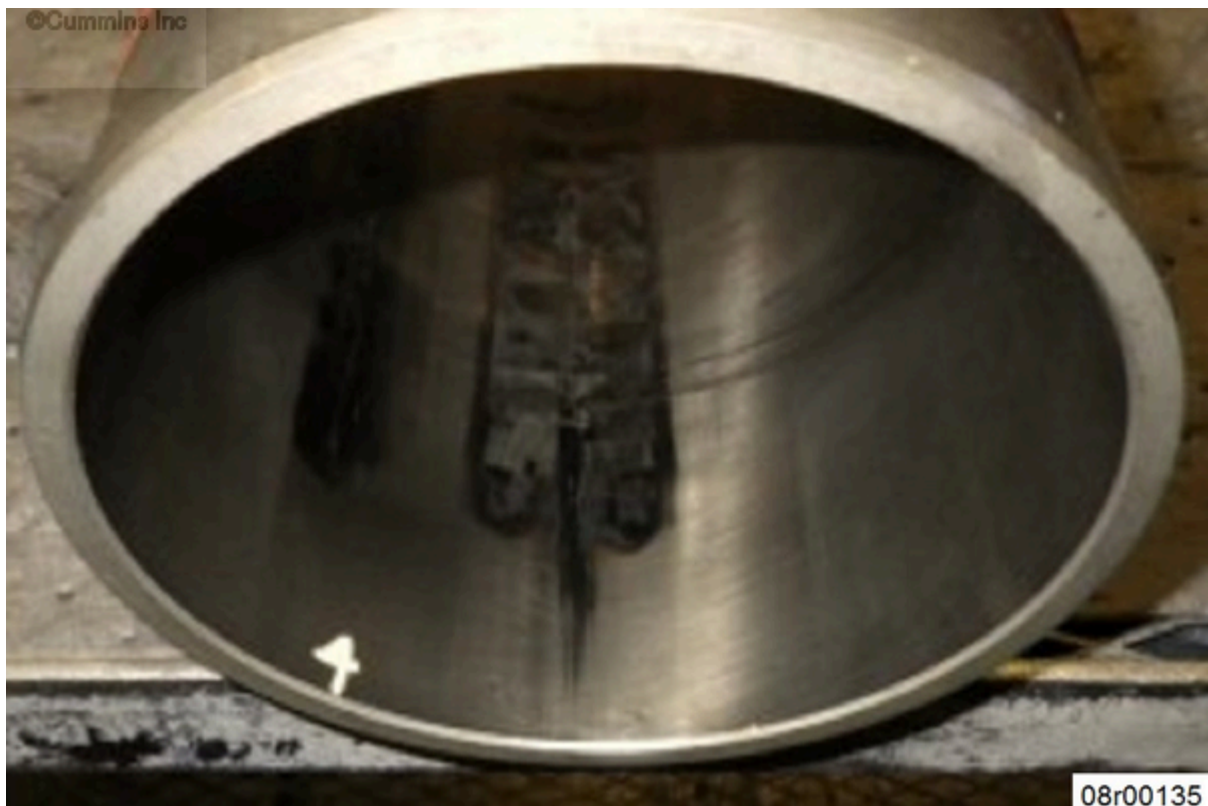
The coolant pre-heater has **not** been correctly connected to the engine for proper heating of the coolant. This results in the engine **not** being warmed properly prior to use at rated speed and load. This can lead to a scuffed piston(s).

Figures 1 through 4 below show center line piston scuffing that resulted from an engine **not** being warmed properly prior to use at rated speed and load.

Figure 1, Anti-Thrust Side Piston Scuff on Cylinder Liner

If the coolant pre-heater coolant inlet and outlet connections are incorrect, correct them per Figure 5 above. This will ensure proper coolant pre-heater operation and heating of the engine.

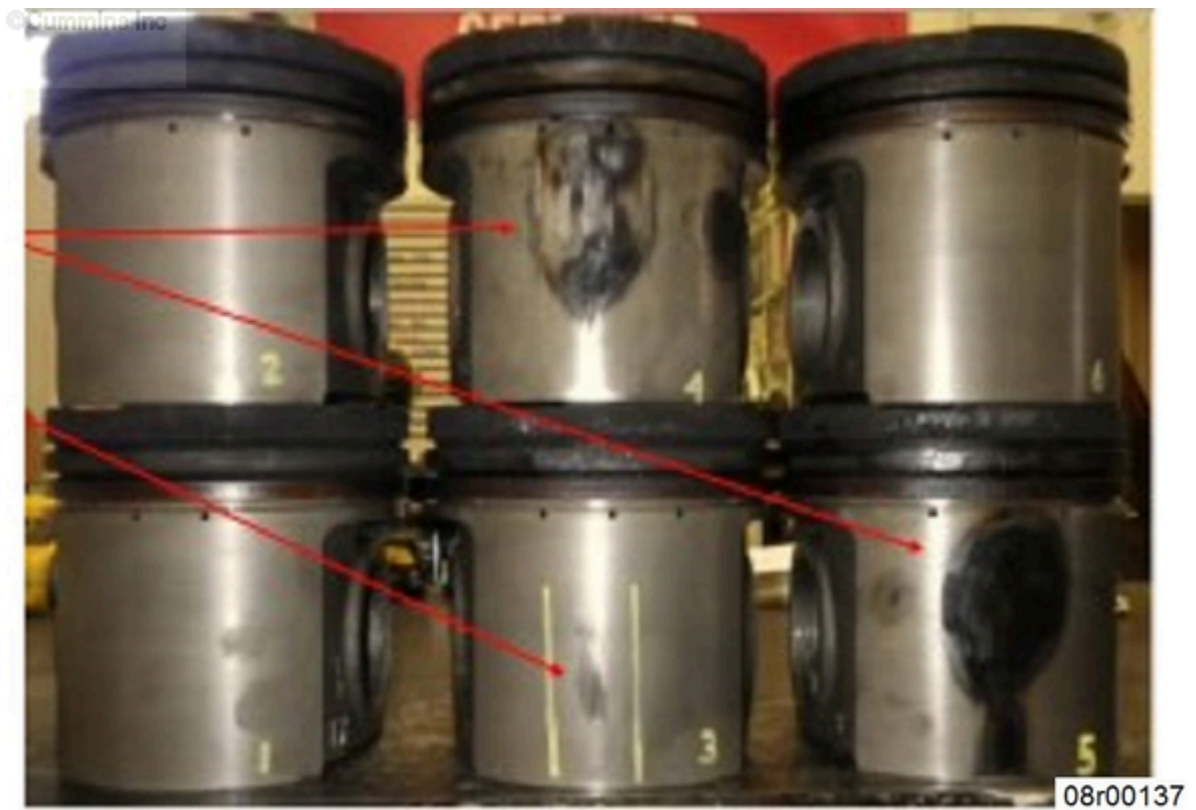
Figure 3, Anti-Thrust Side Piston Scuff

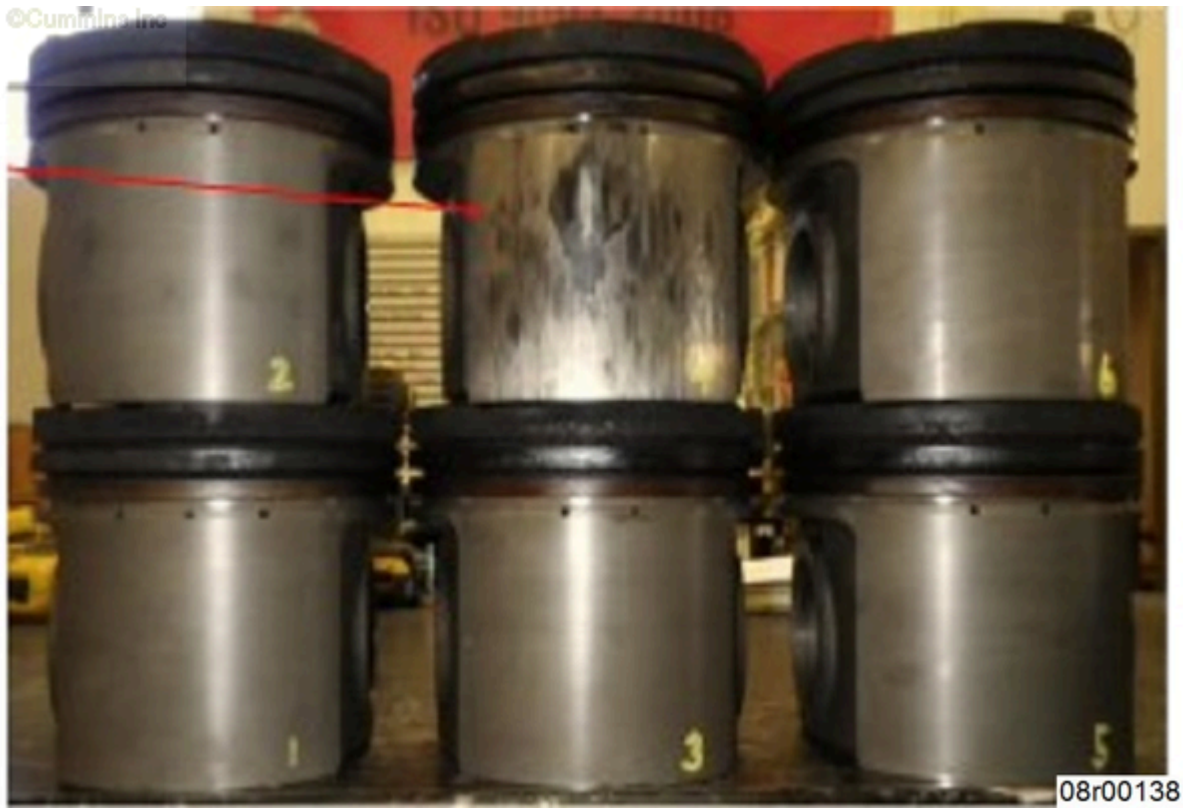
Figure 4, Thrust Side Piston Scuff
