Technical Service Bulletin: TSB160035

Released Date: 06-Apr-2016

Cooling Fan Drive Belt Shredding on Recreational Vehicle Applications

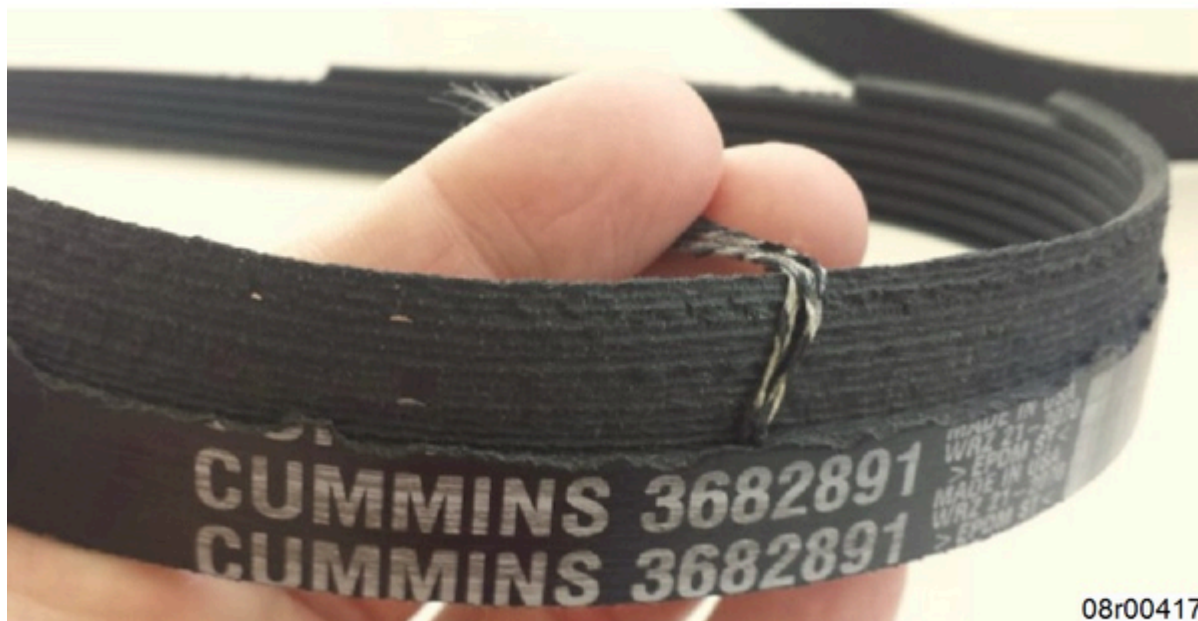
08r00417

- Existing cooling fan drive, Option FA1614, and fan belt drive, Option FA1756, exhibit excessive cooling fan drive belt flap during rapid deceleration on a recreational vehicle applications. This cooling fan drive belt flap leads to the cooling fan drive belt jumping out of alignment.

Figure 1, Example of Belt Shredding

Install the new cooling fan drive belt and automatic belt tensioner listed in the Service Parts Availability section below.
