Technical Service Bulletin: TSB170045

Released Date: 08-Aug-2018

Crankcase Pressure Sensor Fault Code 555 or 556: Reoccurring Issue in Cold Weather

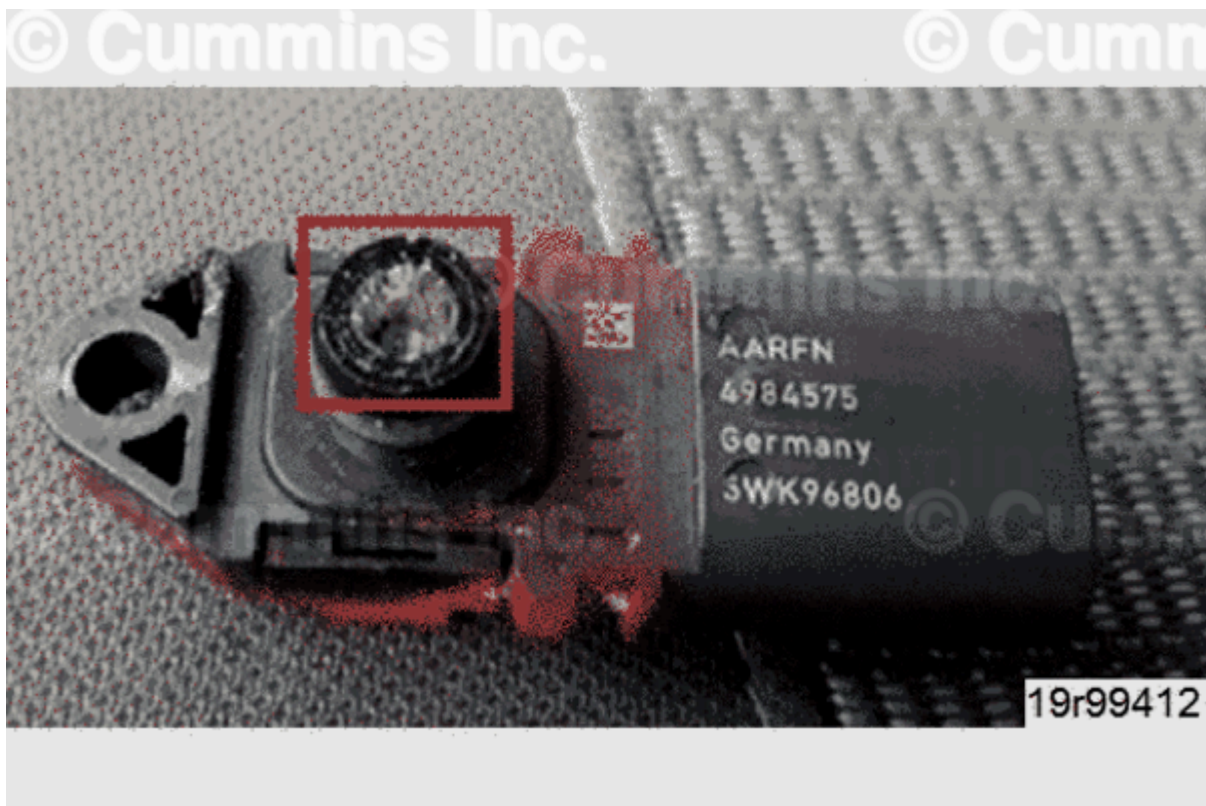
- Excessive moisture can lead to ice build-up inside crankcase pressure sensor. Ice presses against crankcase pressure sensor diaphragm and produces a false occurrence fault code.

- Verify engine has been operating in temperatures below freezing
- Locate crankcase pressure sensor; on inlet hose to crankcase breather or on crankcase breather.
- If crankcase pressure sensor measures within range as stated in Troubleshooting step 2A - Verify Pressure Sensor Accuracy, remove crankcase pressure sensor and inspect for evidence of water accumulation or ice in crankcase pressure sensor port as seen Figure 1 below. See corresponding service manual. Reference Procedure 019-445 in section 19.

Figure 1, Frozen Crankcase Pressure Sensor.

- For ISX15 CM2250, ISX15 CM2250 SN, and ISX15 CM2350 X101 engines a crankcase breather retrofit kit is available. Follow Installation Instructions 5414650 to replace crankcase breather assembly with improved crankcase breather.
- Coating crankcase pressure sensor with CRC 3-36 or WD-40 prevents water or debris accumulation in crankcase pressure sensor port that may freeze when temperatures drop below freezing. See Service Instruction section below.
- Periodic reapplication of CRC 3-36 or WD-40 spray in cold weather as a preventative measure is recommended.

- Let crankcase pressure sensor thaw if frozen debris is found. Spray CRC 3-36 or WD-40 directly into the crankcase pressure sensor port. Do **not** insert nozzles, straws, or other attachments into the crankcase pressure sensor port or damage can occur.
  - Verify crankcase pressure sensor port receives a complete coating of CRC 3-36 or WD-40 spray.
