Technical Service Bulletin: TSB170122

White Residue / Diesel Exhaust Fluid (DEF) Staining On Exhaust

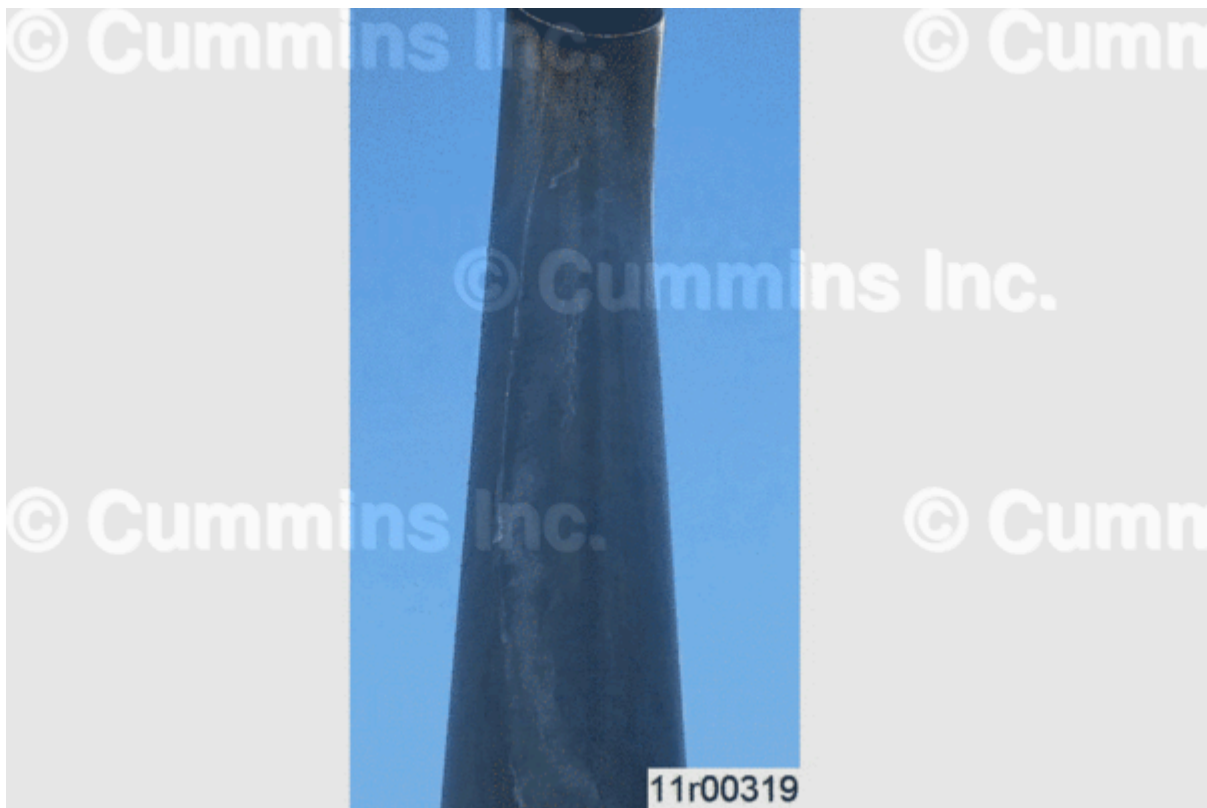
Figure 1, White Staining on Exhaust Stack.

- Urea **not** being decomposed/atomized to gaseous state completely for any of the following reasons

- Presence of diesel exhaust fluid (DEF) deposits in aftertreatment decomposition tube or mixer
- Overdosing aftertreatment DEF dosing valve
- Incorrect concentration of DEF
- However, there may be nothing wrong with DEF system and residue, staining, or powder might be more noticeable for applications that operate with lower aftertreatment temperature less than 250°C [ 482°F ].
- Presence of white staining / DEF staining on exhaust stack does **not**
  - Impact performance of engine and aftertreatment.
  - Impact durability of aftertreatment or exhaust system.
  - Increase DEF consumption.

- If any fault codes related to aftertreatment and/or DEF system are active, troubleshoot fault codes using corresponding troubleshooting tree.
- If there is a complaint of excessive DEF consumption, follow the appropriate Excessive Diesel Exhaust Fluid (DEF) Consumption troubleshooting.

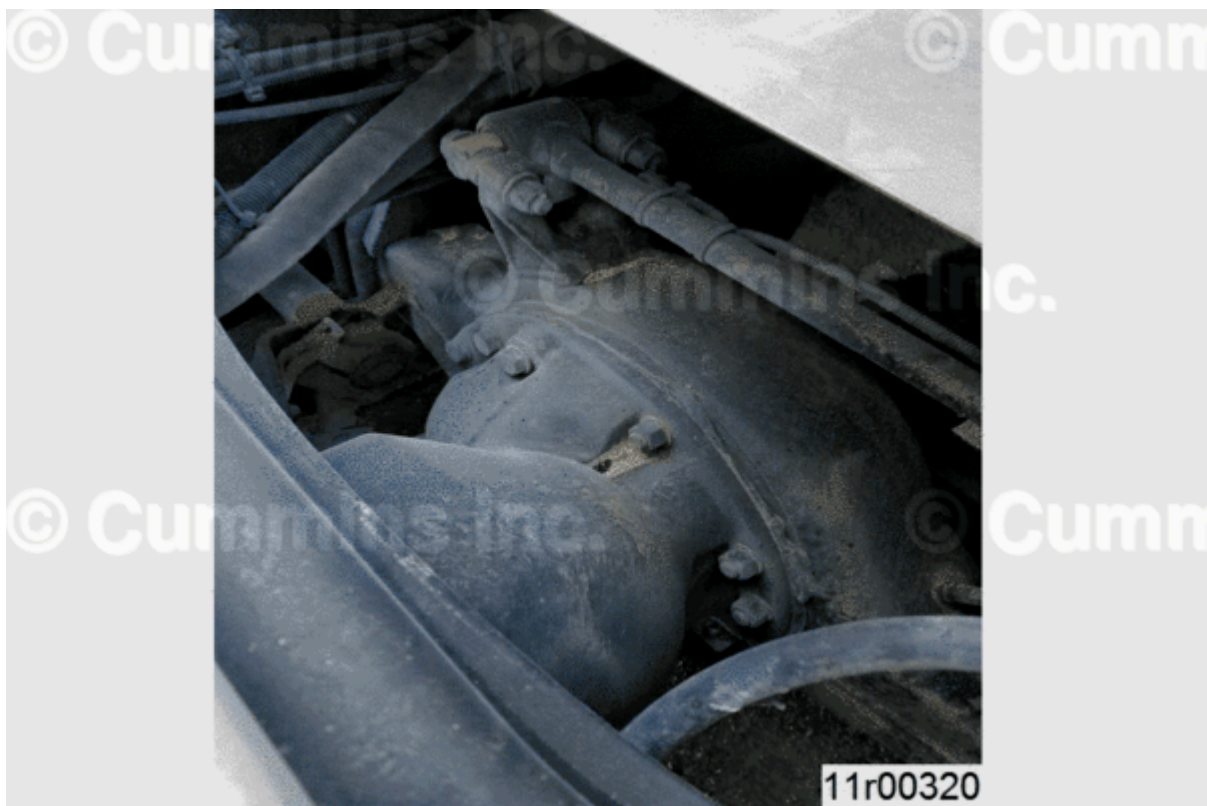
Figure 2, White Powder on Frame.
