Technical Service Bulletin: TSB170124

Released Date: 19-Mar-2020

Fuel Pump Timing Correction to Reduce Engine Noise

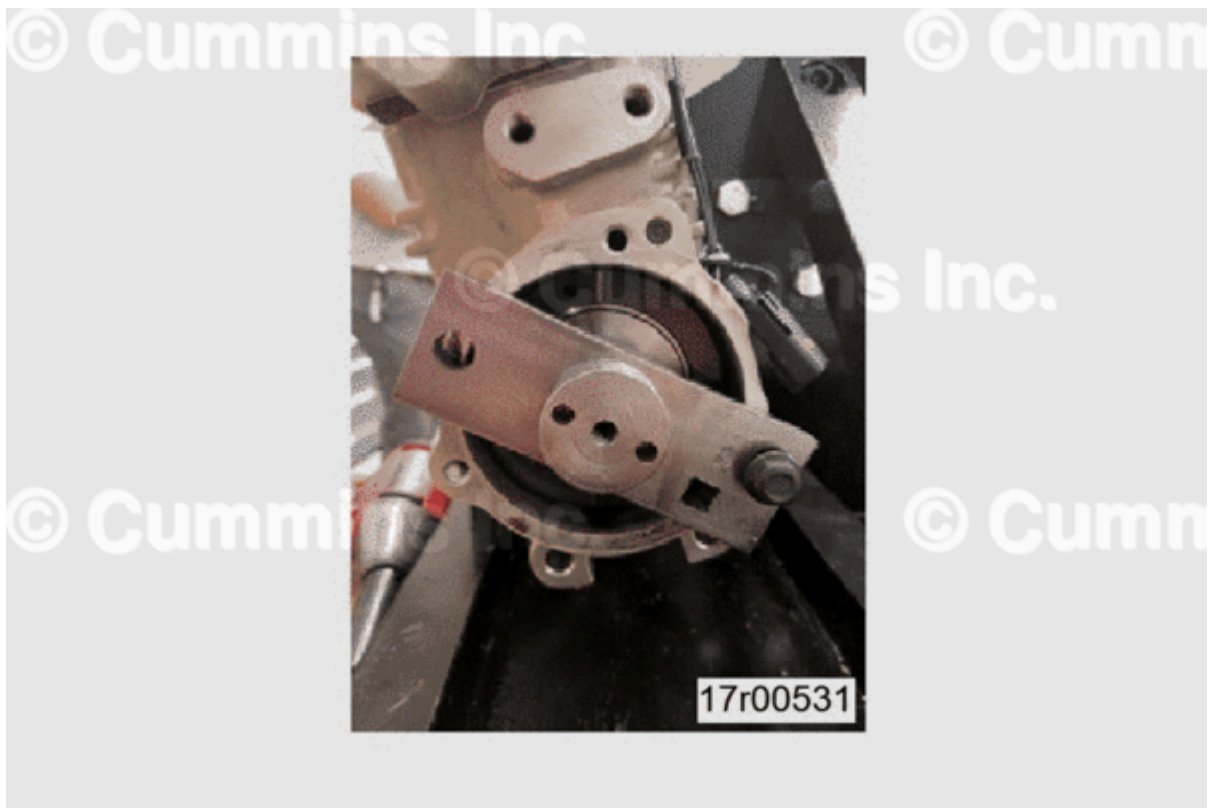
Figure 1. Service Tool Installation on ISX/QSX CM2250, CM2350, and X15 CM2350 114B.

- Verify base engine timing. See corresponding Service Manual. Refer to Procedure 001-088 (/qs3/pubsys2/xml/en/procedures/377/377-001-088.html) in Section 1.
- Time the high-pressure fuel pump. See corresponding Service Manual. Refer to Procedure 005-016 (/qs3/pubsys2/xml/en/procedures/377/377-005-016.html) in Section 5.

- Verify base engine timing. See corresponding Service Manual. Refer to Procedure 001-088 (/qs3/pubsys2/xml/en/procedures/453/453-001-088.html) in Section 1.
- Check the gear lash. See corresponding Service Manual. Refer to Procedure 001-088 (/qs3/pubsys2/xml/en/procedures/453/453-001-088.html) in Section 1.
- Time the high-pressure fuel pump. See corresponding Service Manual. Refer to Procedure 005-016 (/qs3/pubsys2/xml/en/procedures/453/453-005-016.html) in Section 5.

See Figures 1 and 2 for descriptions of tools installed on fuel pump(s).

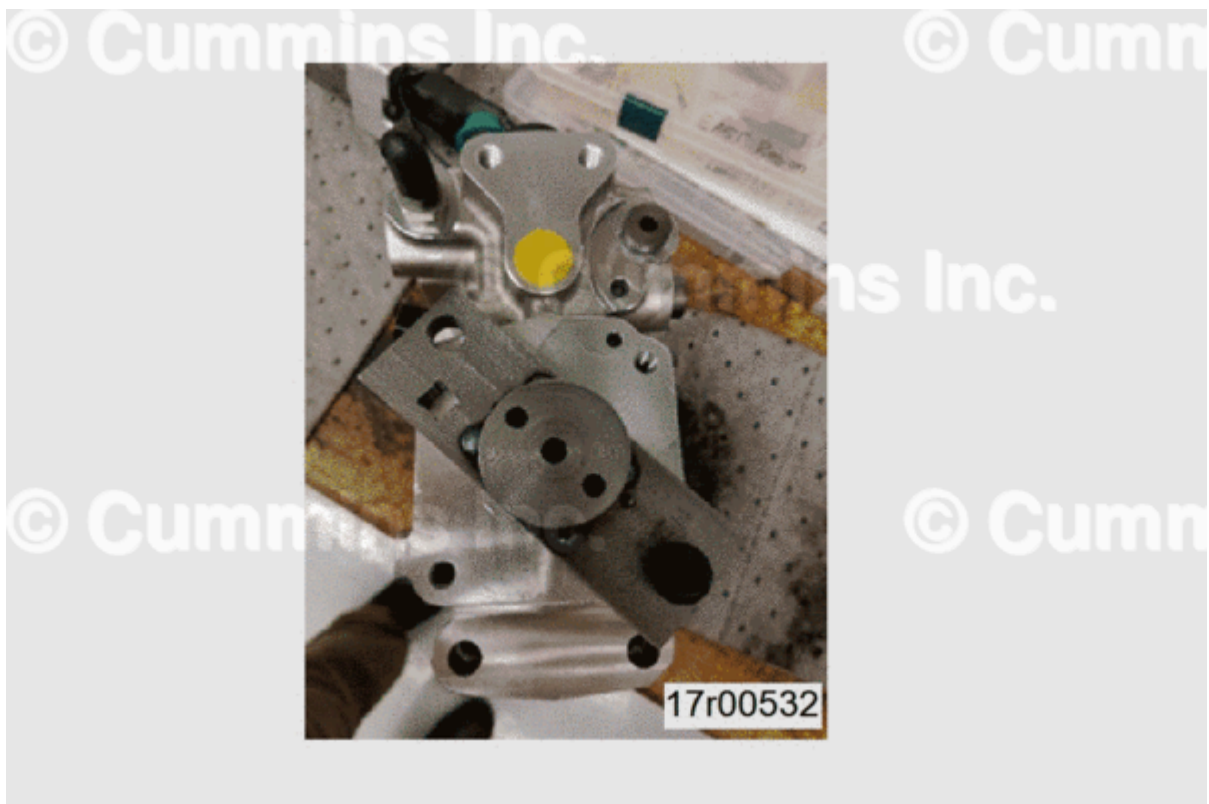
Figure 2. Service Tool Installation on X15 CM2350 116B.
