Technical Service Bulletin: TSB180129

Released Date: 24-Sep-2018

Fault Code 3567and 3568: PACCAR™

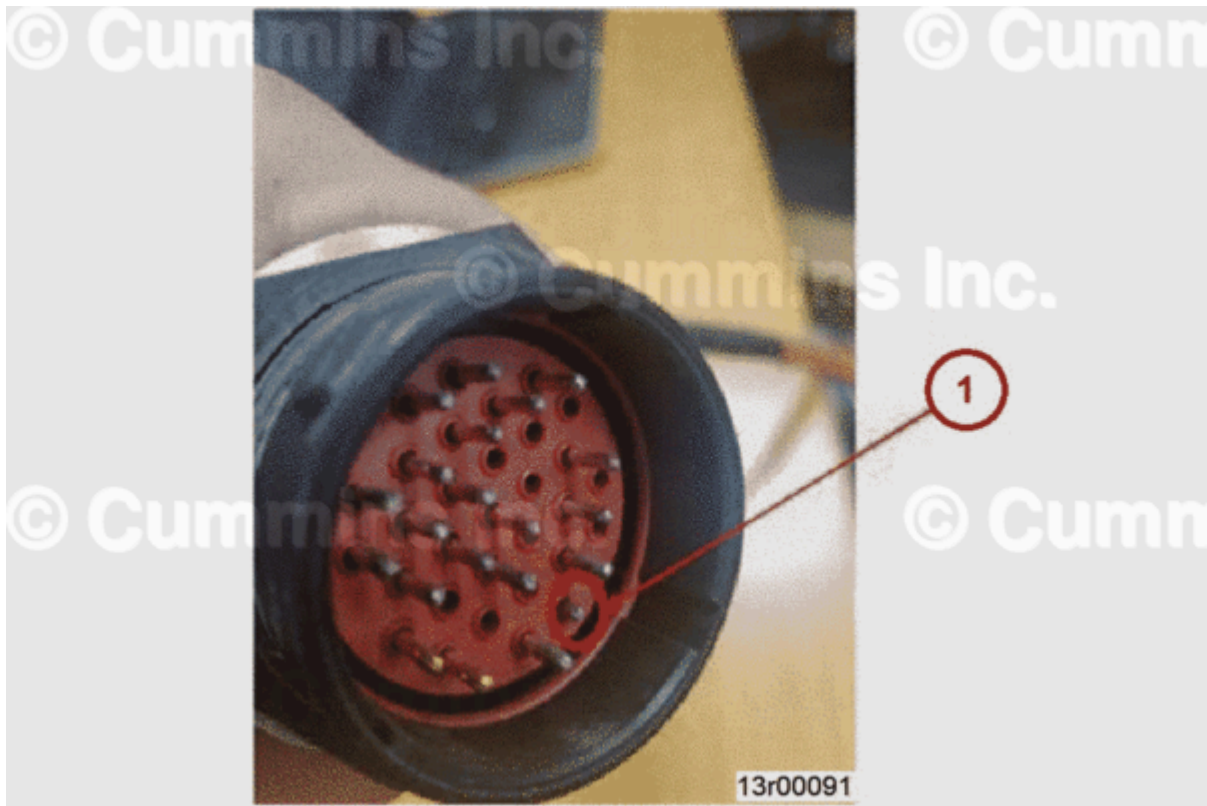
- PACCAR™ wire harness connector to aftertreatment diesel exhaust fluid (DEF) dosing system has a pin that can be pushed back during assembly; Resulting in an intermittent connection causing a low voltage condition, logging Fault Code 3567 and or Fault Code 3568.

Figure 1, Connector with Damaged Pin.

1. Damaged pin.

- Verify Fault Code 3567 or Fault Code 3568 are present.
- Locate connector on left side lower bulkhead.
- Check condition of connector.
- Open connector.
- Check for bent, broken, corroded, or pushed back pins.
- Reference PACCAR™ direction to repair or replace connector.

Contact PACCAR™ for direction.
