Technical Service Bulletin: TSB200098

Released Date: 04-Feb-2021

New Accessory Drive Support

- QSK23 CM500 FCO

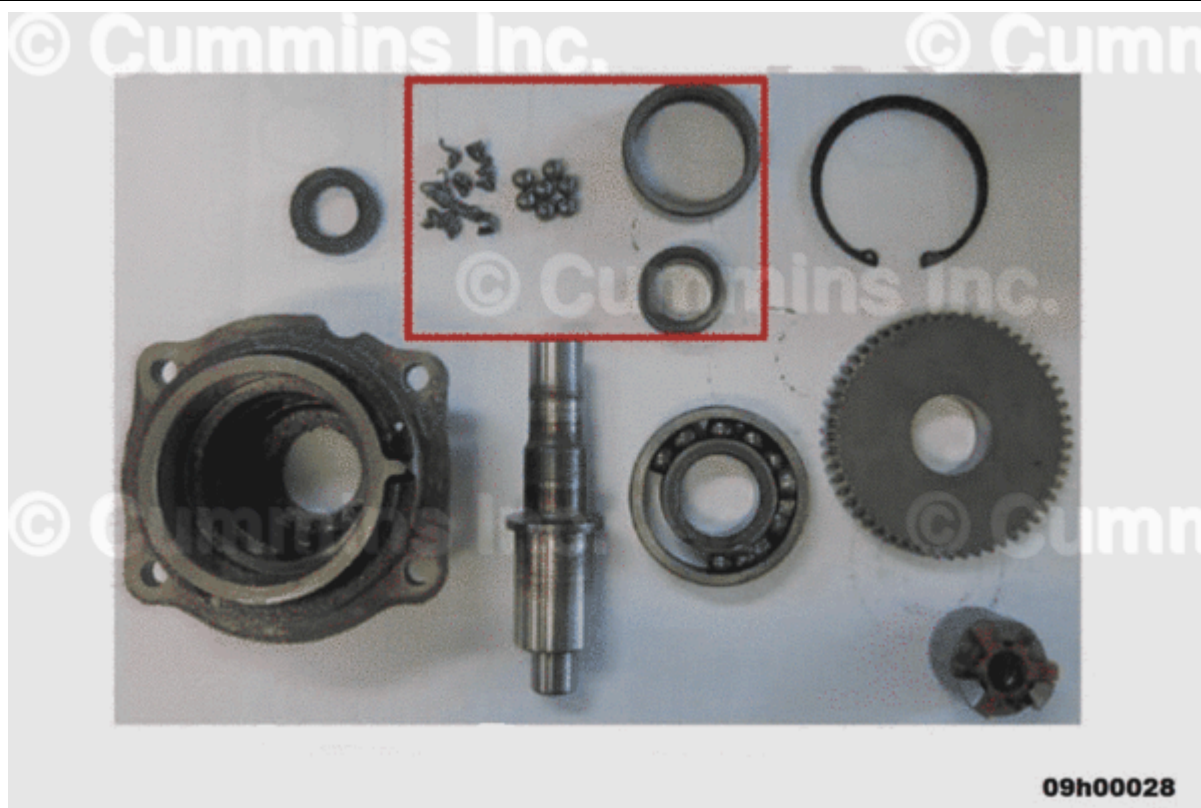
The accessory drive support front bearing experiences increased radial load due to the fitted 140A alternator configuration and increase in overhang.

- Excessive noise from the front of the engine
- Accessory drive support front bearing malfunction. See Figure 1.

- Excessive load applied to the accessory drive support front bearing.

Figure 1, Disassembled Accessory Drive Support, Front Bearing In Red Box

- A new accessory drive support with a front cylindrical roller bearing has been released.
- Service parts are available. See Table 1 for part numbers.

The new accessory drive support, Part Number 5633425, with cylindrical roller bearing is compatible with both the 75A and 140A alternator configurations.
