Technical Service Bulletin: TSB200210

Released Date: 21-Oct-2020

Fault Code 6637 on PACCAR™ Chassis with Horton® Fan Controller

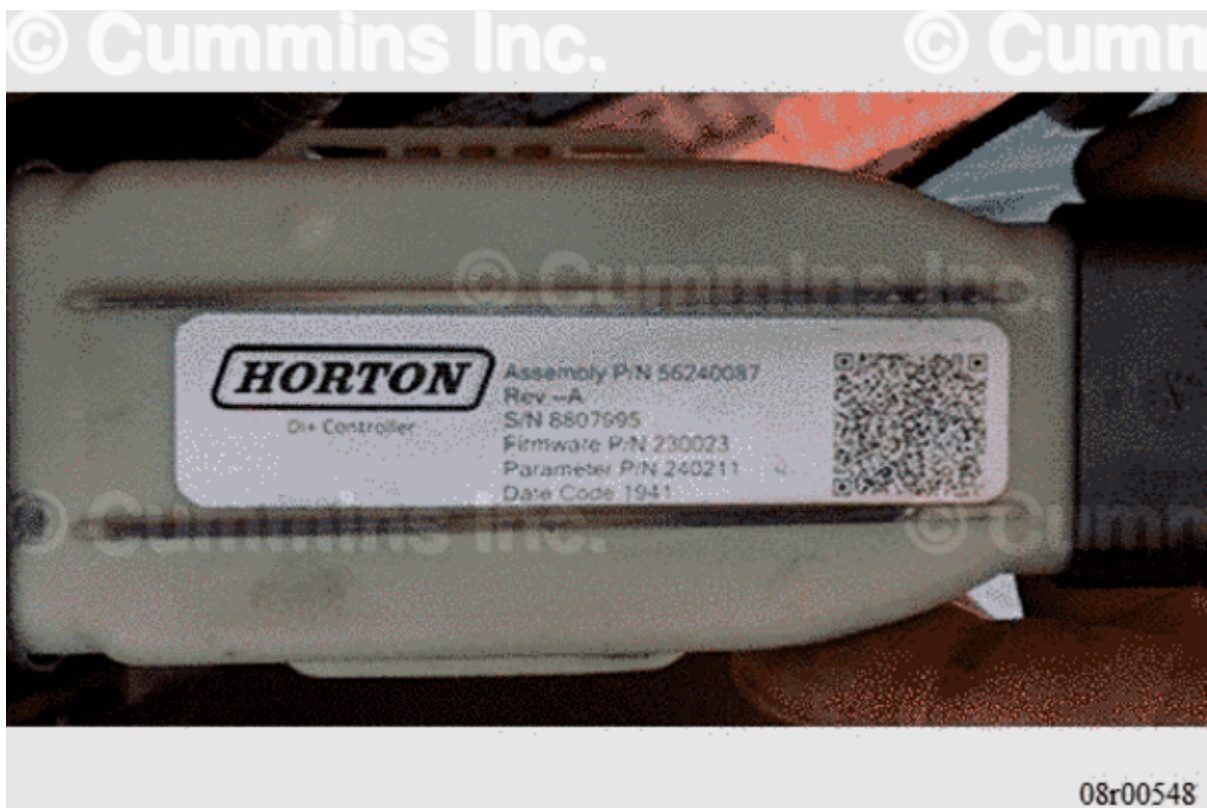
Figure 1, Horton® Fan Controller

- Horton® fan controller (OEM part with firmware part number 230023) sends "Fan speed signal >100%" to engine control module (ECM) causing FC6637 to become active.

- The firmware version of the fan controller can be found on the back label of the fan controller.
- Confirm unit has fan controller with old firmware, part number 230023.

- This issue is unique to PACCAR™ chassis. All claims and parts should be sourced appropriately through PACCAR™.
- Contact the OEM for the appropriate part number, reference Horton® Product Technical Bulletin PTB 2020.
- Horton® has released an updated fan controller under the existing assembly part number.
- The firmware part number located on the back of the fan controller has been updated.
