# Technical Service Bulletin

Technical Service Bulletin: TSB220192

Premature Battery Power loss: Fault Code 1117

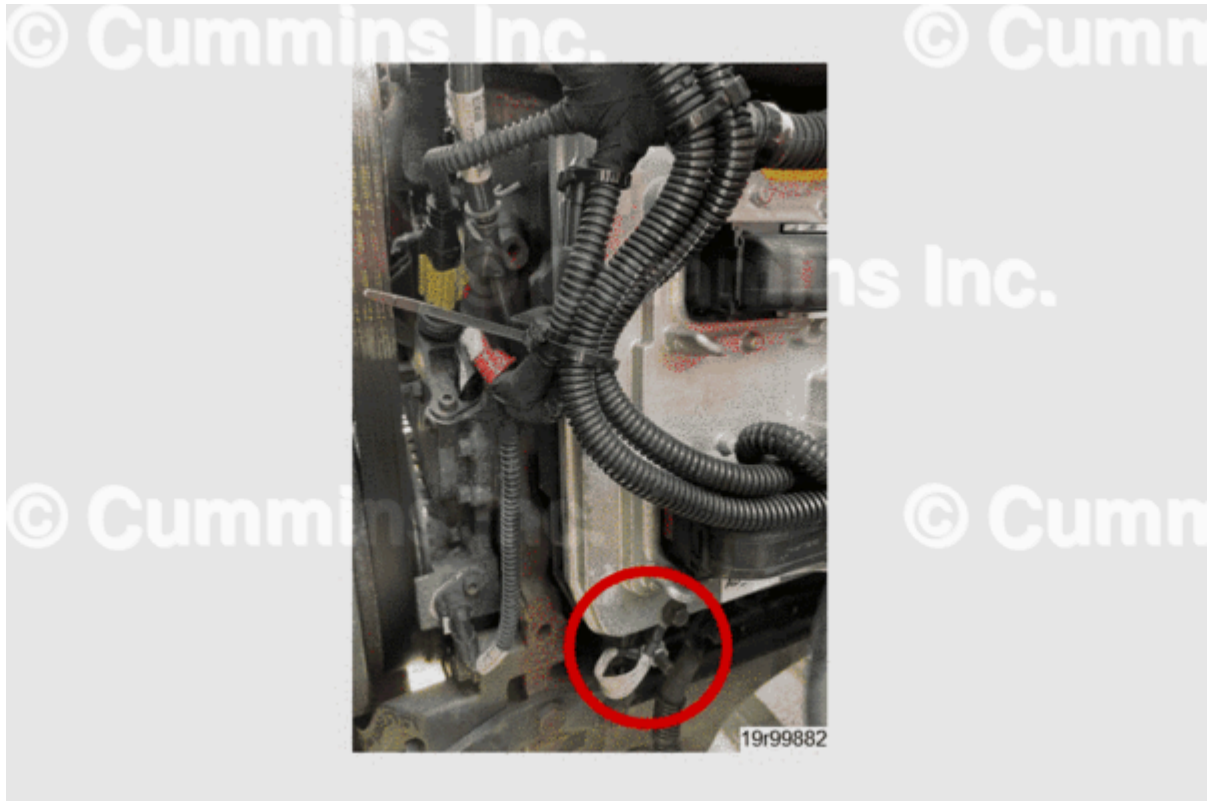
Figure 1, Grounding Strap.

**Note :** Some applications may have an ECM case ground strap. This grounds **only** the housing of the ECM and does **not** ground internal connections. This is **not** a connection that would lead to Fault Code 1117.

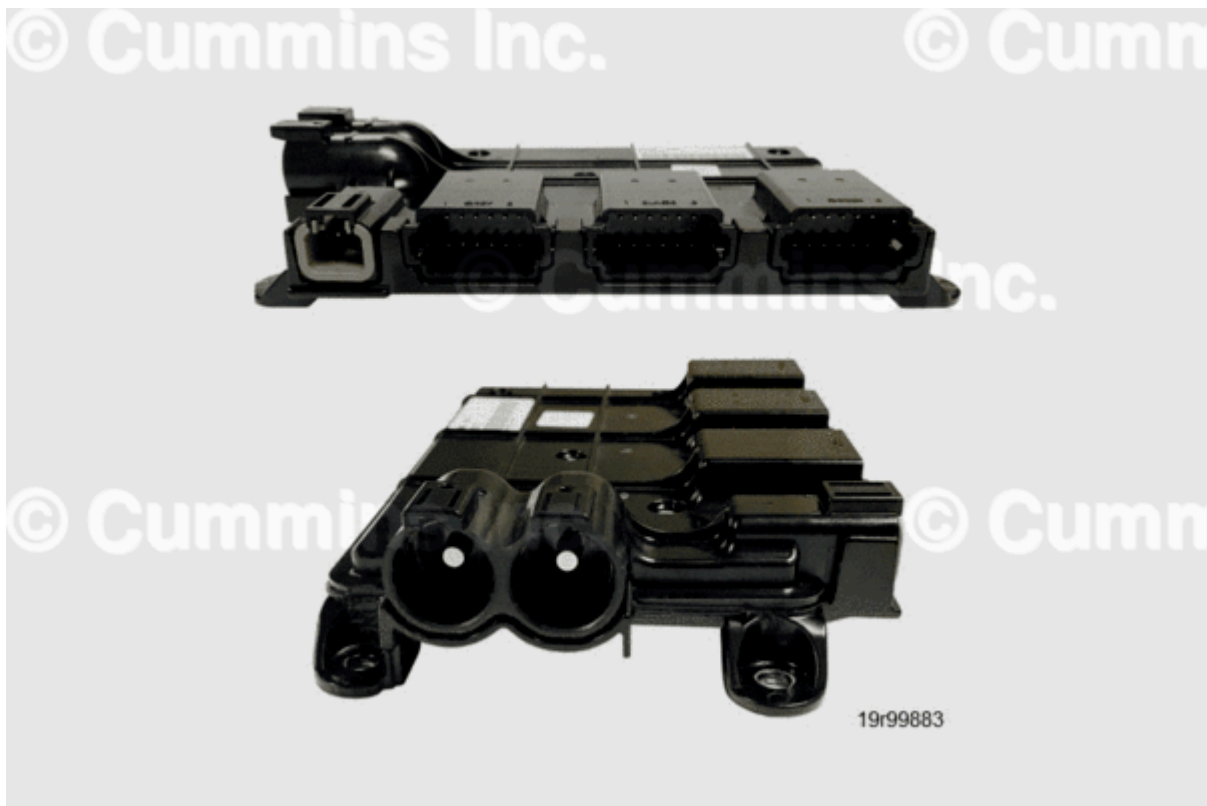
Figure 2, Example Power Distribution Module.

- Using a Power Distribution Module (PDM) can cause a premature power supply loss. Depending on application this may or may **not** be present. If present, A PDM is a module that can be used to control power on and off to a subset of the equipment or the whole engine.
- If the ECM Power wiring is connected through the starter to the battery a power supply loss could be detected by the ECM.

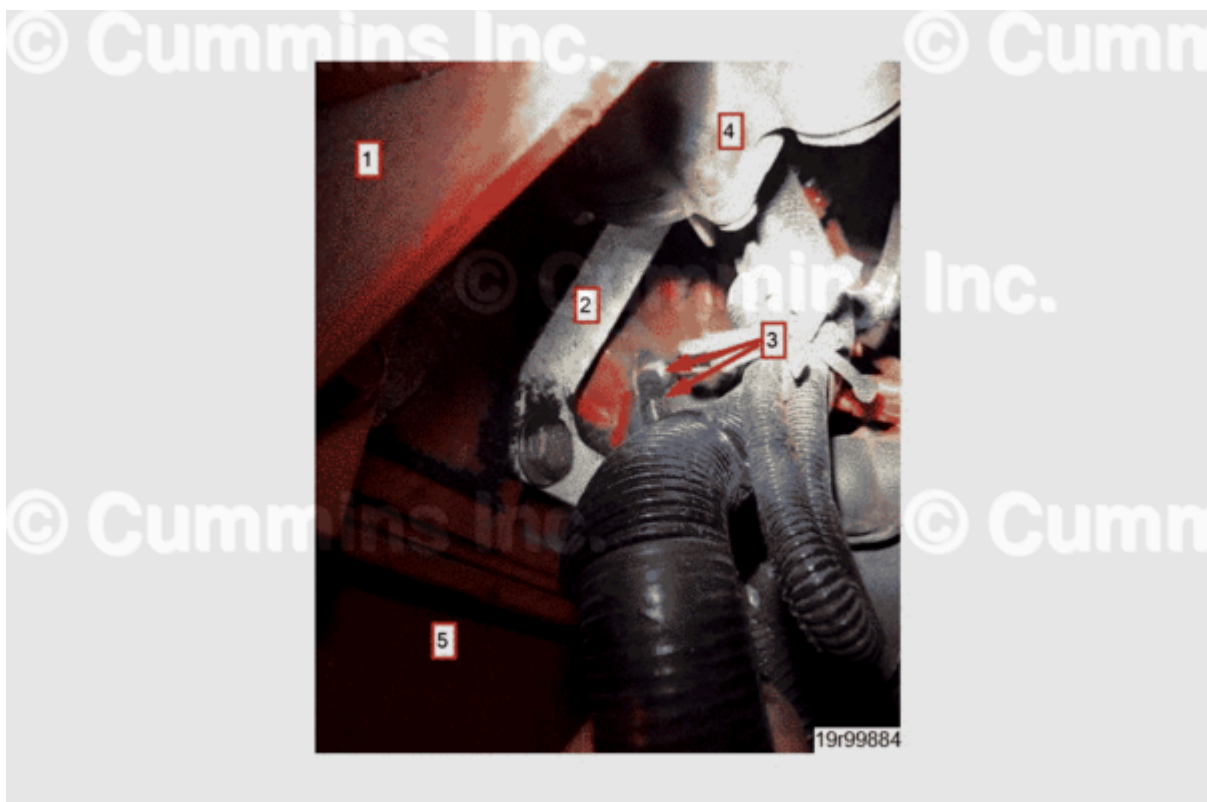
Figure 3, Example Grounding Wire Location.

- Loose ECM ground connections will cause intermittent ECM power ground loss. The ECM ground connection is located on the cylinder block as a threaded stud below or near the ECM.

- Ground noise issues can cause ECM power ground loss if Cummins Inc. grounding best practices are **not** followed.

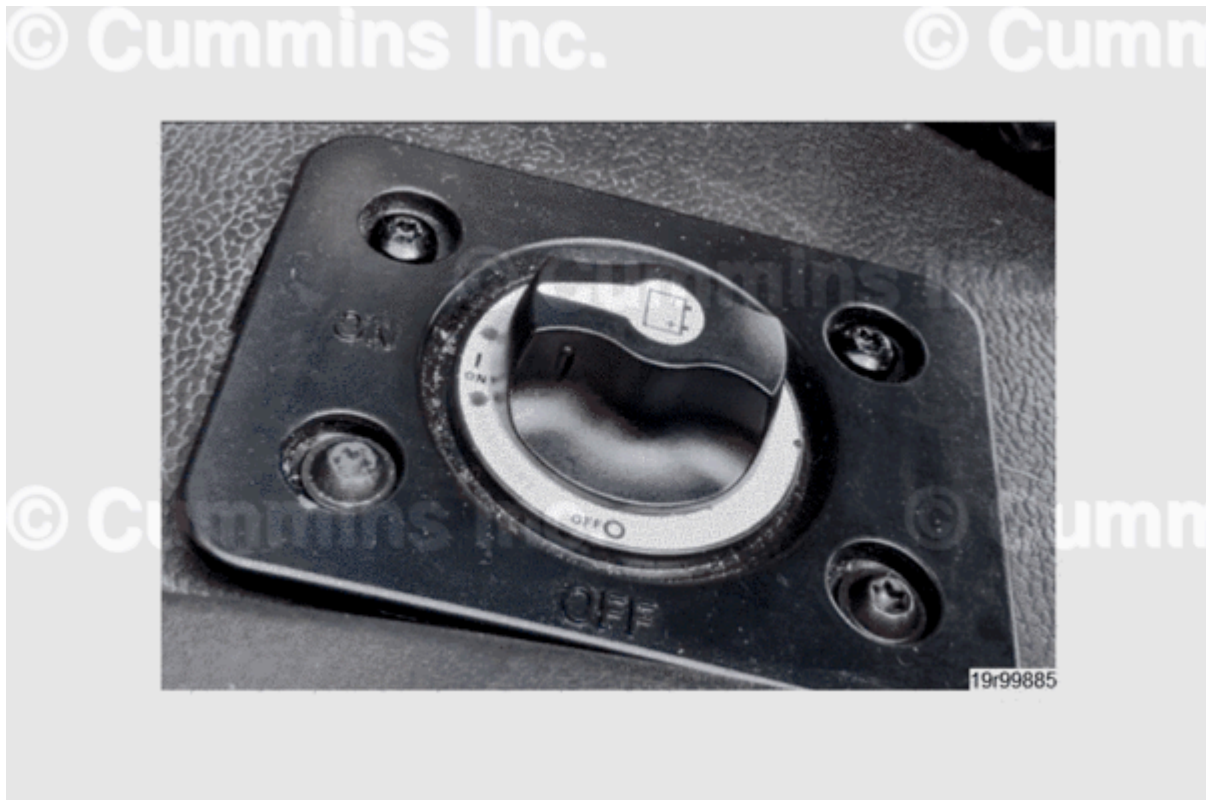
Figure 4, Example Kill Switch.

- a. Using an OEM Disconnect switch, sometimes referred to as a kill switch, E-Stop, etc., and/or **not** letting the ECM power down appropriately can cause a Fault Code 1117 indicating a premature power supply loss
  - The ECM continues to write data and work after engine key off and needs uninterrupted power for a set time to finish.
