Technical Service Bulletin: TSB220262

Debris Found in Fuel Filter Misdiagnosed as Fuel System Malfunction

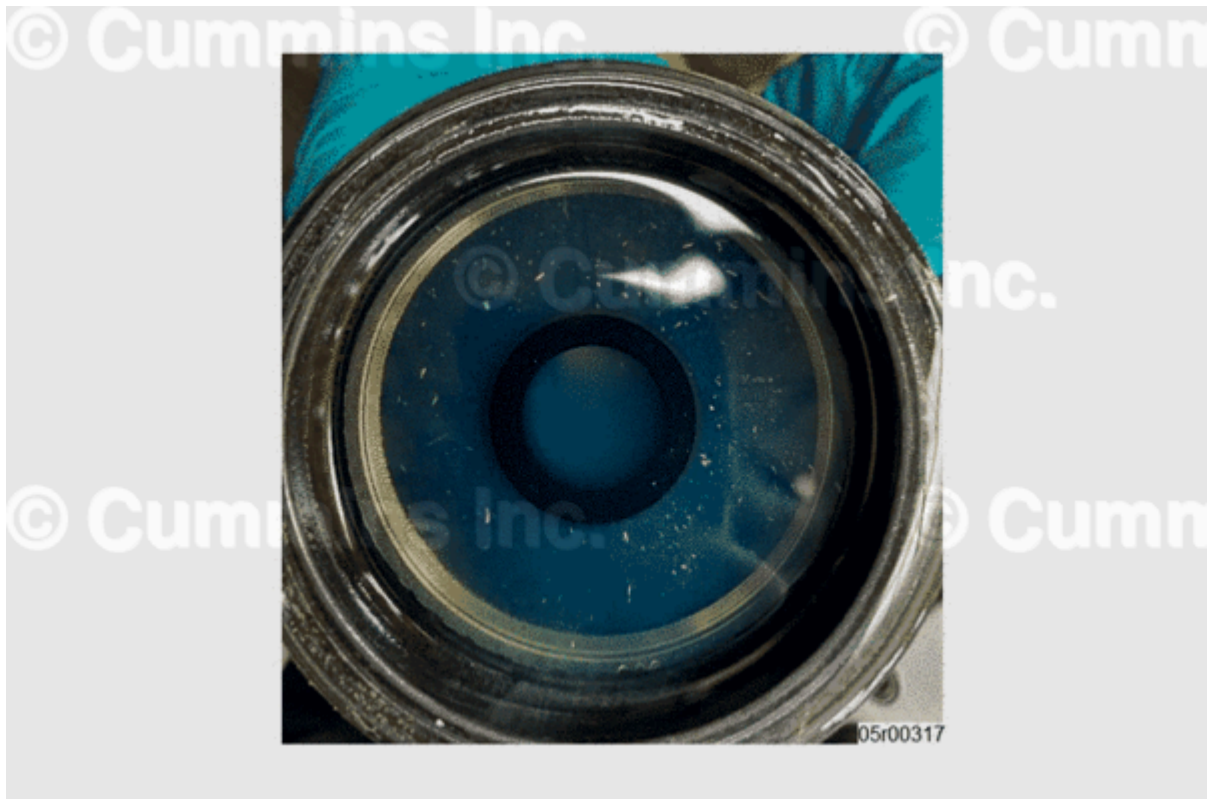
- Metal debris present in the dirty (inlet) side of any fuel filter.

- This TSB should **only** be referenced when the fuel filter is being removed. Do **not** remove the fuel filter solely to inspect for debris.
- Metal identified in any fuel filter could be attributed to normal fuel system component wear. Debris can be ferrous or non-ferrous and is **not** considered a fuel system malfunction.
- Debris seen on the dirty (inlet) side of the fuel filter can be like what is shown in Figure 1.

Figure 1, Example of Metallic Debris in the Dirty (Inlet) Side of the Pressure Side Fuel Filter.

- If engine does **not** have symptoms or fault codes, no further action is required. The presence of debris in the dirty (inlet) side of the Fuel Filter is **not** effective in identifying a fuel pump malfunction.
- If engine has symptoms or fault codes, reference published troubleshooting for the diagnosed malfunction.

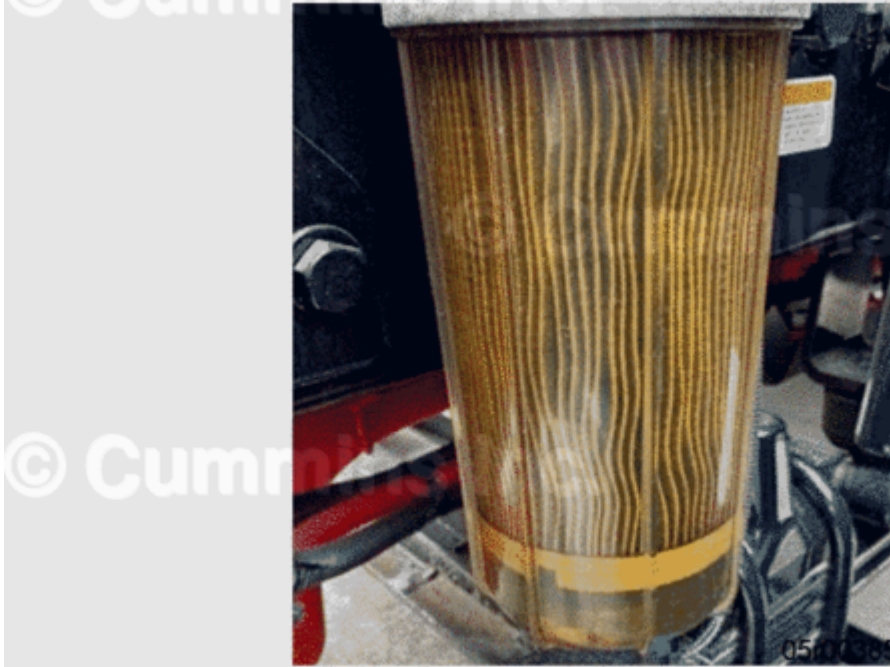
Figure 2, Example of Dirty Side of the Suction Side Fuel Filter.

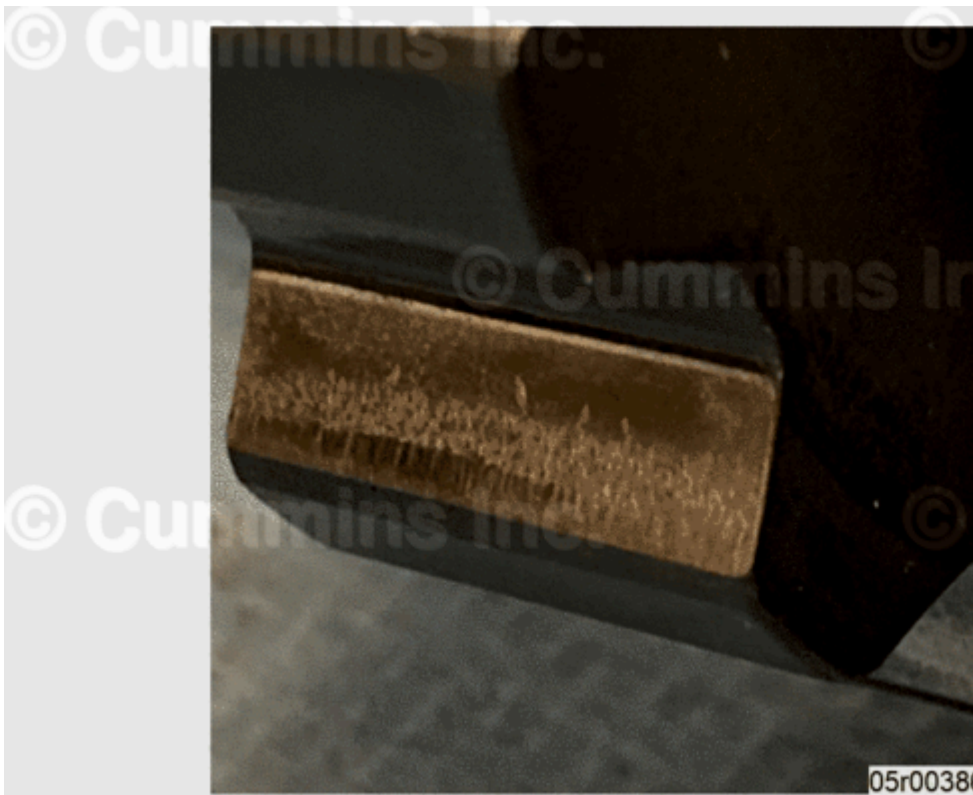
Figure 3, Example of Normal Fuel Pump Gear Pump Tooth Wear.

Figure 3 is for reference **only**. **Never** disassemble the fuel pump gear pump.
