Technical Service Bulletin: TSB230203

Released Date: 20-Oct-2023

New Upper Idler Gear Idler Shaft

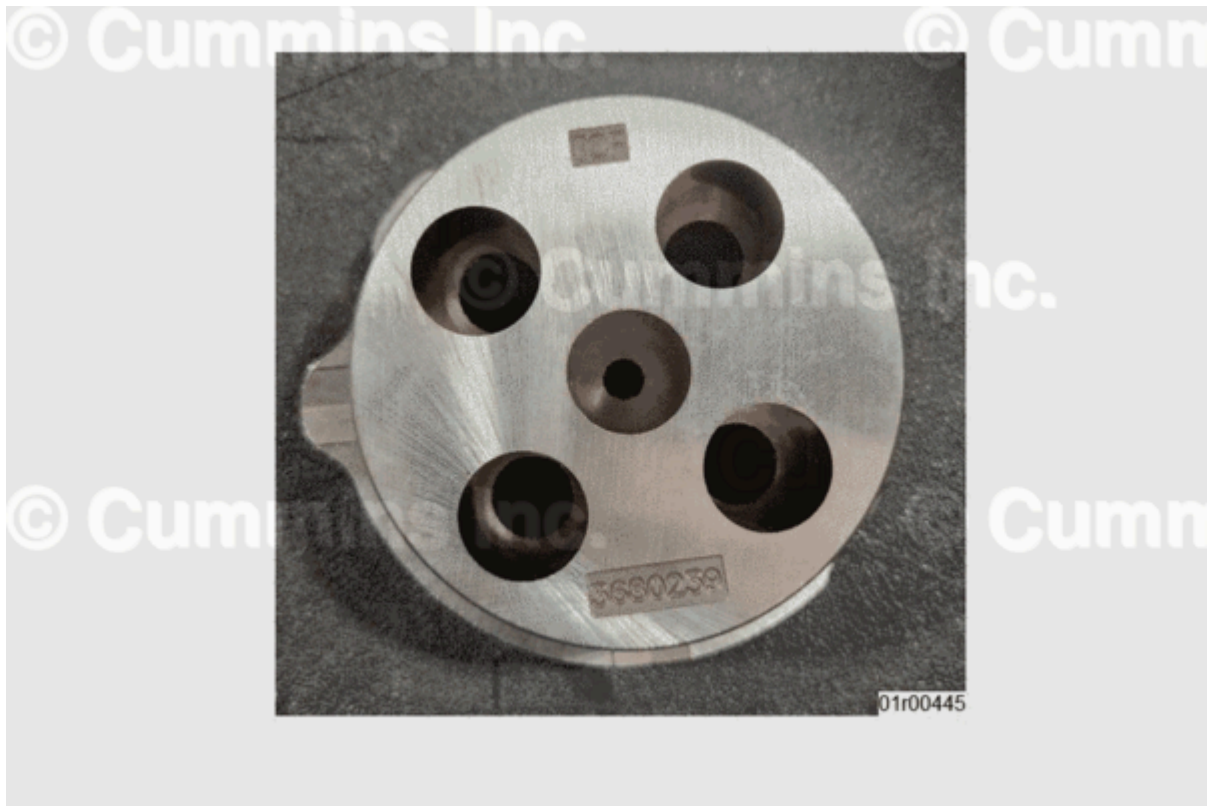
Figure 1, Idler Shaft, Part Number 3680239, With "Top" Indicator.

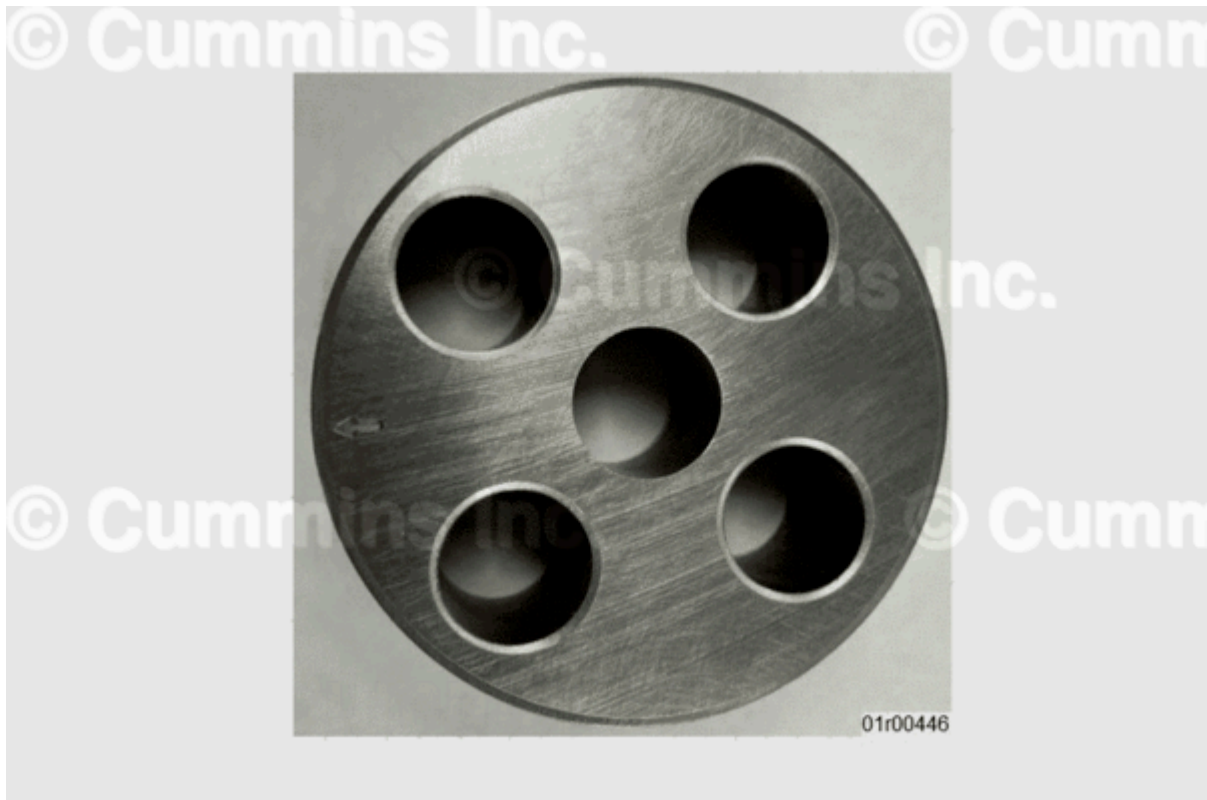
Figure 2, Idler Shaft, Part Number 3685252, With Arrow Indicator.
