Technical Service Bulletin: TSB250170

Injector Rocker Lever Adjusting Screw Improvement: Low Power, High Blowby, and Engine Noise

- QSK23 CM500
- QSK78 CM500

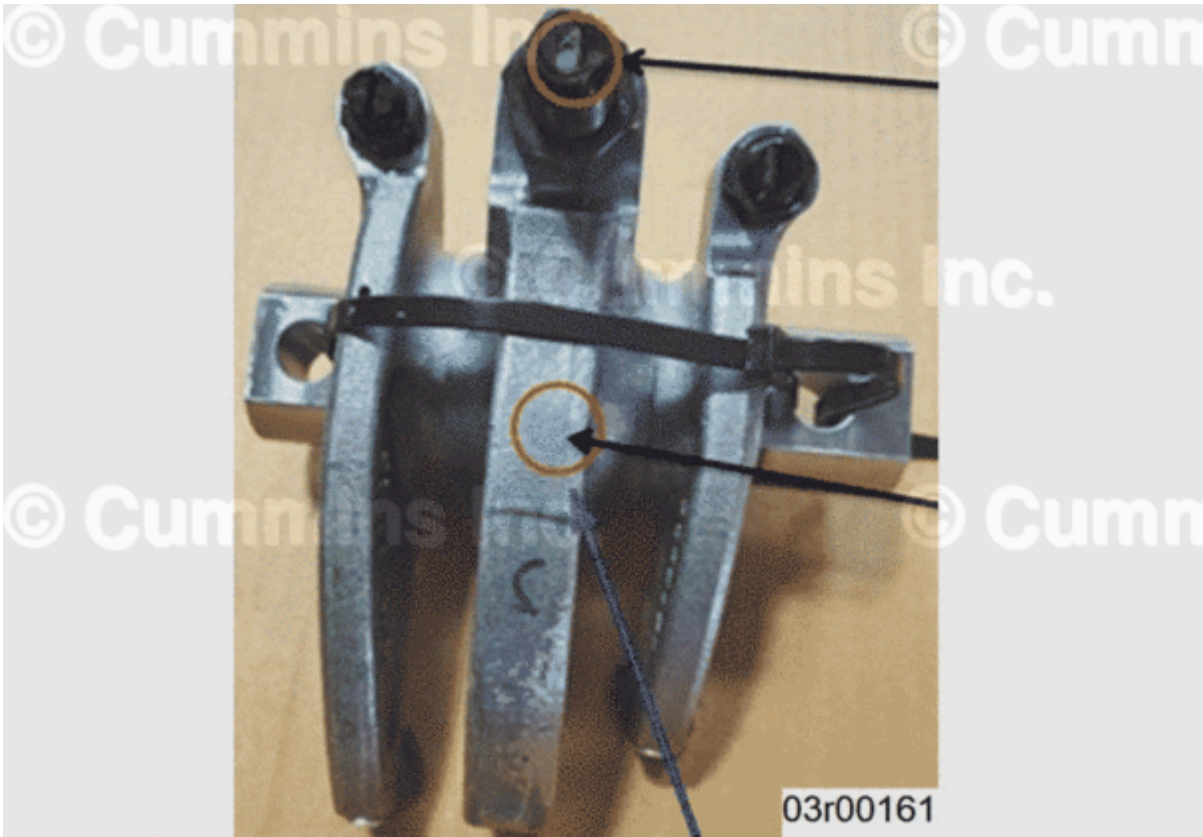
Figure 1, Rocker Lever Assembly.

All injector rocker lever adjusting screws with the updated dimensional controls will be denoted with a green paint mark on the rocker lever assembly (See Figure 1) and a laser etching with the letter "A" on the top of the injector rocker lever adjusting screw (See Figure 2).

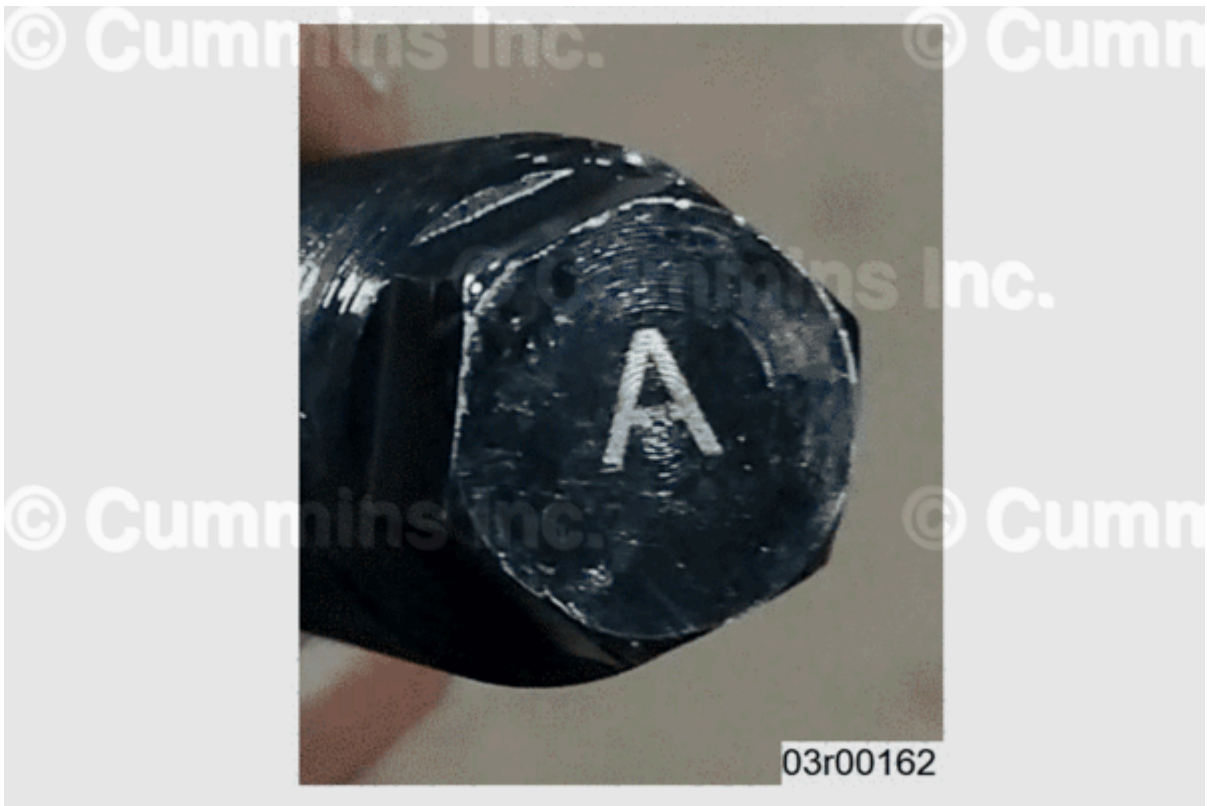
Figure 2, Injector Rocker Lever Adjusting Screw.

- "A" mark provided on the screw top face to eliminate part misidentification.
- Green dot identification mark on the lever forging area.
