Technical Service Bulletin: TSB260061

Revised Air Intake Manifold bracket for QSK23 Air Intake Manifold Heater Coil Fatigue Malfunction

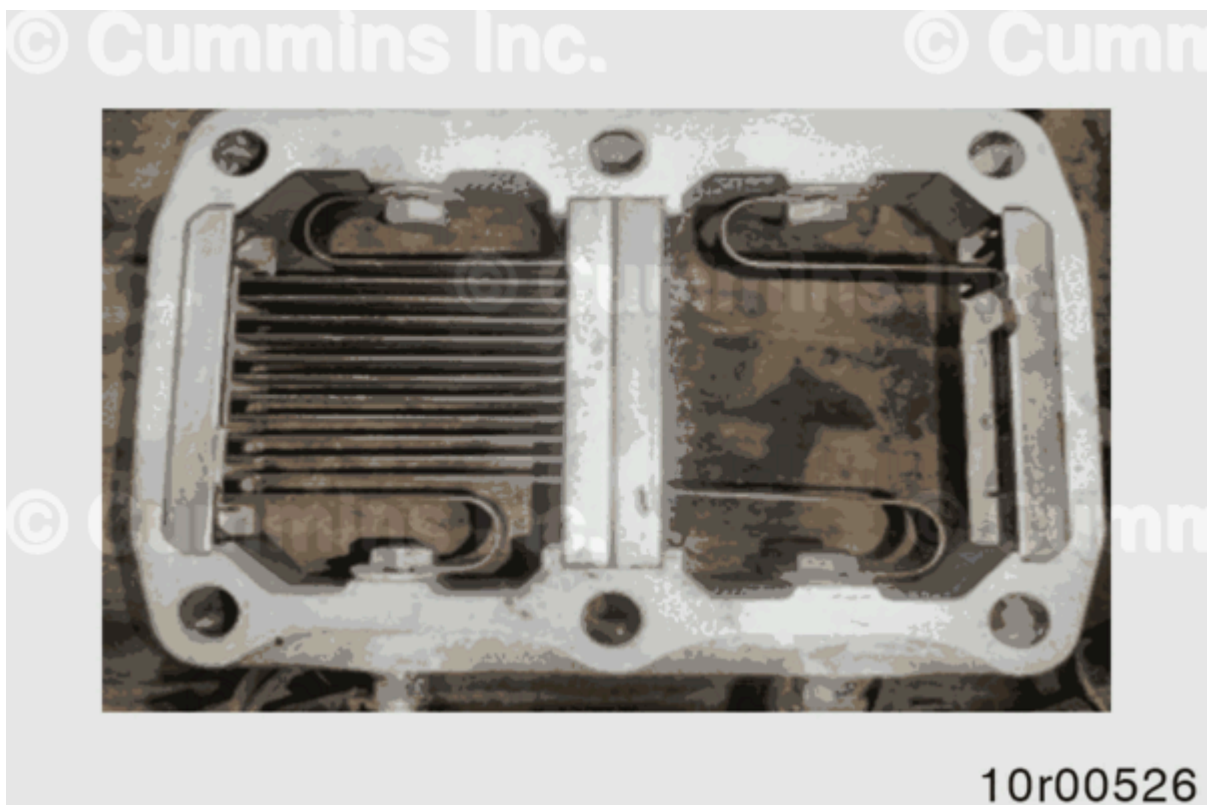
- The air intake manifold heater coil is malfunctioning because of higher vibration excitation.

Observed air intake manifold heater coil breakage. Damage was then caused to power cylinder components and exhaust path components, leading to low power and white smoke.

Figure 3, Damaged air intake manifold heater coils

Additional air intake manifold brackets added will reduce the vibration excitation of air intake manifold heater coils to prevent malfunctions.
