Technical Service Bulletin: TSB150158

**Bosch® Aftertreatment Diesel Exhaust Fluid (DEF) Dosing Pump with Unidentified Fluid at Seams**

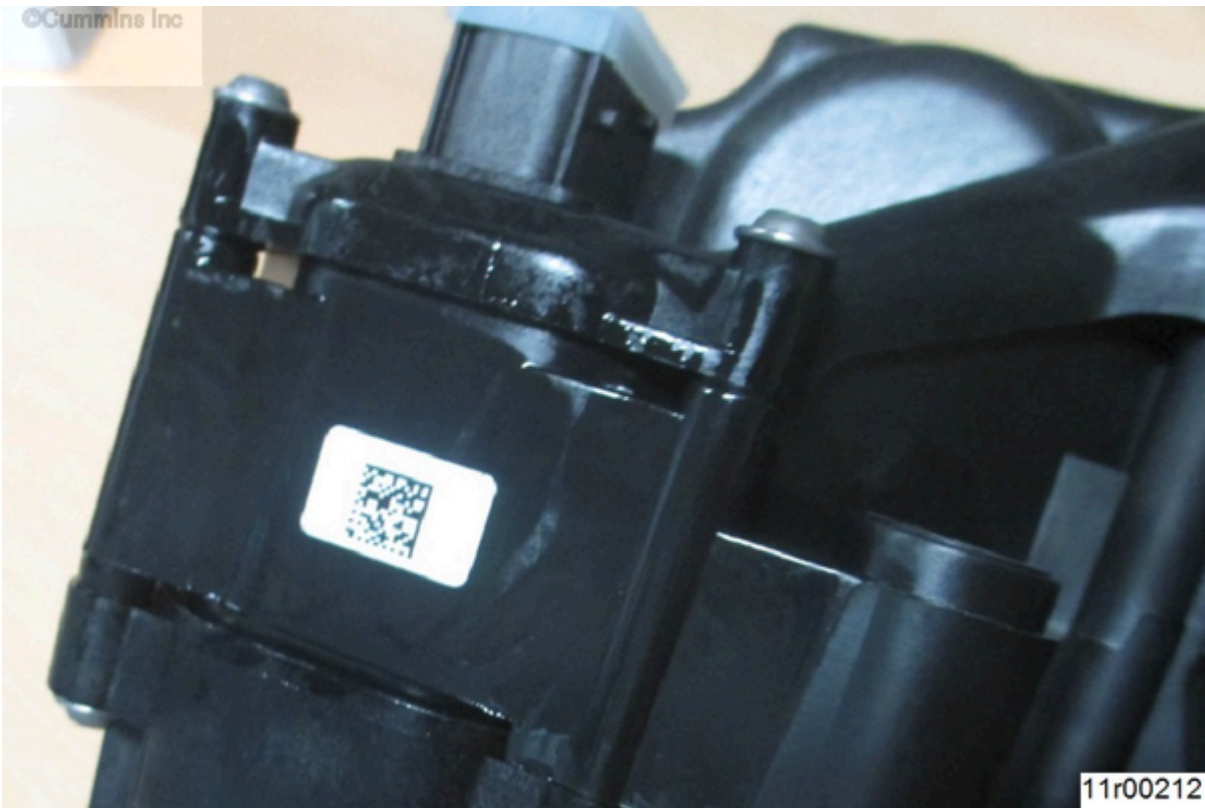
This document is to communicate that an oily substance near the seams of the Bosch® aftertreatment DEF dosing unit is normal and does **not** indicate a malfunction has occurred.

Plasticizer is a chemical used for sealing the aftertreatment DEF dosing unit seams. The plasticizer will appear as an oily or grease like substance. See Figure 2 below.

Figure 1, Example of Plasticizer at the Seams of the Aftertreatment DEF Dosing Unit

Plasticizer at the seams of the aftertreatment DEF dosing unit is normal and does **not** indicate a malfunction.
