Technical Service Bulletin: TSB170003

Released Date: 01-Feb-2017

Fault Codes 1867 and 2962 Caused by Water Intrusion

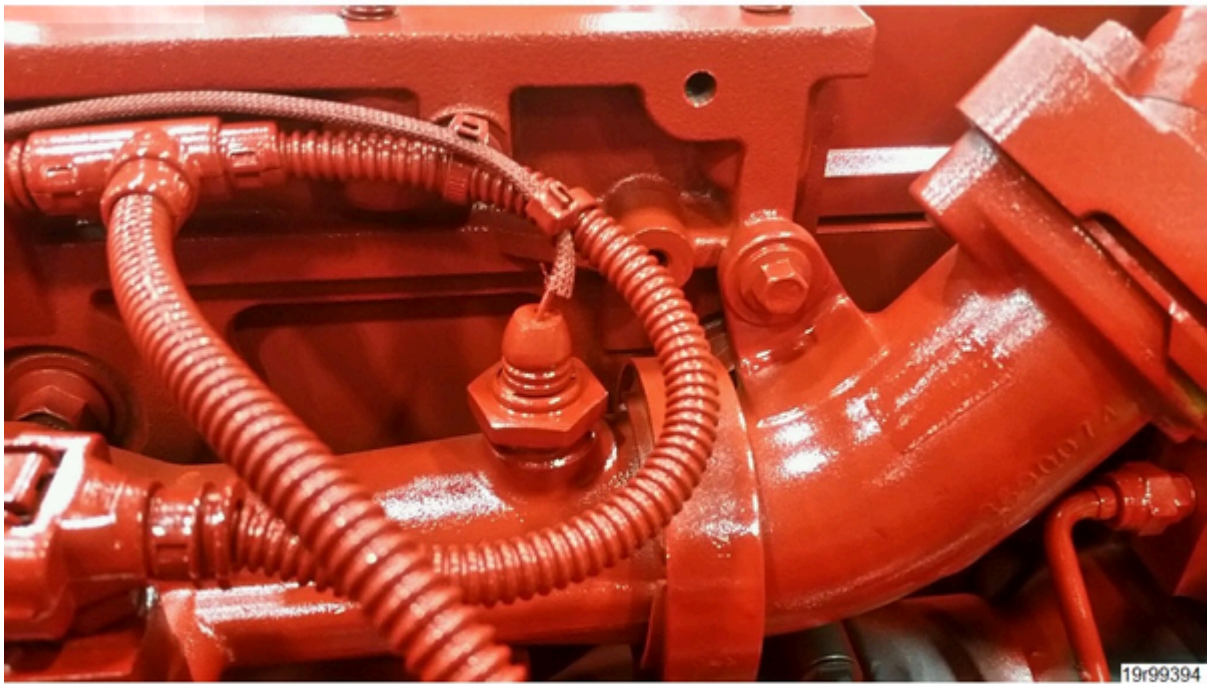
- Water intrusion caused by exhaust gas recirculation (EGR) temperature sensor water jacket distortion. EGR temperature sensor wires on select chassis were overstretched during EGR temperature sensor installation and wiring harness routing.

Figure 1, Incorrect Routing of EGR Temperature Sensor Wiring.

- If EGR temperature sensor water jacket is distorted, replace EGR temperature sensor and route the wiring harness per the Service Instructions section below.

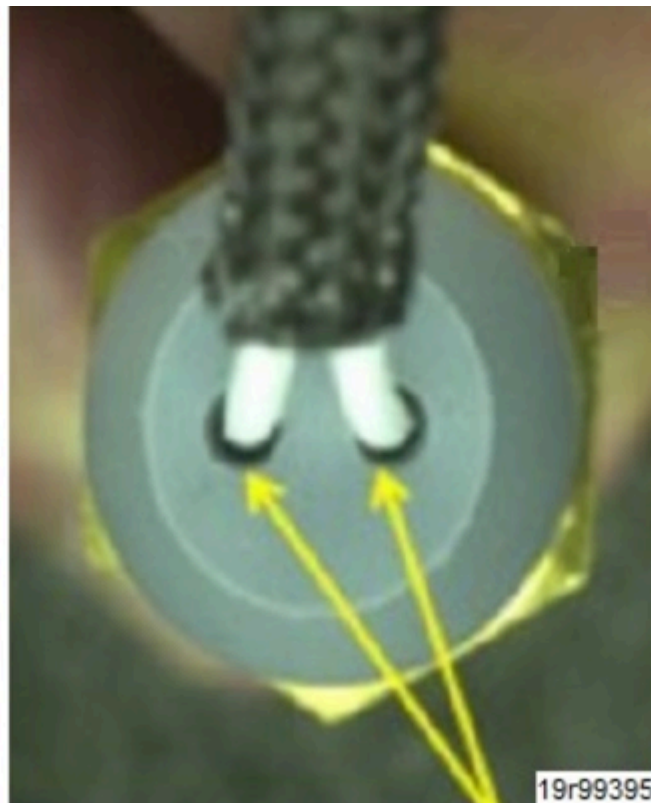
Figure 2, Normal EGR Temperature Sensor Water Jacket.

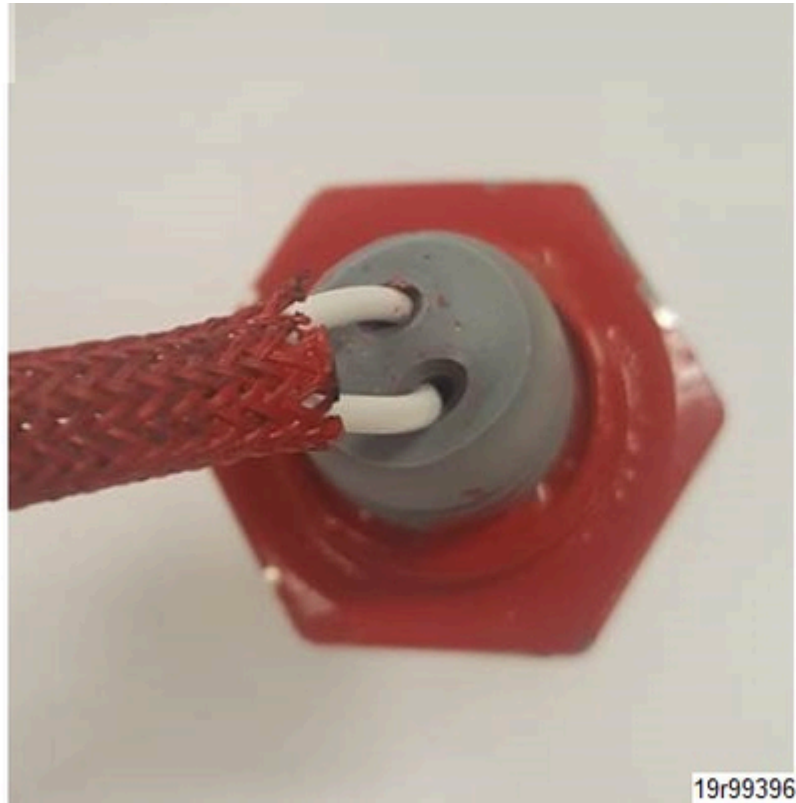
Figure 3, Distorted EGR Temperature Sensor Water Jacket.

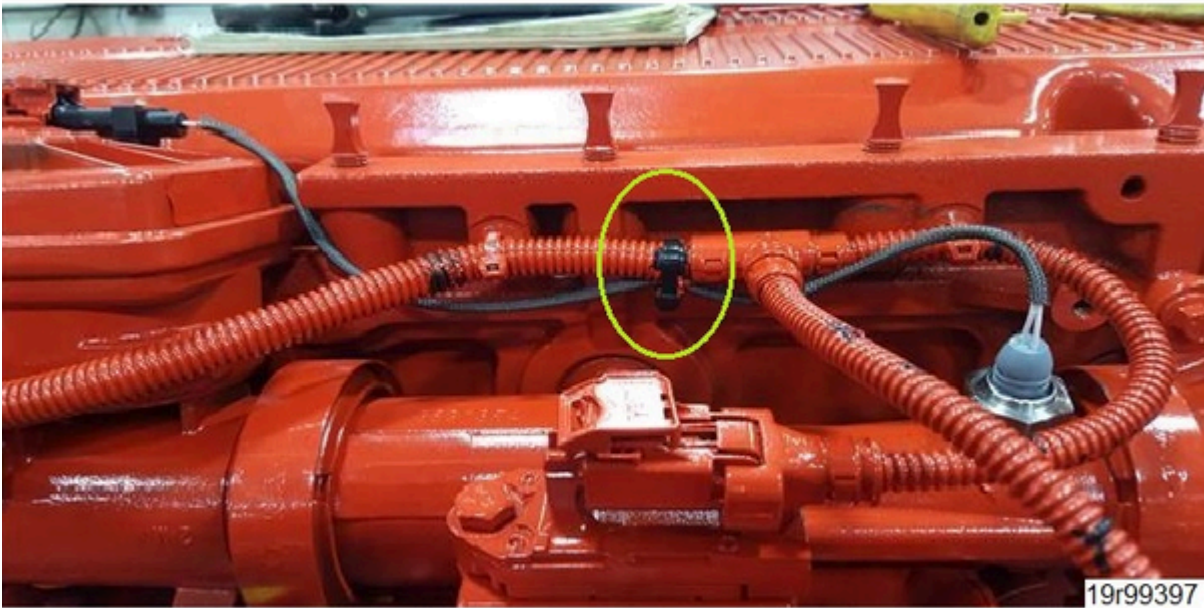
Figure 4, Correct Routing of EGR Temperature Sensor Wiring.

- Route new EGR temperature sensor wiring below wiring harness convolute, securing EGR temperature sensor wiring using **only** one zip-tie as shown in Figure 4 below.
- Secure EGR temperature sensor wiring so wire leads going into EGR temperatures sensor are near vertical. See Figure 4 below.
- Do **not**:
  - Twist EGR temperature sensor wires during installation.
  - Pinch or crush EGR temperature sensor wiring or wiring harness convolute by over-tightening zip-tie.
