Technical Service Bulletin: TSB170070

Released Date: 12-Jun-2017

Adhesive Aftertreatment Main Body Gasket

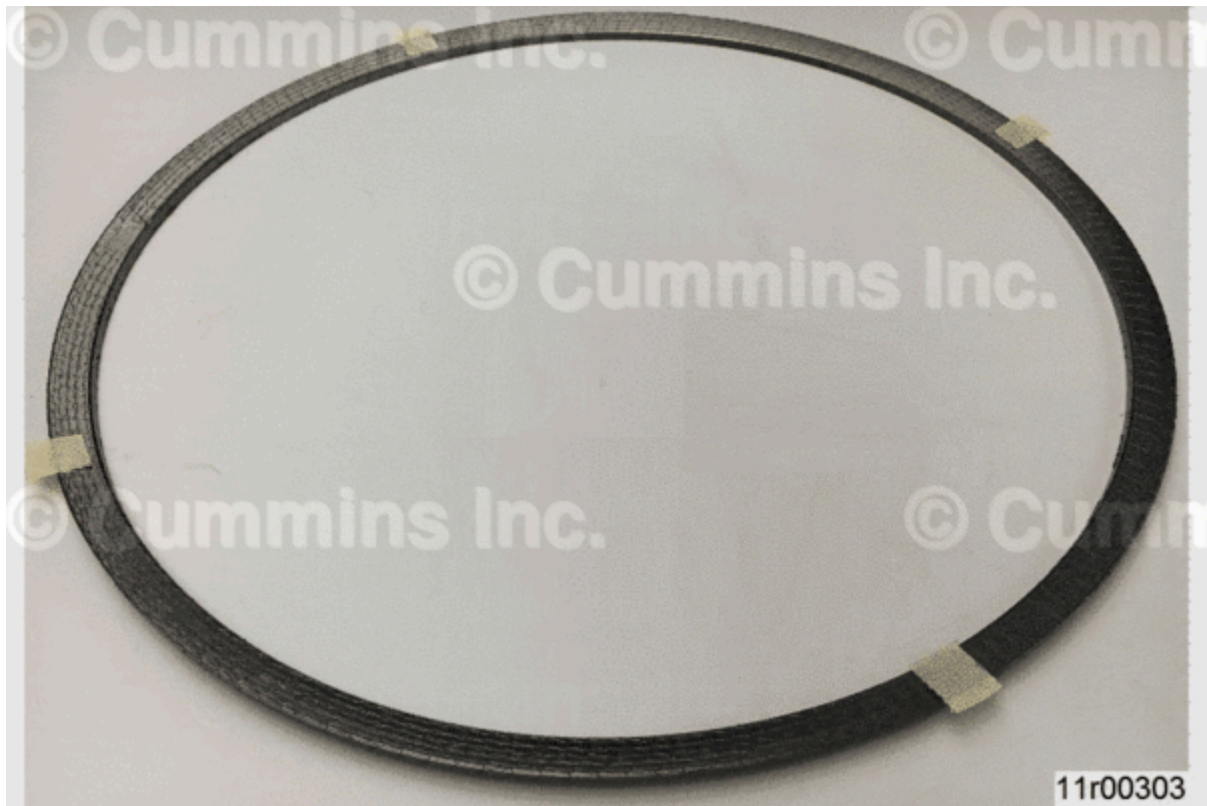
A new adhesive gasket has been developed to aid in aftertreatment system assembly. When assembling a horizontal aftertreatment system the gasket can become misaligned and cause exhaust leaks or v-band clamp damage. The adhesive strips will maintain gasket alignment during aftertreatment system assembly.

Figure 1, New Adhesive Gasket with Paper Backing.

Paper backing **must** be removed prior to gasket installation. See Figure 1 below.
