Technical Service Bulletin: TSB170079

Released Date: 30-Apr-2018

Incorrect Aftertreatment Part Number Etching

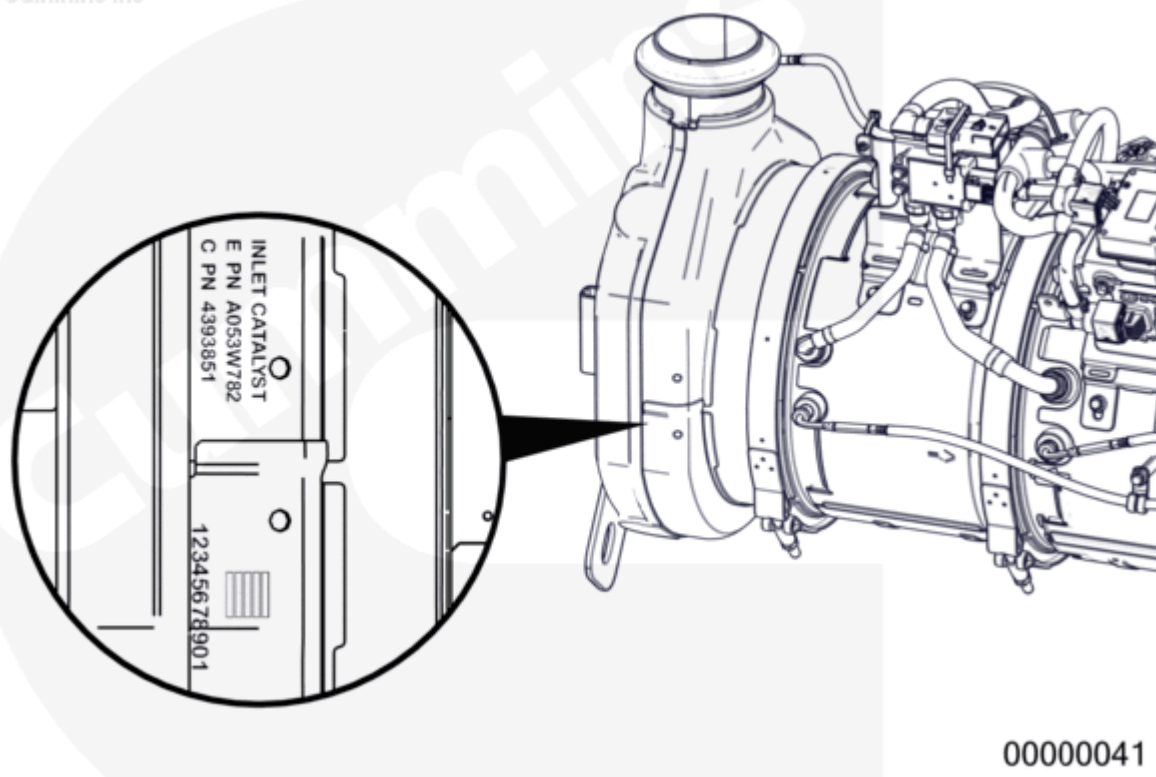
Figure 2, Aftertreatment DOC E PN and C PN Location.

- Figure 1 below displays location of entire assembly part number, which can guide in further identification of needed individual parts.
- Figure 2 below displays location of E PN and C PN on aftertreatment DOC.

- Before ordering an aftertreatment diesel particulate filter (DPF), aftertreatment decomposition tube (DRT), aftertreatment diesel oxidation catalyst (DOC), or aftertreatment selective catalytic reduction (SCR) catalyst, verify aftertreatment component part numbers are correct for the specific aftertreatment system. Use Tables 1, 2, 3, and 4 below to verify part numbers.
- See Technical Service Bulletin, Adhesive Aftertreatment Main Body Gasket, TSB170070 for correct gasket part numbers.
