Technical Service Bulletin: TSB170102

Belt Shredding: Charging System Alternator Out of Alignment

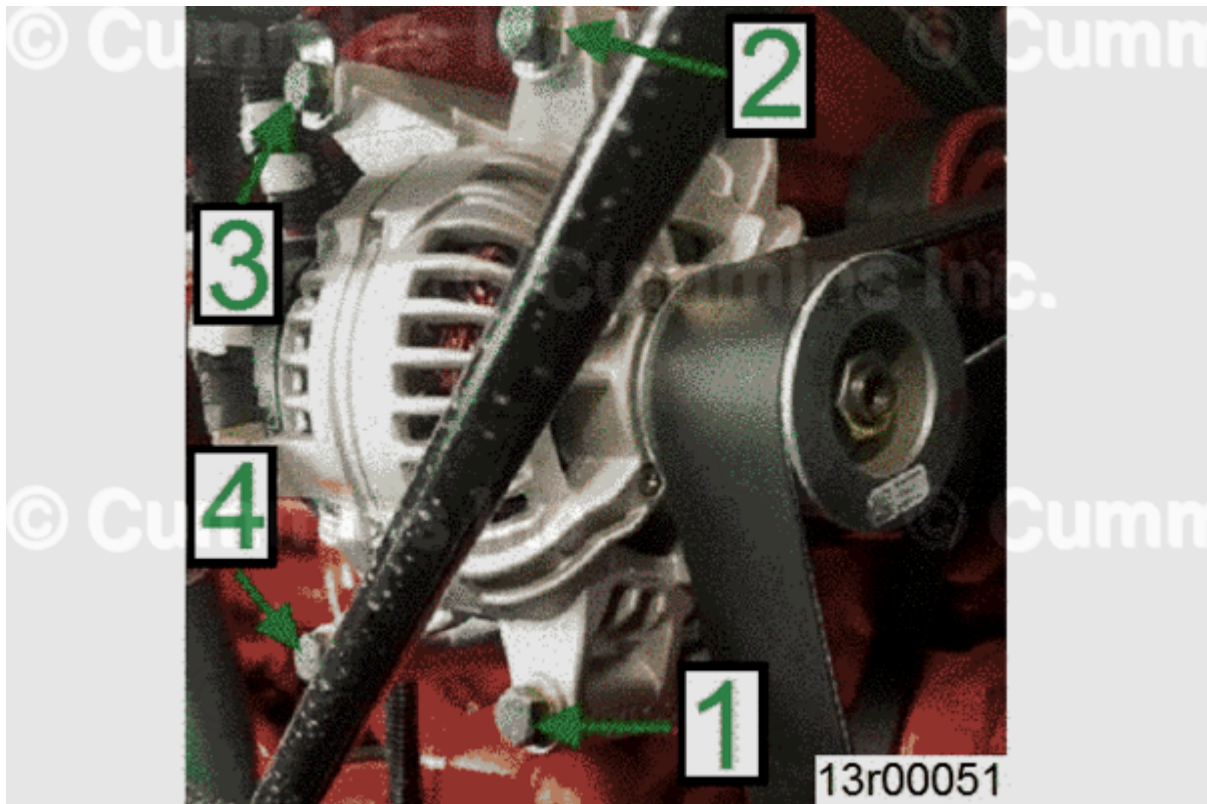
Figure 1, Charging System Alternator Mounting Torque Sequence.

- Belt shredding beginning on inside rib (closest to cab of truck)

- Charging system alternator is **not** properly aligned

- If charging system alternator is **not** properly aligned, four charging system alternator mounting capscrews **must** be loosened and torqued starting with bottom right capscrew and continuing **counterclockwise**.
  - See Figure 1 below for charging system alternator capscrew torquing sequence.
  - For charging system alternator capscrew torque specifications, see corresponding Service Manual. Reference Procedure 013-001 in Section 13.
- After following charging system alternator capscrew tightening sequence outline above, use laser alignment tool to confirm charging system alternator is properly aligned.
