Technical Service Bulletin: TSB190190

Aftertreatment Selective Catalytic Reduction (SCR) Cracked/Broken Outlet Flange

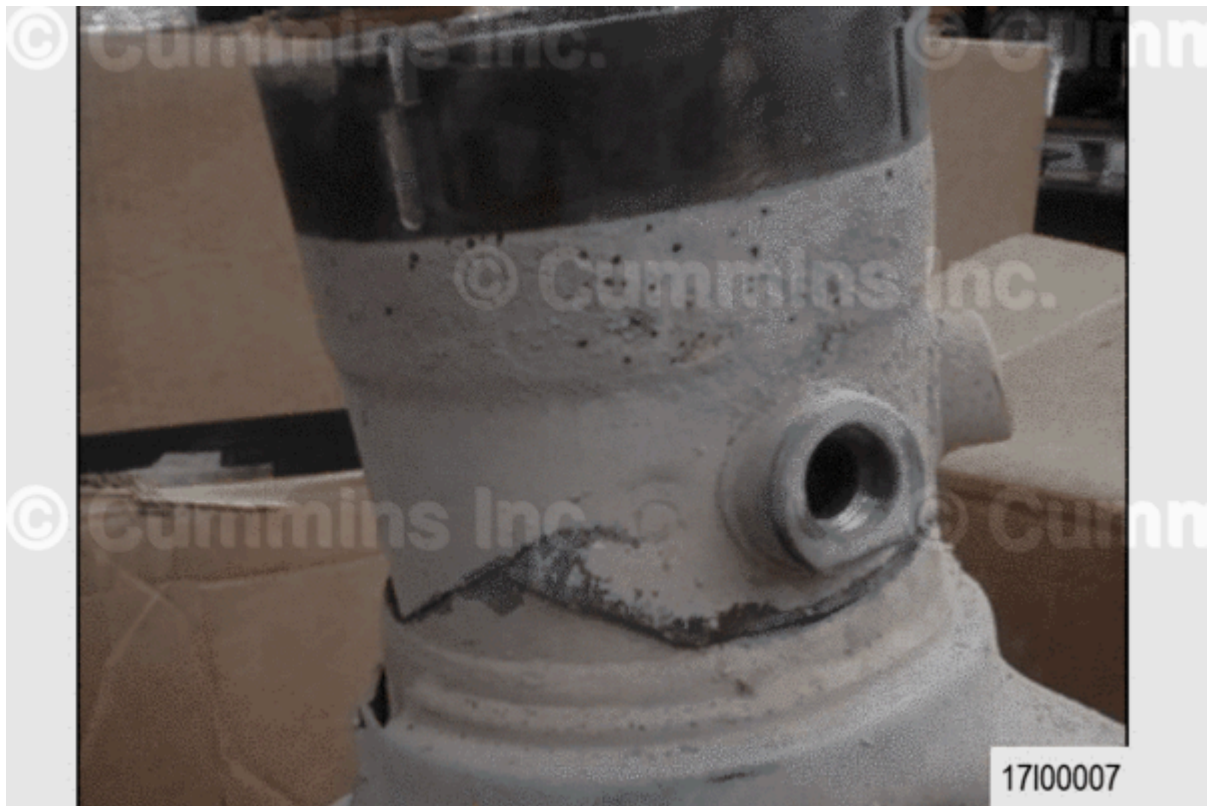
- An exhaust leak is present on the outlet of the aftertreatment selective catalytic reduction (SCR) outlet flange.

- Cracking or breakage of the aftertreatment SCR catalyst outlet flange.

Figure 1, Cracked Aftertreatment SCR Catalyst Outlet Flange.

If the aftertreatment SCR catalyst outlet flange is cracked or broken; replace the aftertreatment SCR catalyst. See corresponding Service Manual. Reference Procedure 011-036 in Section 11.

Do **not** weld or modify the aftertreatment system to correct the malfunction.

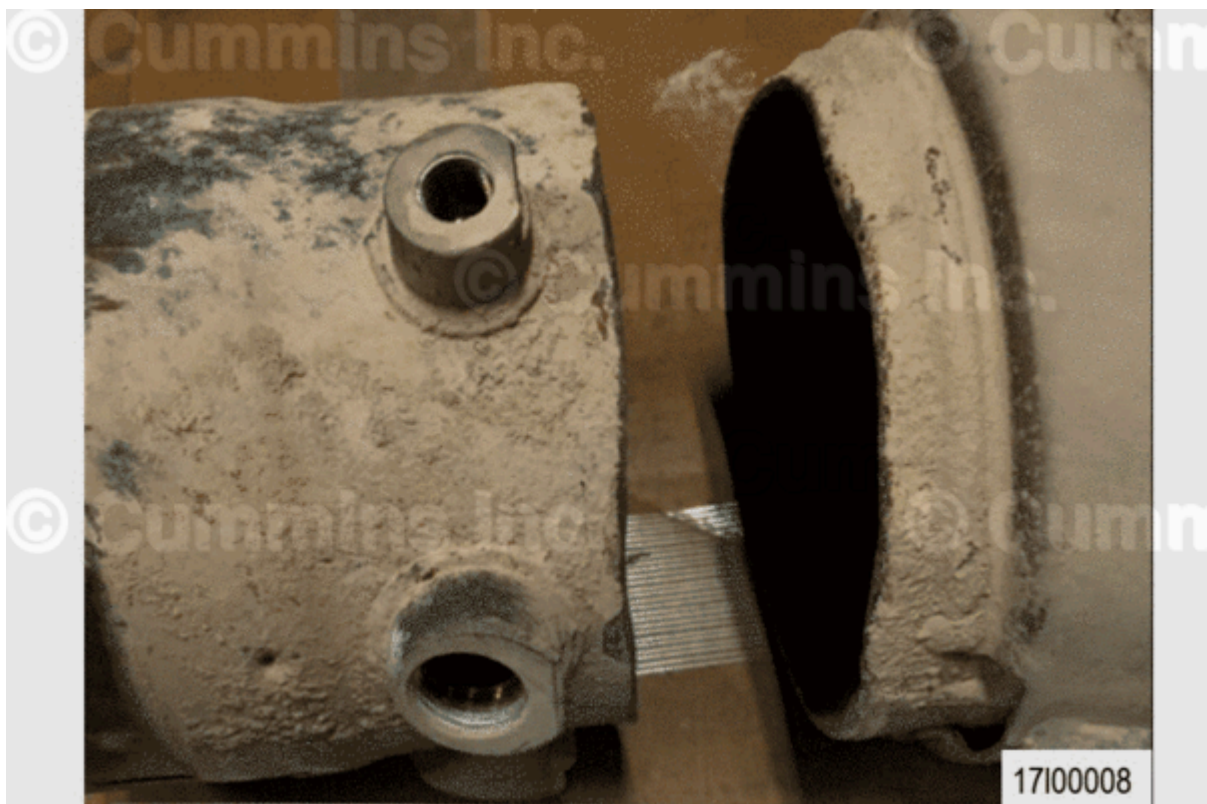
Figure 2, Broken Aftertreatment SCR Catalyst Outlet Flange.
