Technical Service Bulletin: TSB210088

Released Date: 24-Aug-2022

Camshaft Idler Plate or Camshaft Idler Gear Cover Seal Lubricating Oil Leak Misdiagnosed as Leaking Front Gear Housing Gasket and New SRTs

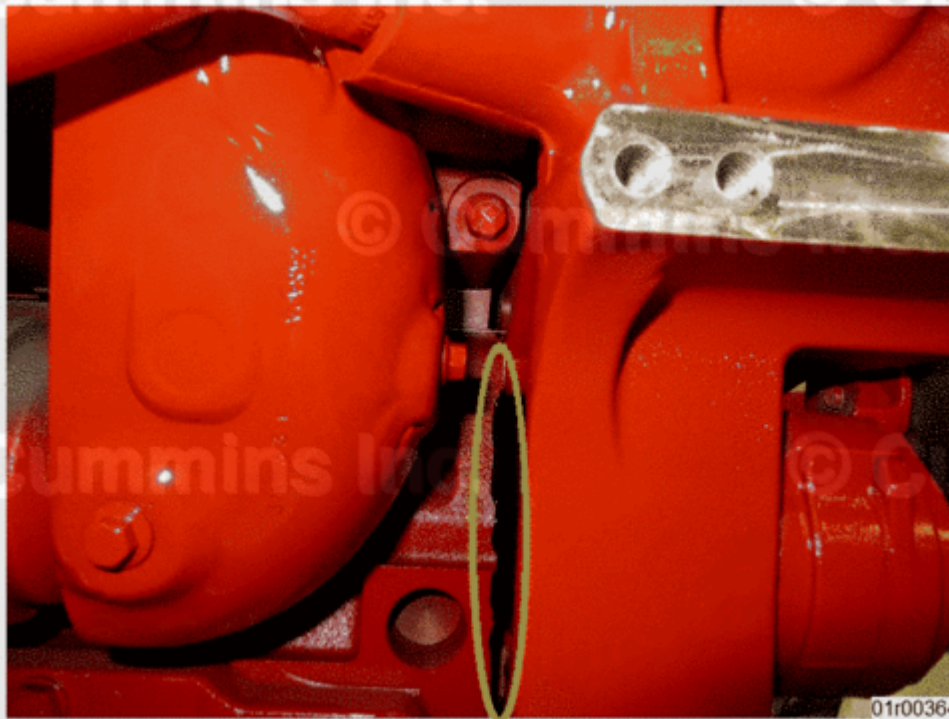
- Evidence of lubricating oil leak above the top of the front gear housing to cylinder block joint indicates the front engine lubricating oil leak is likely **not** the gear housing gasket, but the camshaft cover seal or adjustable camshaft idler cover plate seal.

Figure 2, Camshaft or Adjustable Camshaft Idler Gear Cover Seal Lubricating Oil Leak. View: Front of Exhaust Manifold with Accessories Removed.

Complete the repair as normal. See corresponding Service Manual. Reference Procedure 002-050 in Section 2 or 001-036 in Section 1.
