Technical Service Bulletin: TSB230190

Internal Actuator Wiring Harness Intermittent Signal: Injector Fault Codes

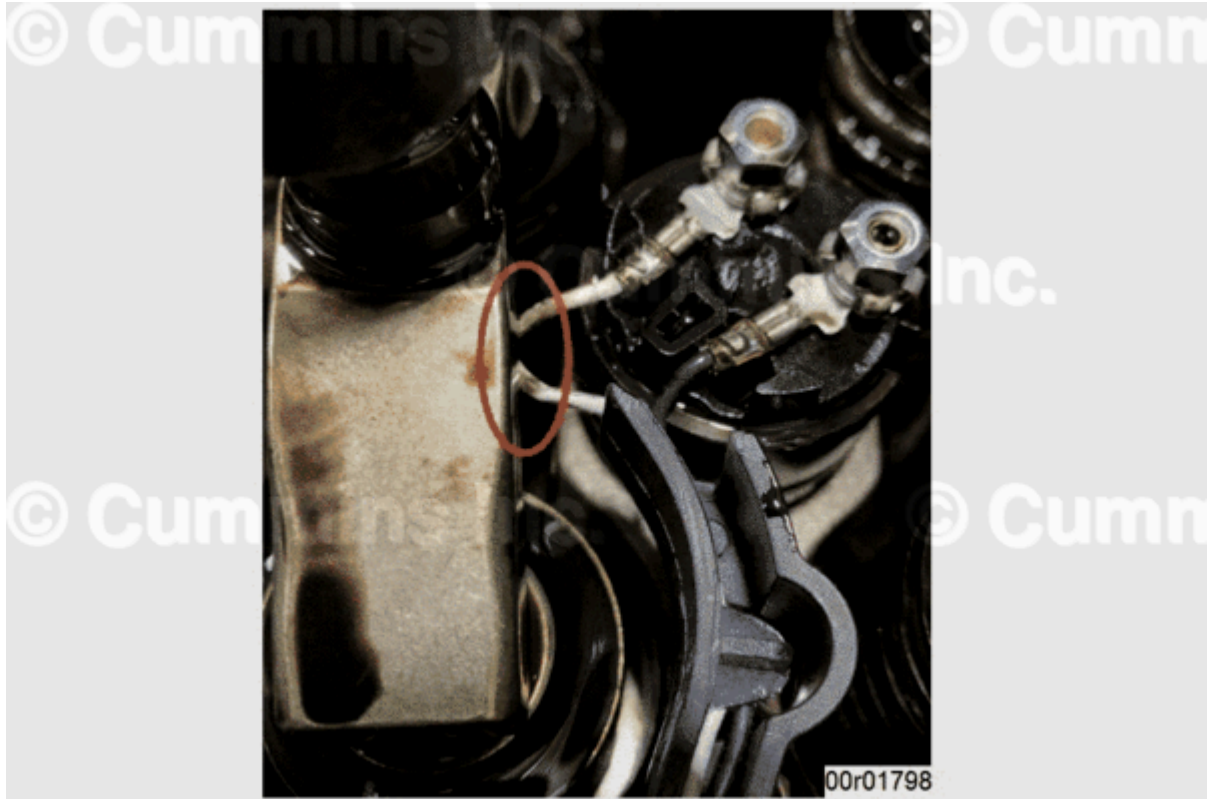
- Valve crosshead contact with internal actuator wiring harness injector wire causing fatigue near crimp connector

Figure 1, View of Contact between Crosshead and Internal Actuator Wiring Harness.

If damage is found, replace injector internal actuator wiring harness, which has been improved to eliminate this failure mode. See corresponding Service Manual. Reference Procedure 019-063 in Section 19.

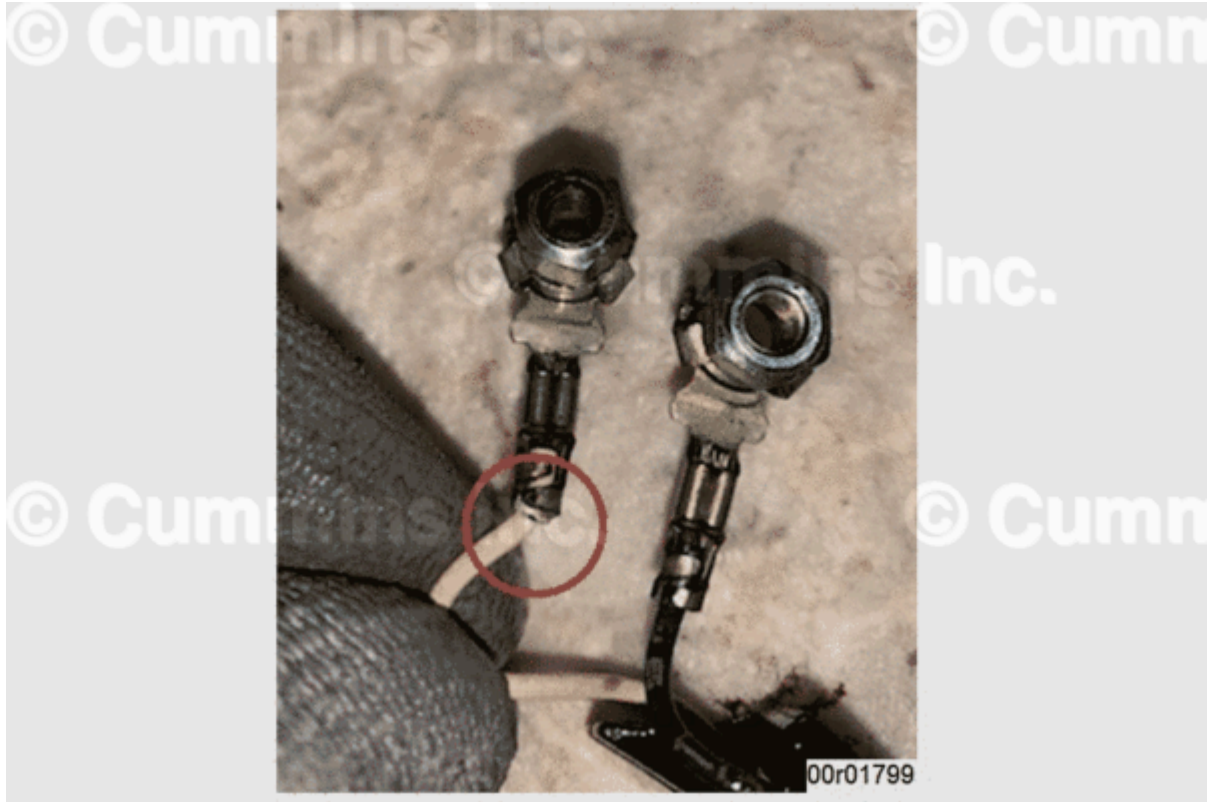
Inspect internal actuator wiring harness for fractured or damaged areas and/or contact with the valve crosshead as seen in Figure 1. As a result of contact with the valve crosshead, the internal actuator wiring harness damage is **not** always obvious. Check for signs of damage to the wiring insulation near the crimp connector. See Figure 2.

Figure 2, View of Partial Insulation Break Near Crimp.
