Technical Service Bulletin: TSB180046

Broken Aftertreatment Diesel Oxidation Catalyst (DOC) Baffle: Fault Code 1664 or 1691

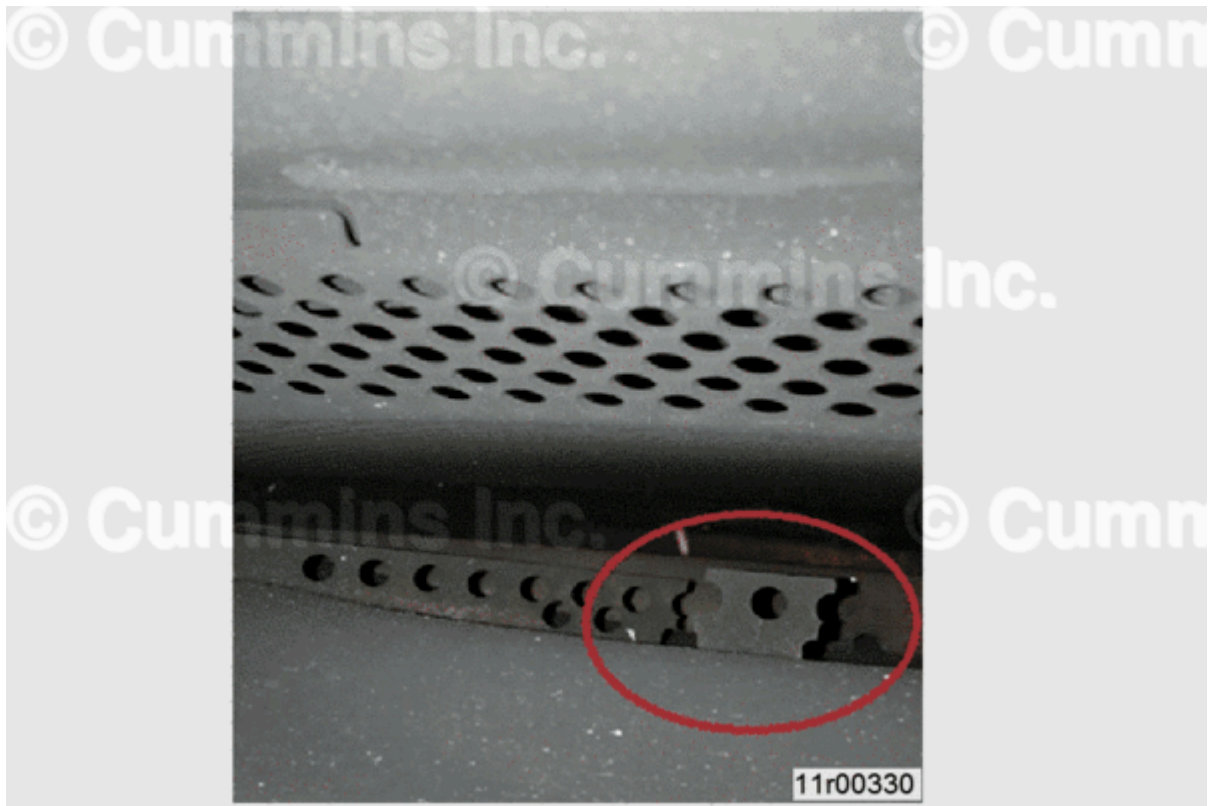
- Welding issues have been found inside inlet tube of aftertreatment DOC causing baffle breakage.
- See Figures 1 and 2 for examples of broken aftertreatment DOC baffles.

Figure 1, Broken Baffle in Inlet of Aftertreatment DOC.

- If troubleshooting the applicable Fault Codes 1691 and 1664 lead to finding a cracked or broken baffle, replace the aftertreatment DOC. See corresponding Service Manual. Reference Procedure 011-049 in Section 11.
- If applicable Fault Codes 1691 and 1664 are **not** present, do **not** replace the aftertreatment DOC, even if a cracked or broken baffle is found. If a piece of the baffle is detached, as in Figure 2 above, remove detached baffle piece and install the aftertreatment DOC as is. See corresponding Service Manual. Reference Procedure 011-049 in Section 11.

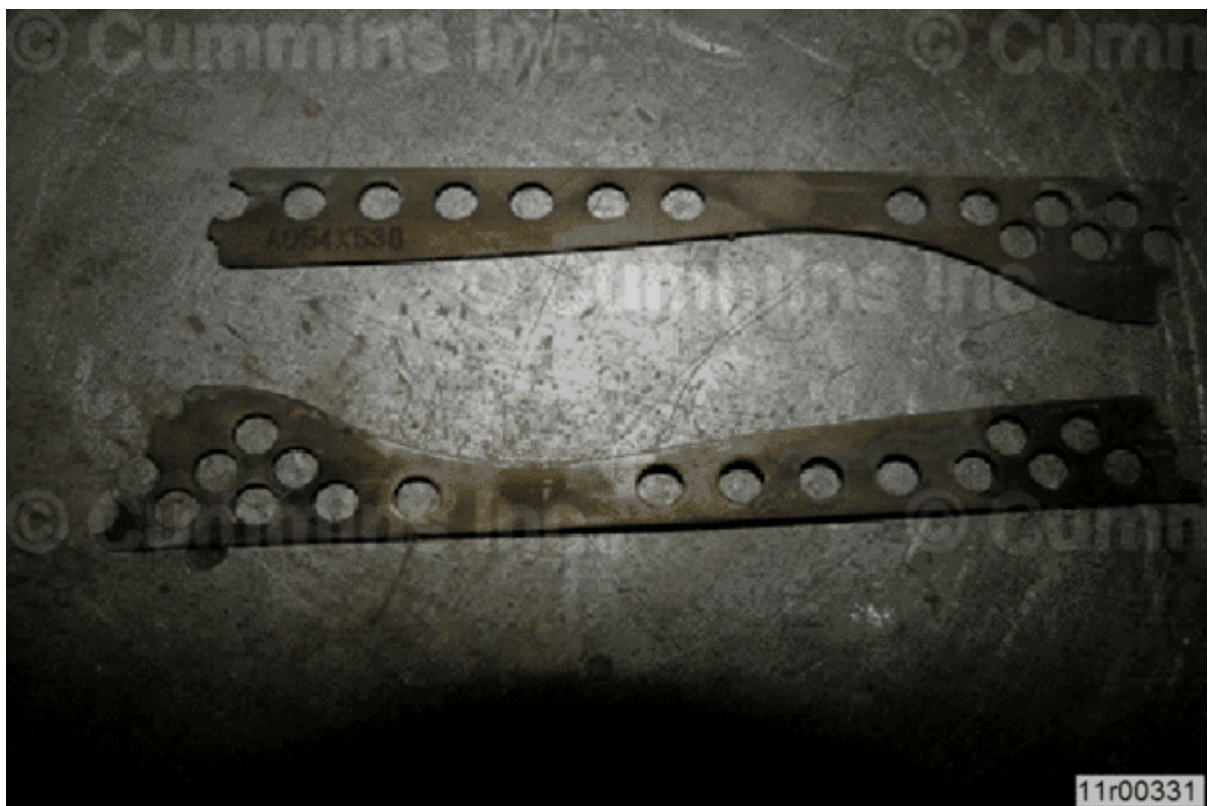
Figure 2, Broken Aftertreatment DOC Baffle.
