Technical Service Bulletin: TSB180047

Aftertreatment Diesel Exhaust Fluid Dosing Unit Heating Element Discoloration

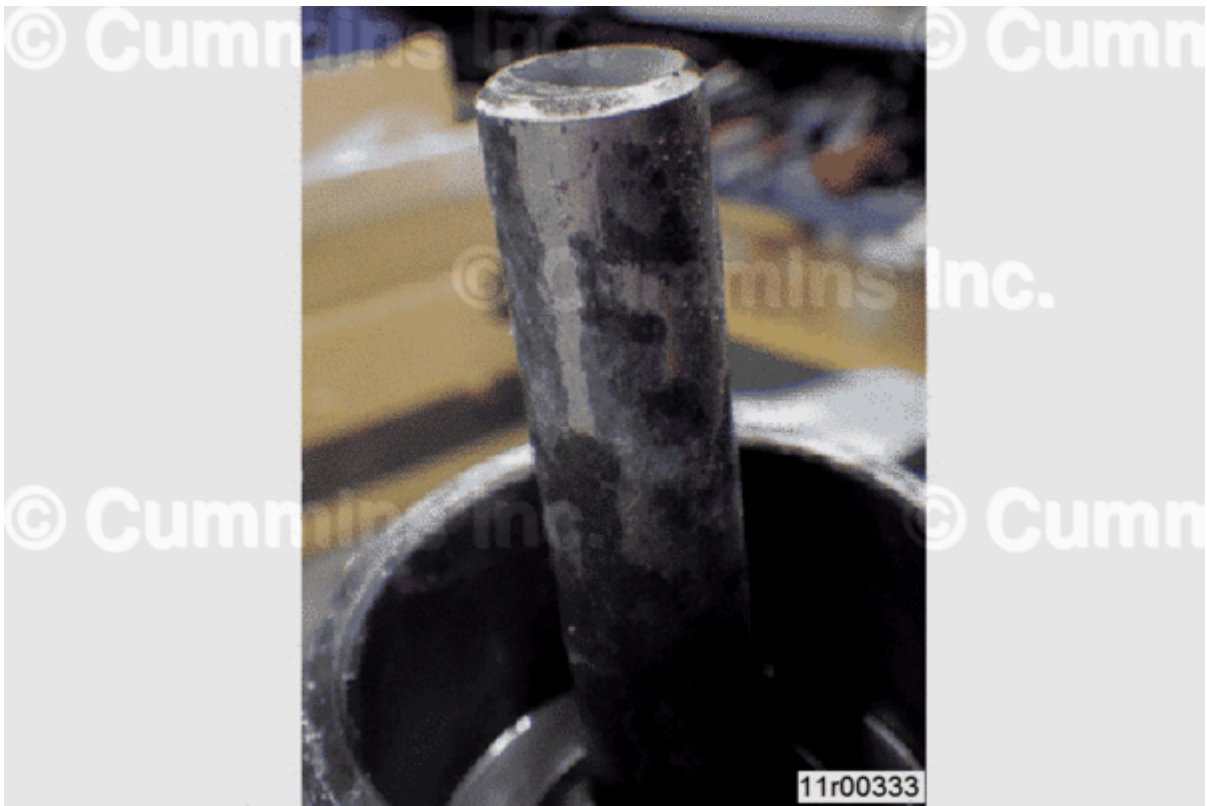
- Diesel exhaust fluid (DEF) dosing unit heater elements can be discolored caused by chemical reactions between aluminum housing and DEF.
- DEF dosing valve inlet screen can become plugged with debris when corrosion on the DEF dosing unit heating element flakes off.
- A plugged DEF dosing valve inlet screen will typically lead to FC1682, FC3574, and/or FC3596.

Figure 2, Corroded DEF Dosing Unit Heating Element

If DEF dosing valve inlet screen is found to be plugged with debris, and corrosion on DEF dosing unit heating element is flaking off:

- DEF dosing unit and DEF dosing valve inlet screen must be replaced. DEF pressure line, between DEF dosing unit and DEF dosing valve must be flushed with distilled water to remove any residual debris.
- See Figure 1 for an example of a plugged DEF dosing valve inlet screen.
- See Figure 2 for an example of a DEF dosing unit heating element with corrosion that is flaking off.

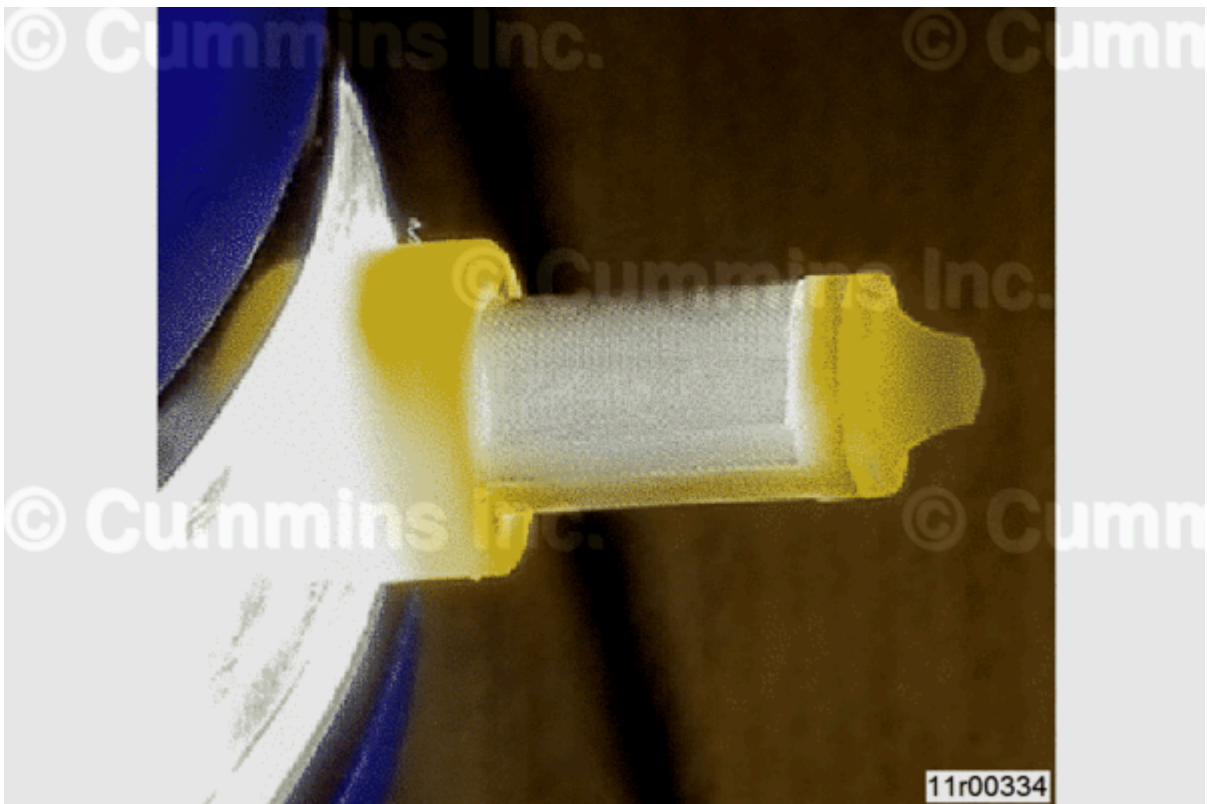
Figure 3, Normal DEF Dosing Valve Inlet Screen.

If DEF dosing valve inlet screen is **not** plugged with debris and there is corrosion on DEF dosing unit heating element, but is **not** flaking off:

- Do **not** replace DEF dosing unit (for this condition). All DEF dosing units will have some level of discoloration/corrosion internally.
- See Figure 3 for an example of a clean DEF dosing valve inlet screen.
- See Figures 4, 5, and 6 for examples of DEF dosing units with acceptable levels of discoloration/corrosion.

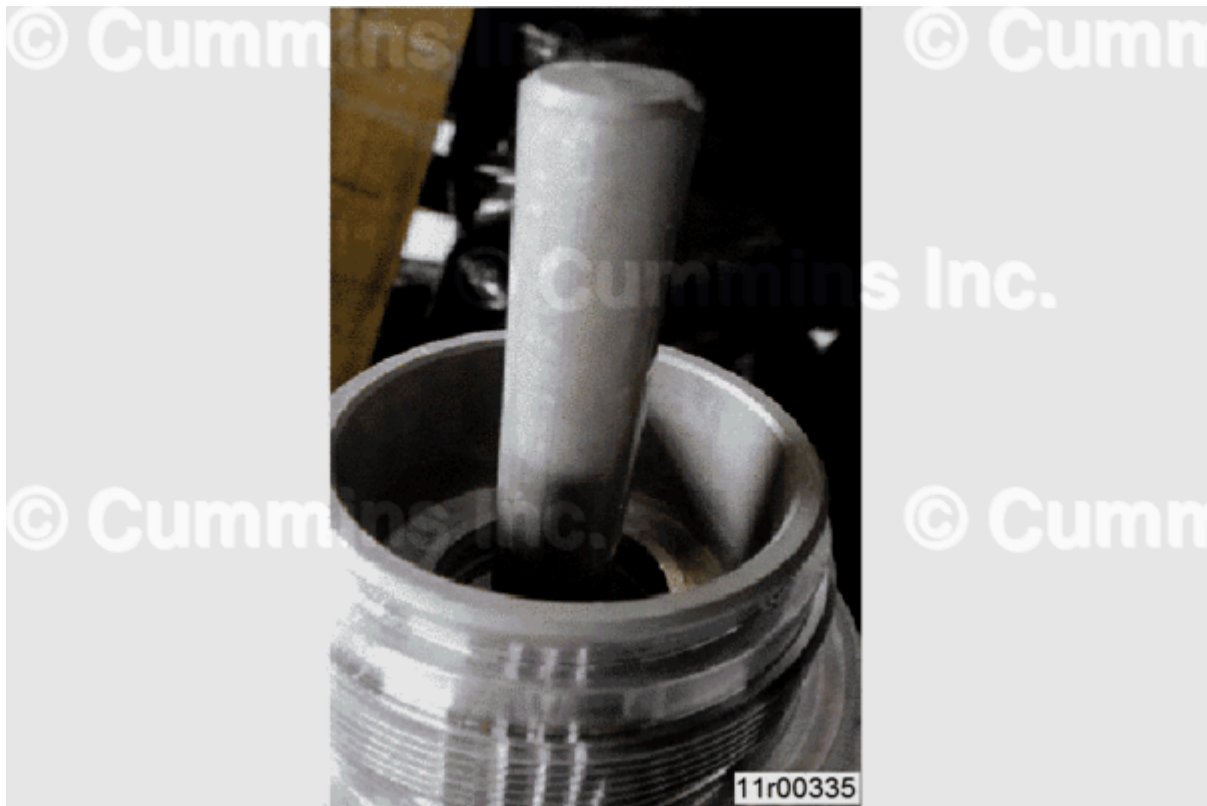
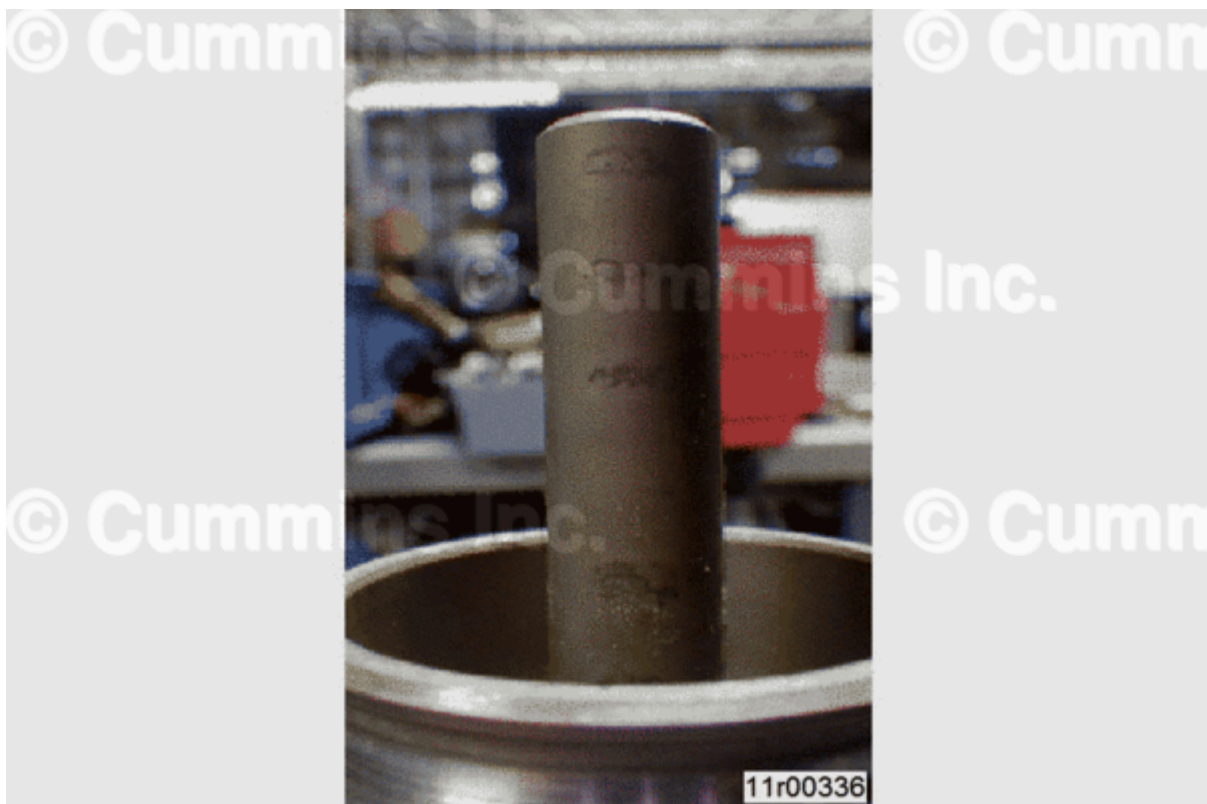
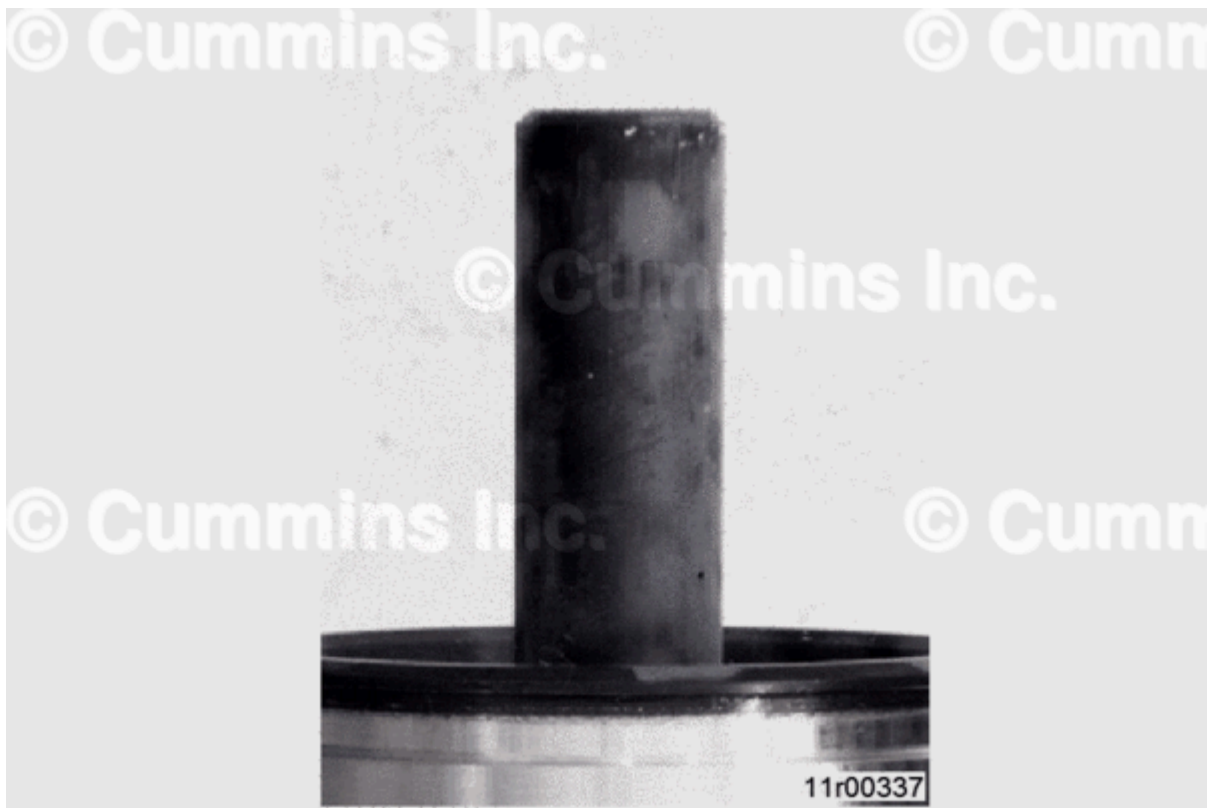
Figure 4, Normal DEF Dosing Unit Heating Element Discoloration.

Figure 5, Normal DEF Dosing Unit Heating Element Discoloration.

Figure 6, Normal DEF Dosing Unit Heating Element Discoloration.
