Technical Service Bulletin: TSB180139

UL2 DEF Dosing Unit External DEF Leaks

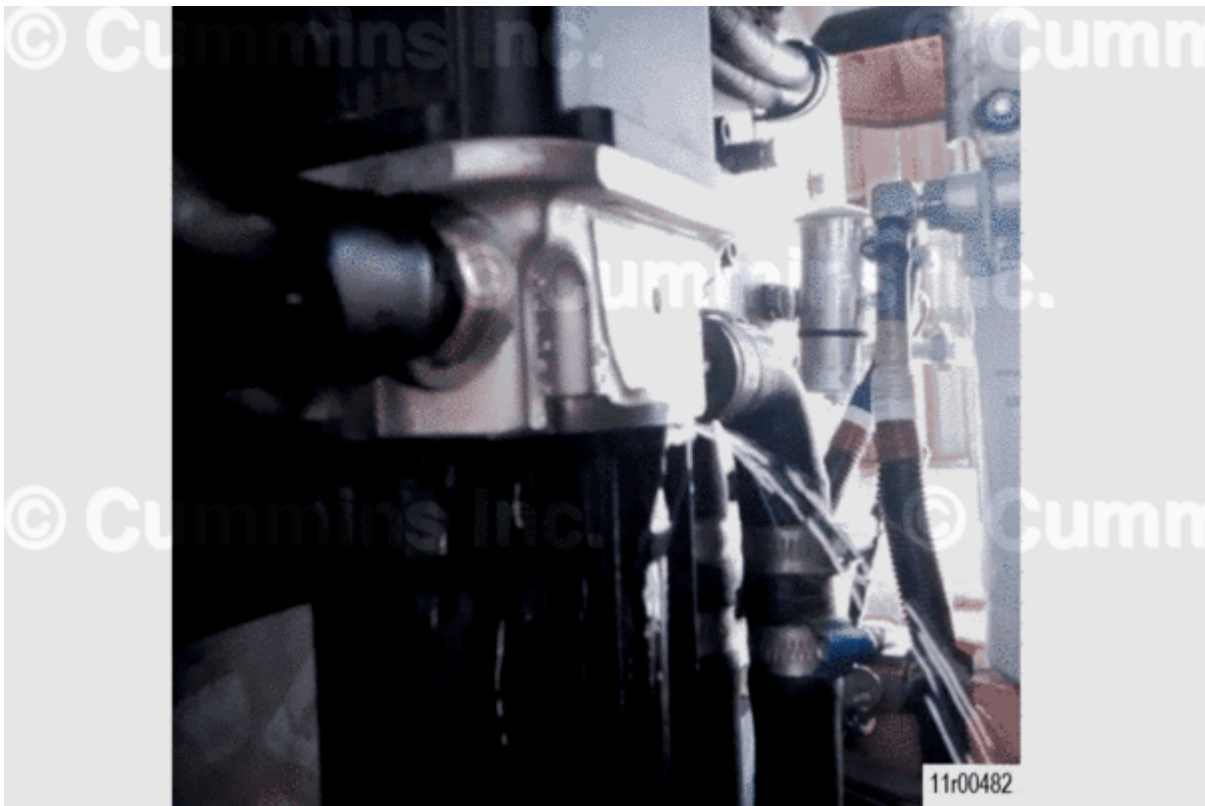
- Some diesel exhaust fluid dosing unit filter housings have been observed to swell over time and lose clamping force required to seal DEF between the dosing unit housing and the freeze membrane.

(/qs3/pubsys2/xml/en/procedures/493/493-011-080.html) in Section 11. Observe for leakage between the plastic filter cap and aluminum dosing unit housing. See Figures 1 and 2 below.

Figure 1, Leak between Aftertreatment Diesel Exhaust Fluid Dosing Unit and Filter Housing.

- If leakage is present, remove aftertreatment diesel exhaust fluid dosing unit filter housing and freeze membrane and inspect for damage.
- If an external leak is present at aftertreatment diesel exhaust fluid dosing unit filter housing, replace the diesel exhaust fluid dosing unit filter, freeze membrane, and filter housing. See corresponding service manual. Refer to Procedure 011-060 (</qs3/pubsys2/xml/en/procedures/493/493-011-060.html>) in Section 11.
- All required parts are contained in diesel exhaust fluid dosing unit filter kit, Part Number 4388378.

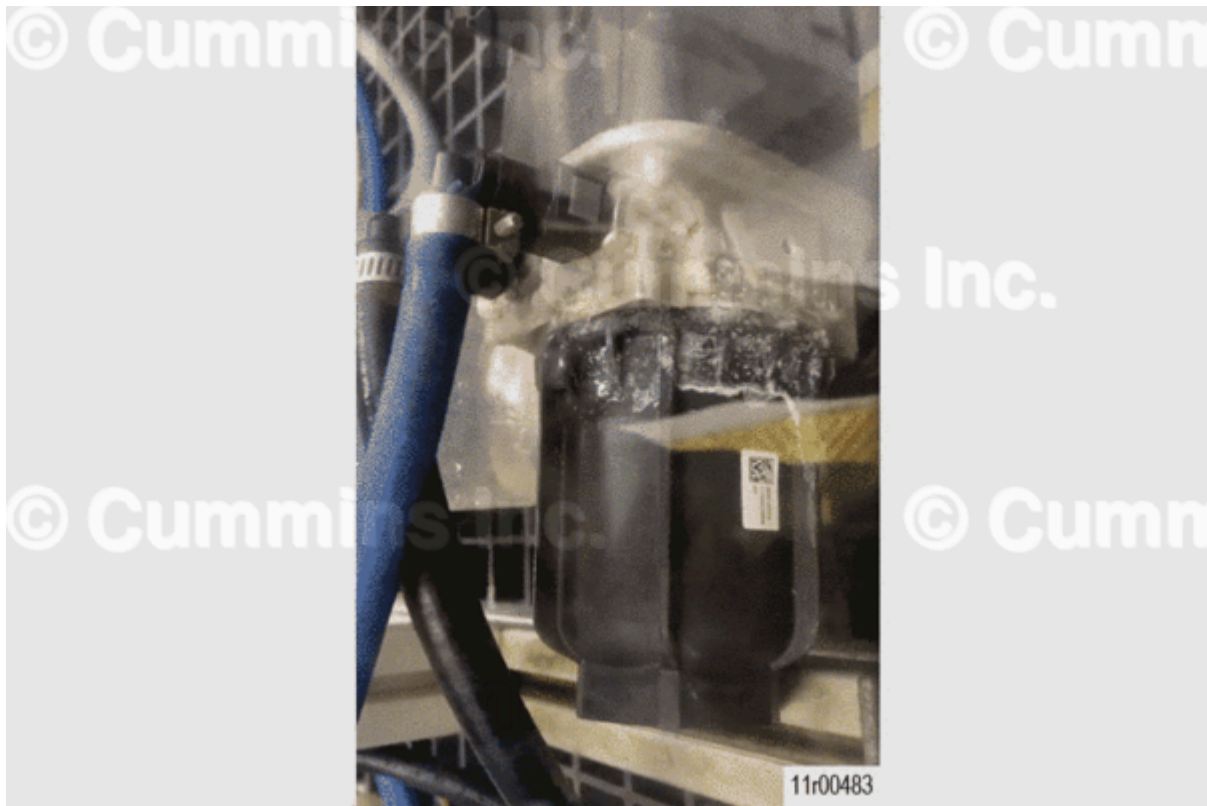
Figure 2, Signs of External DEF Leak Present on Aftertreatment Diesel Exhaust Fluid Dosing Unit.

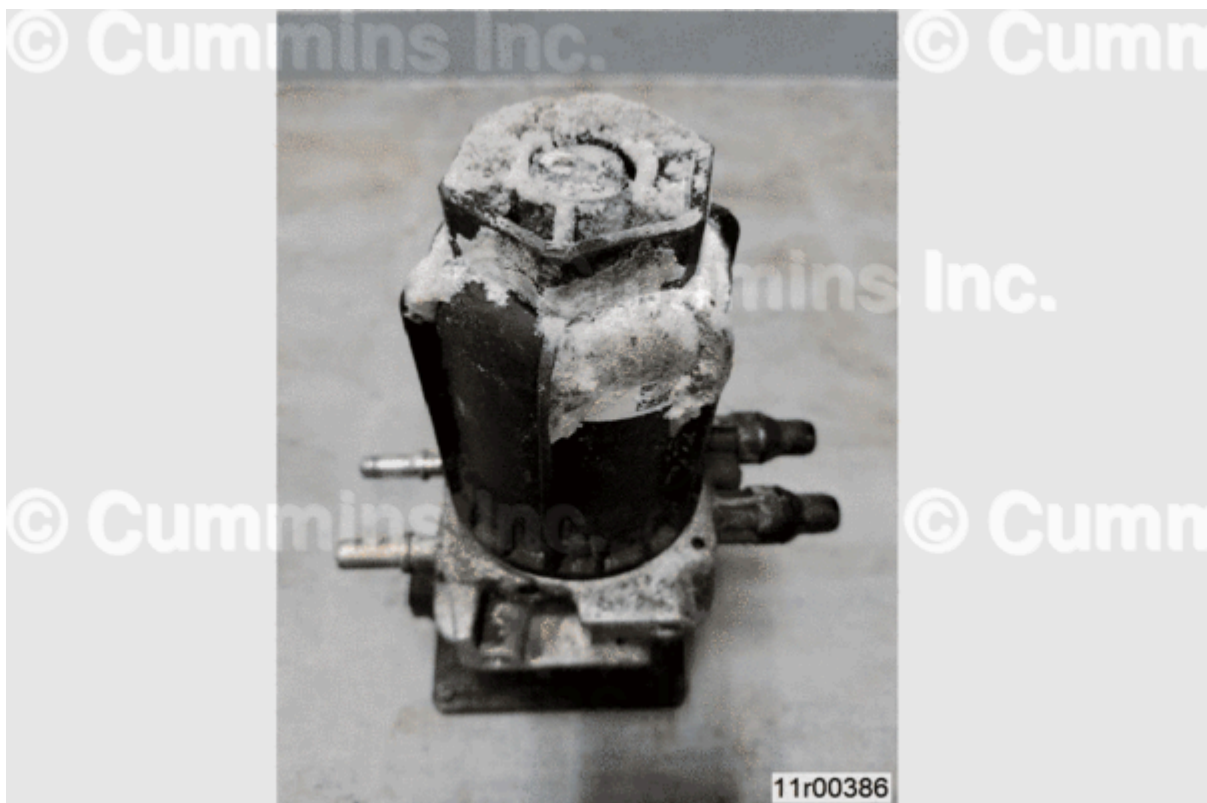
Visually inspect diesel exhaust fluid dosing unit filter housing for signs of leakage from filter housing vent. See Figures 3 and 4 below.

Figure 3, Aftertreatment Diesel Exhaust Fluid Dosing Unit with External Leak

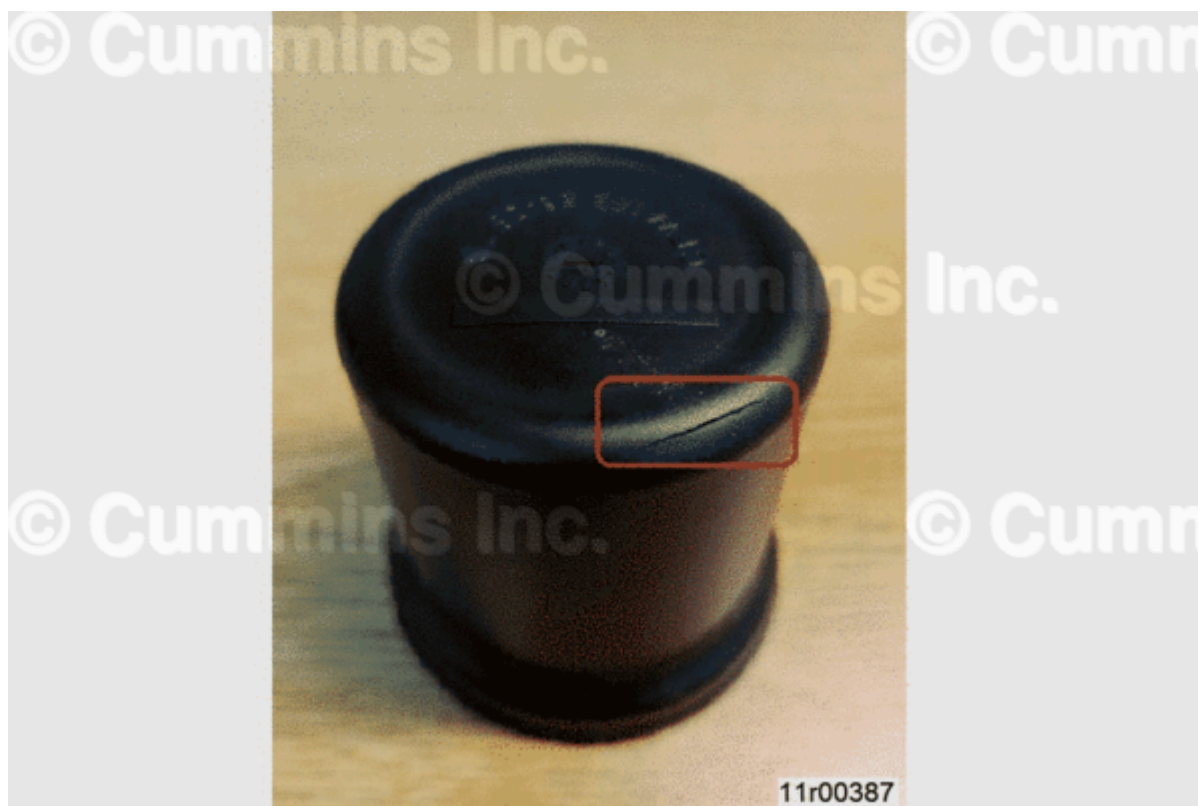
- A hard interference between the diesel exhaust fluid dosing unit filter, freeze membrane, and filter housing can cause the freeze membrane to tear and allow aftertreatment diesel exhaust fluid to leak into the filter housing and leak out the filter housing vent.

Figure 4, Damaged Aftertreatment Diesel Exhaust Fluid Dosing Unit Freeze Membrane

A new aftertreatment diesel exhaust fluid dosing unit filter design has been released to prevent interference between aftertreatment diesel exhaust fluid dosing unit filter, freeze membrane, and filter housing. This improvement is a running change and no new part number will be released.
