Technical Service Bulletin: TSB200008

Released Date: 26-Jul-2020

Introduction of Turbocharger Actuator Boot Cover Service Kit

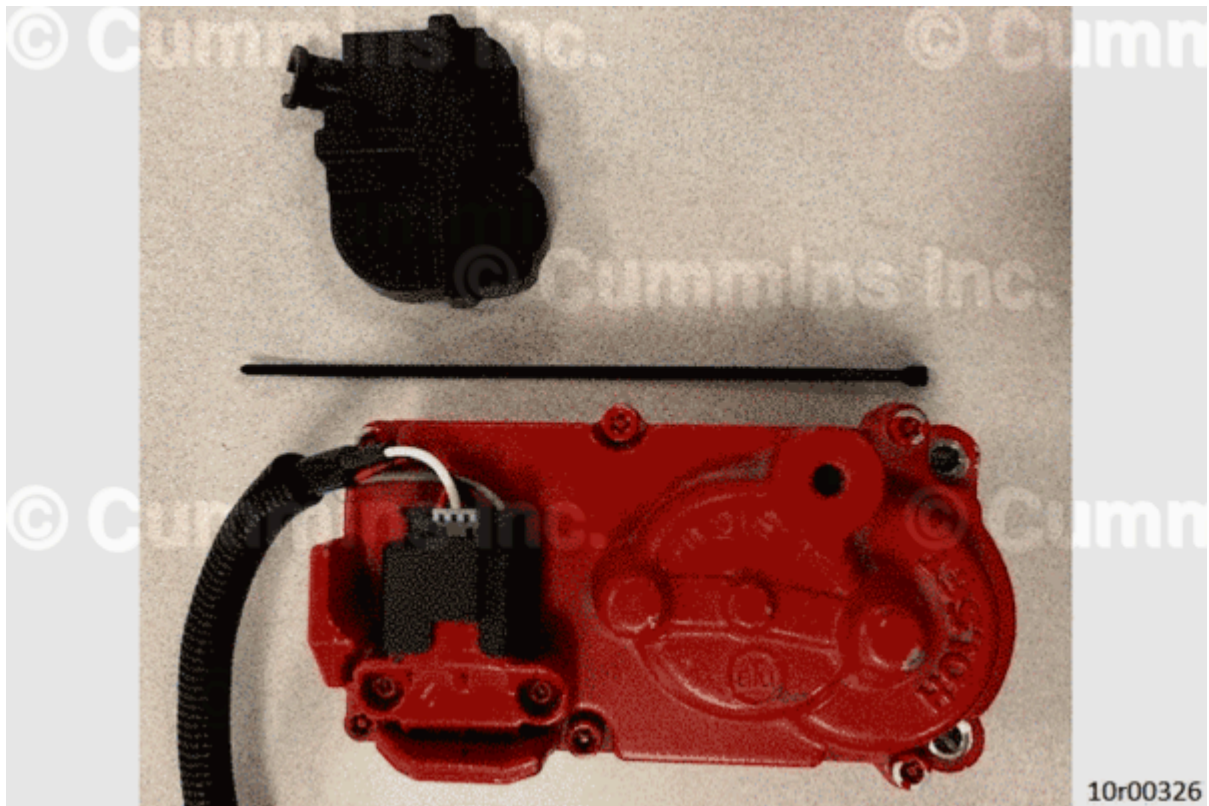
Figure 1, Boot Cover and Zip Tie

Turbocharger actuator corrosion found due to water intrusion through actuator connector.

Turbocharger actuators without a boot cover and with Fault Code 1894 active, **must** have a boot cover installed.

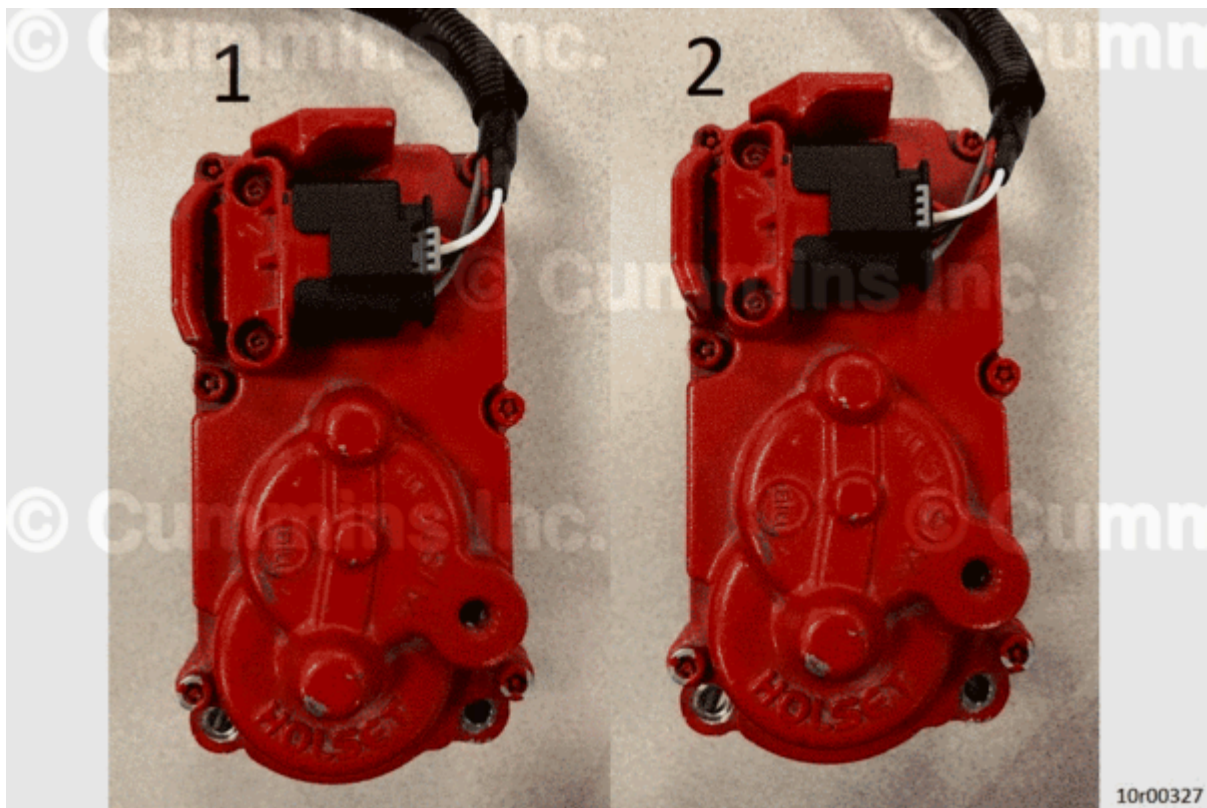
Figure 2, Location of Grey Tab

1. Incorrect: grey tab **not** fully inserted.
2. Correct: grey tab fully inserted.

Prior to installing boot cover, make sure grey tab is fully inserted (clip locked) into the black connector.
