Technical Service Bulletin: TSB210192

Engine Wiring Harness Malfunctions Causing Datalink Fault Codes

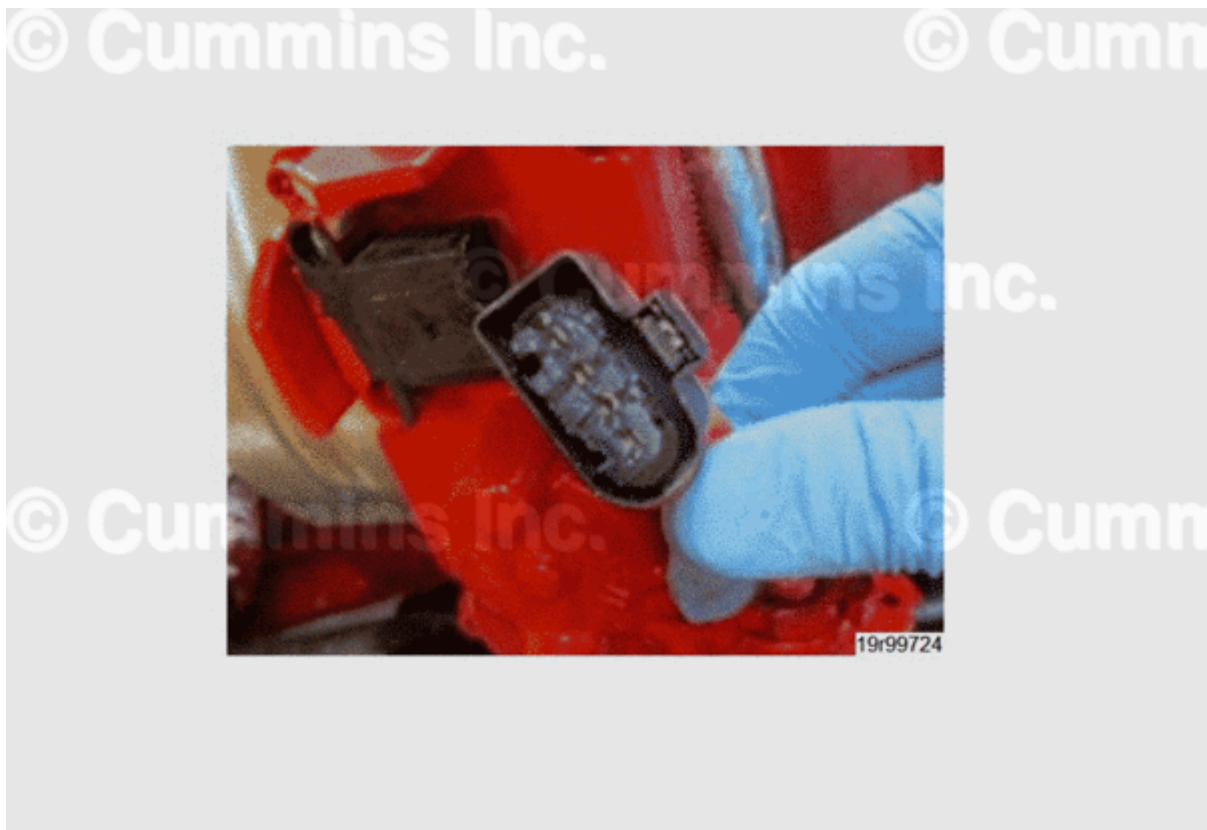
1. If checking a connector while following the published troubleshooting tree, visually inspect the connector for evidence of dielectric grease usage. See Figure 1 below.

Figure 1, Dielectric Grease in Connector.

- If there is evidence of dielectric grease usage in a connector, remove the dielectric grease and clean the connector.

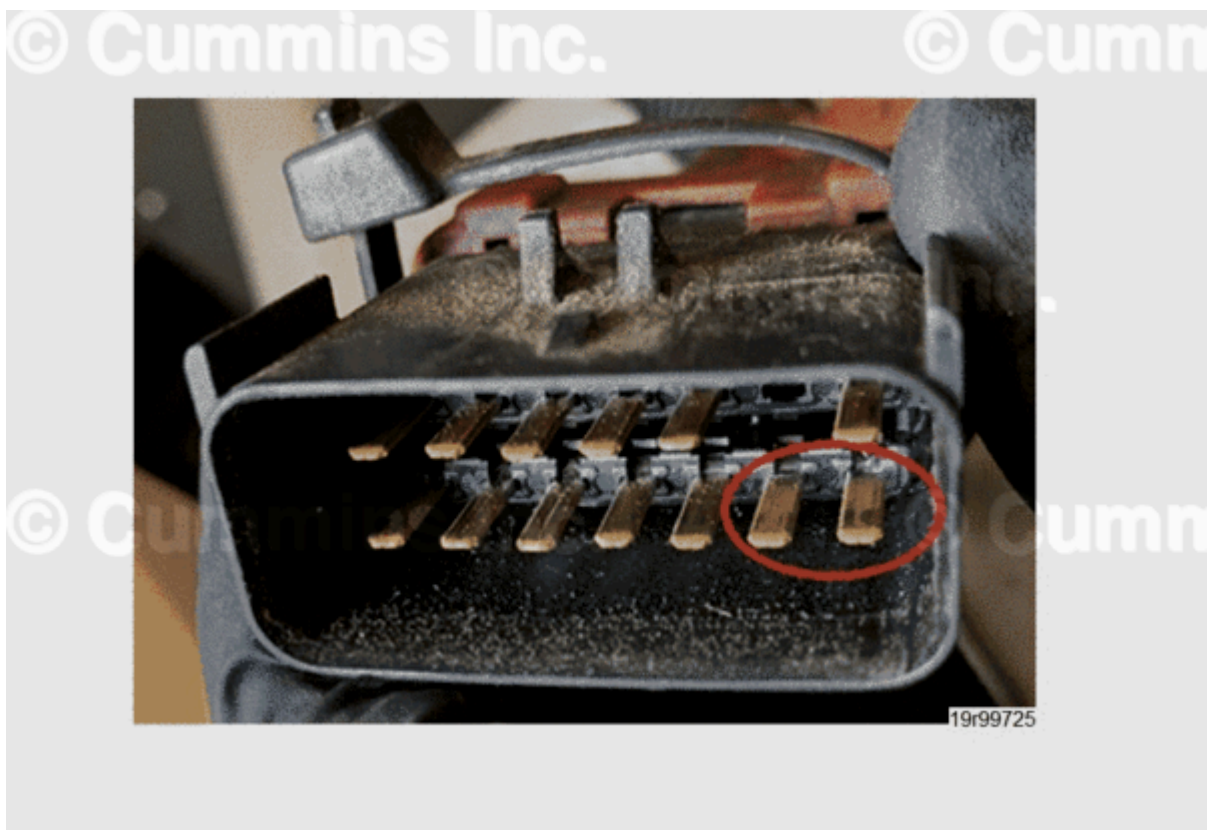
2. If checking a 14-pin connector while following the published troubleshooting tree, inspect connector for evidence of water intrusion or corrosion. See Figure 2 and Figure 3 below.

Figure 2, Evidence of Water Intrusion or Corrosion.

- If there is evidence of water intrusion through into a connector, follow the corresponding service manual procedure to repair or replace the connector.

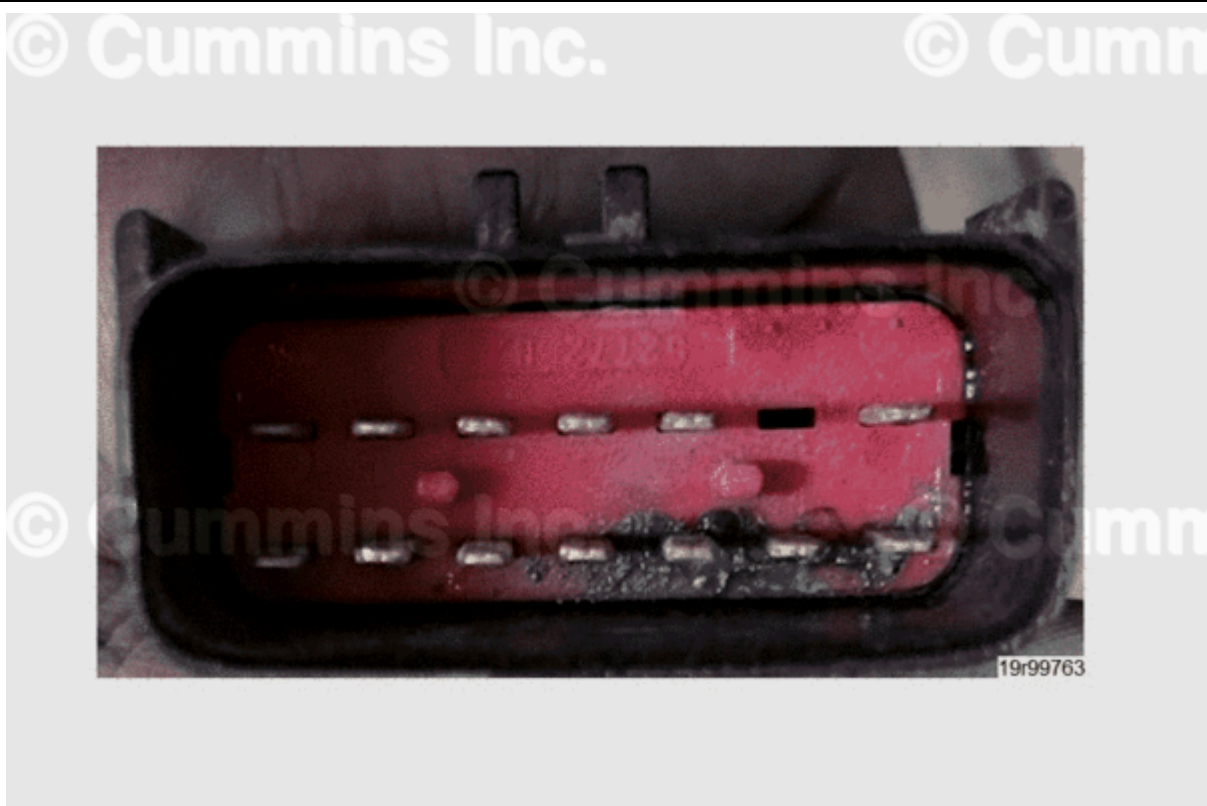
Figure 3, Evidence of Water Intrusion or Corrosion.
