Technical Service Bulletin: TSB220195

Coolant Level Sensor Identification: Fault Code 195 or 196

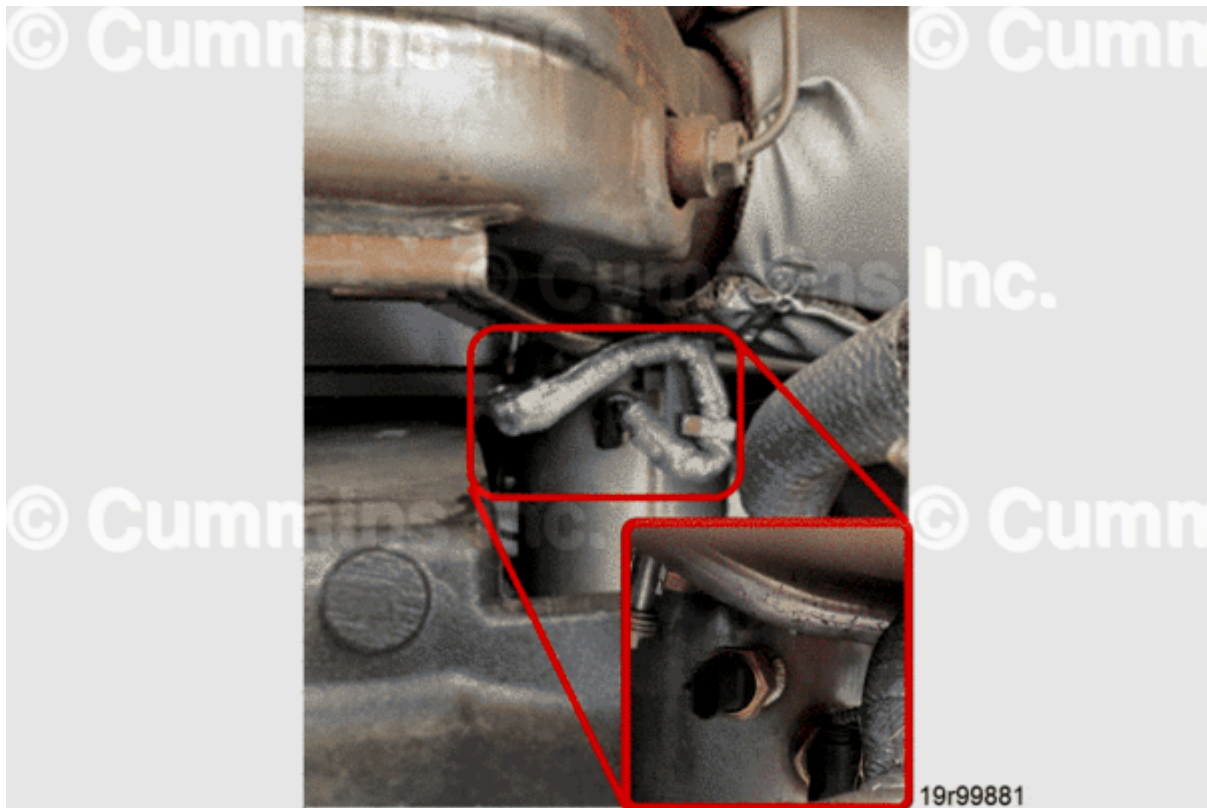
- Fault Code 195 or 196
- There can be two coolant level sensors (typically on the Bus Applications) that are related to the coolant level sensor. One coolant level sensor is connected to the ECM and the fault code, the other coolant level sensor is connected to the OEM as the dashboard light.

The fault code can **only** be cleared and issue corrected by troubleshooting the correct coolant level sensor. Before beginning the troubleshooting process, the correct sensor that connects back to the ECM **must** be identified. When the ECM is powered down the OEM sensor will still have voltage

Figure 1, Example of Two Coolant Level Sensors.

If there are two coolant level sensors, identify the correct ECM connected coolant level sensor and continue with the normal troubleshooting steps.
