Technical Service Bulletin: TSB240227

Aftertreatment Diesel Exhaust Fluid (DEF) Dosing Valve Inlet Filter with Fault Code(s) 1682 and 7325

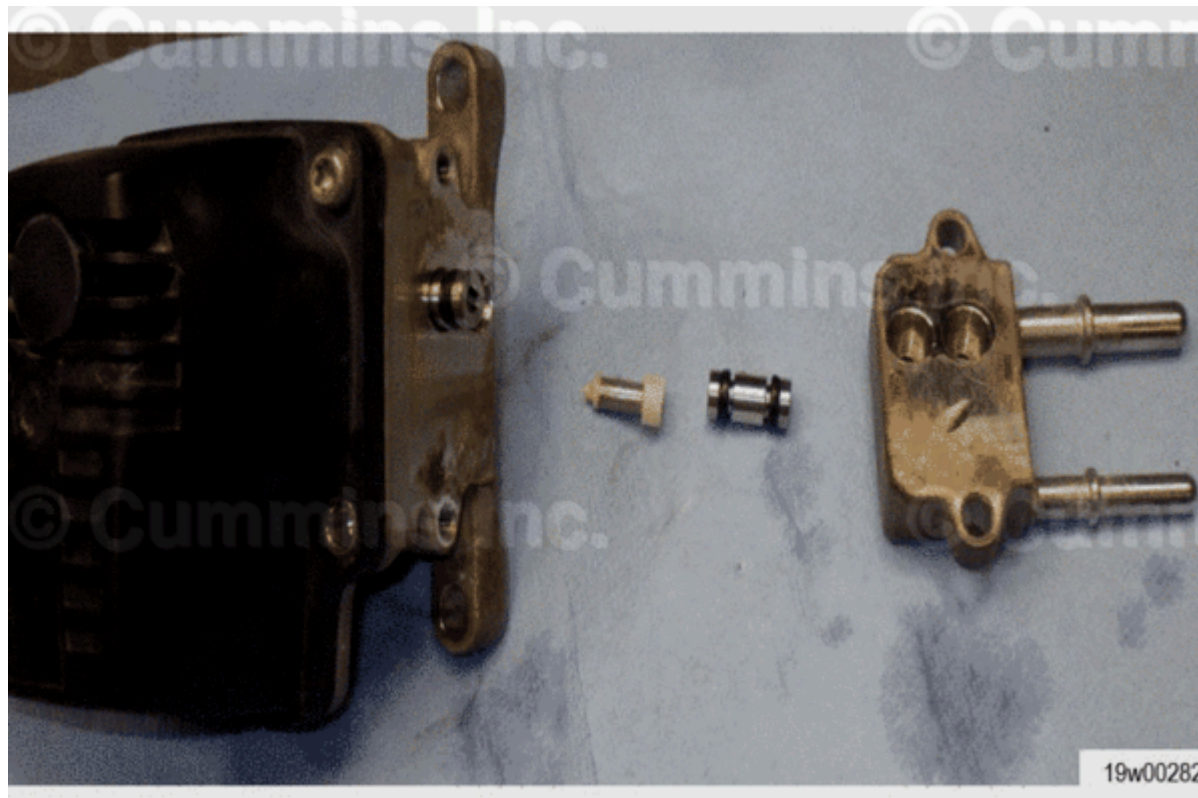
- Aftertreatment diesel exhaust fluid (DEF) dosing valve inlet filter blocked or restricted leading to improper DEF dosing unit replacement.

Figure 1, UL2.0 DEF Dosing Valve Inlet Filter Location

- Replace the aftertreatment DEF dosing valve inlet filter. Refer to Procedure 011-059 in Section 11 of the corresponding service manual.

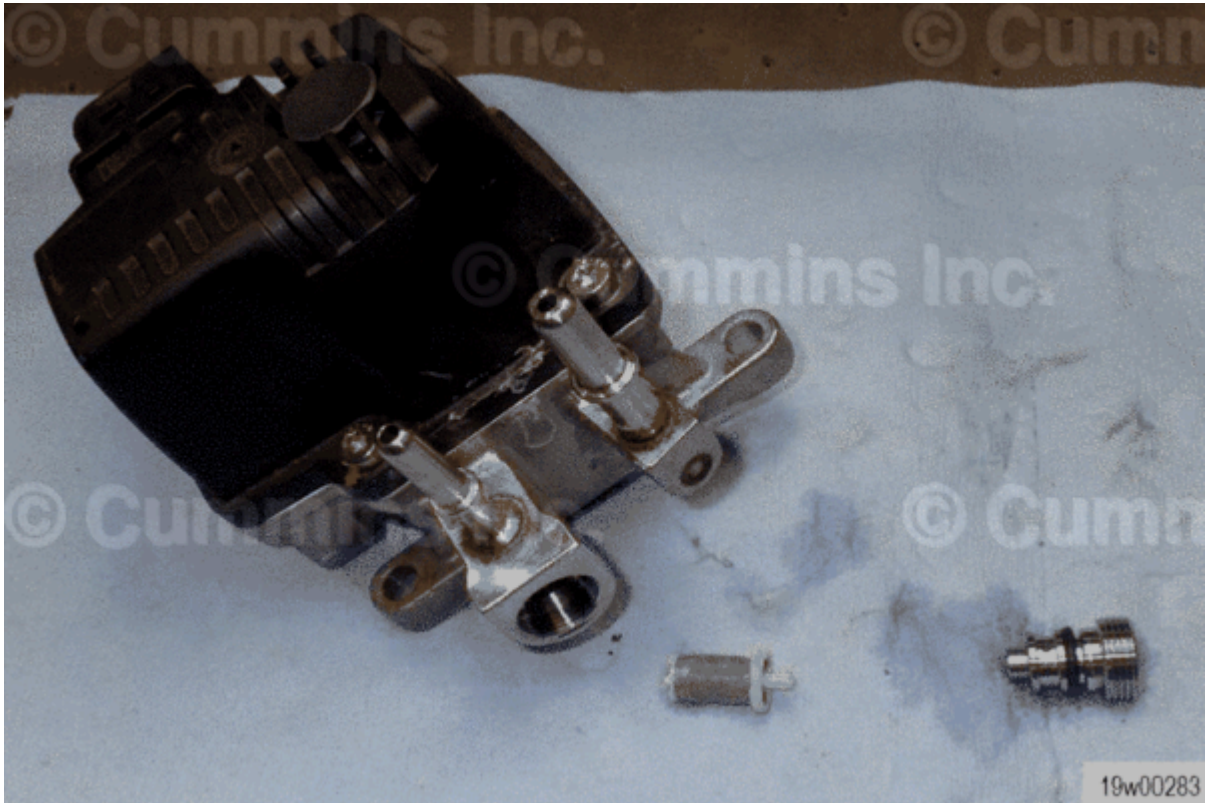
Figure 2, UL2.2 DEF Dosing Valve Inlet Filter Location

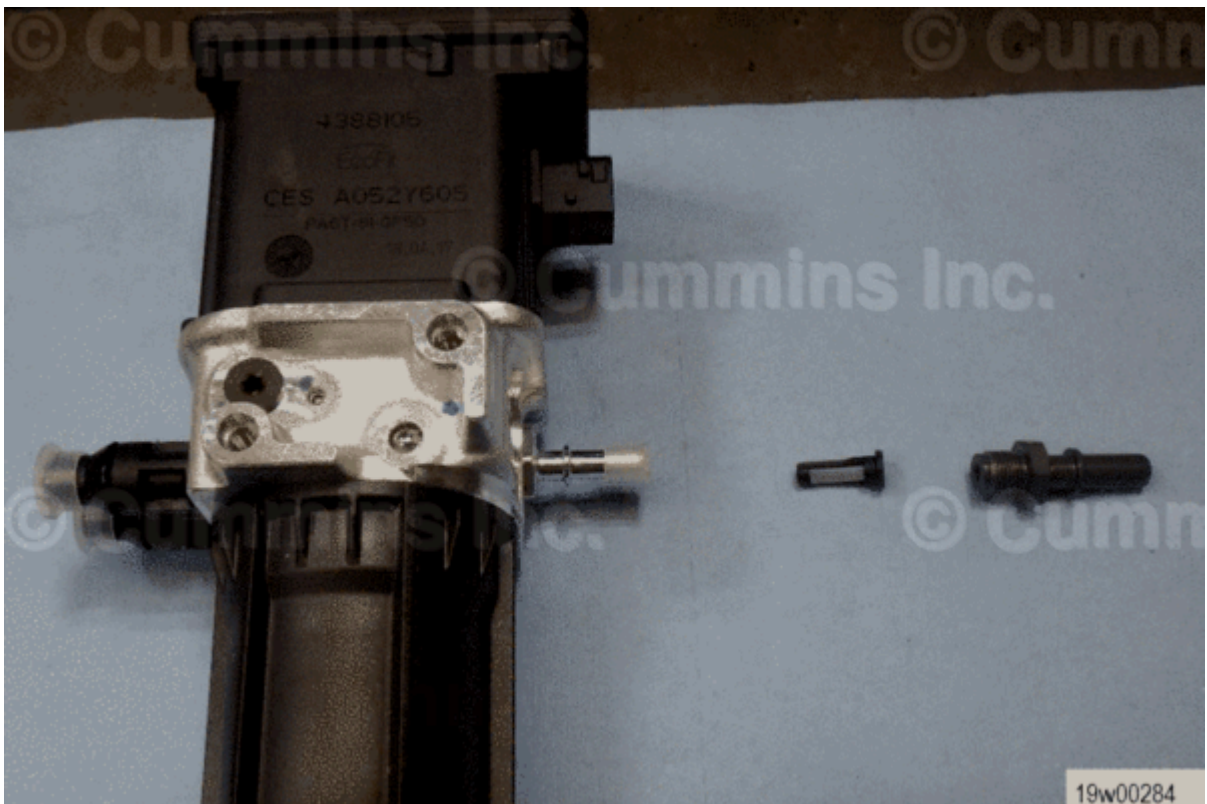
Figure 3, UL2.0 DEF Dosing Unit Inlet Filter Location

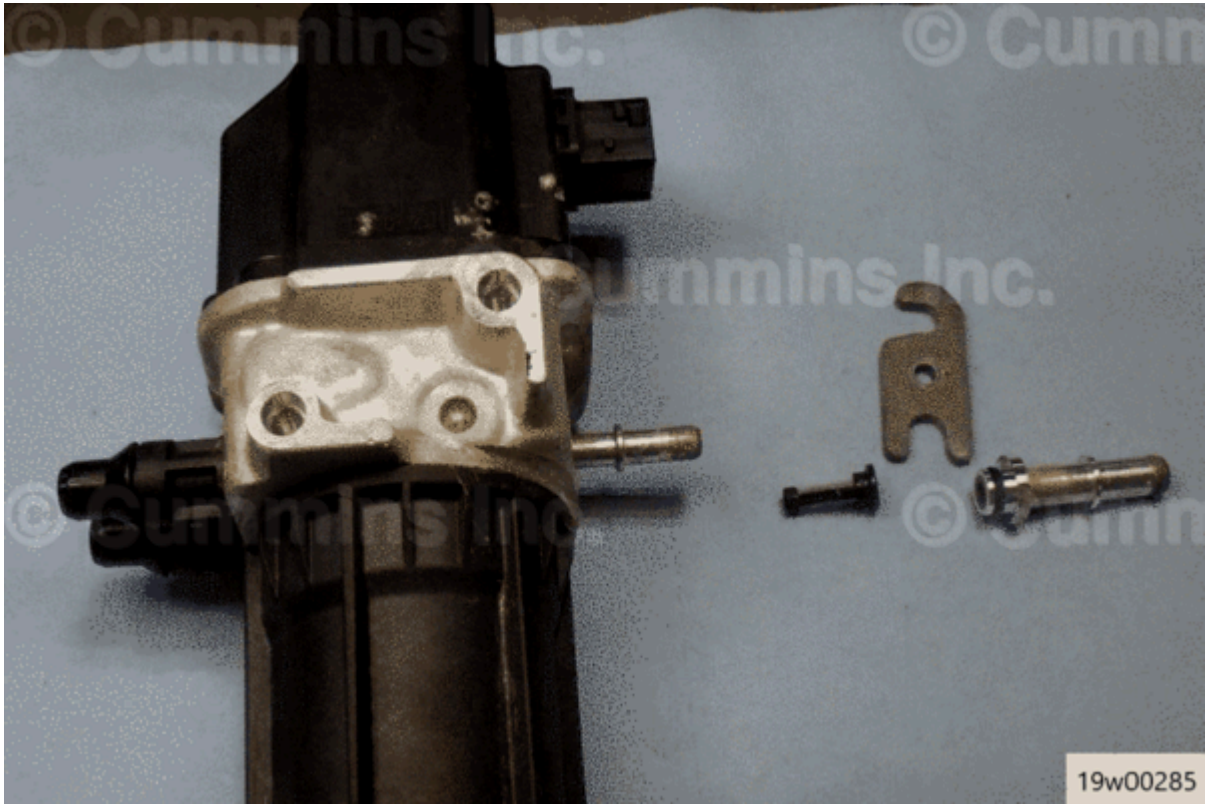
Figure 4, UL2.2 DEF Dosing Unit Inlet Filter Location
