Service Bulletin Number: 4021600

Released Date: 10-Sep-2014

Aftertreatment Diesel Oxidation Catalyst (DOC) and Aftertreatment Diesel Particulate Filter (DPF) Reuse Guidelines

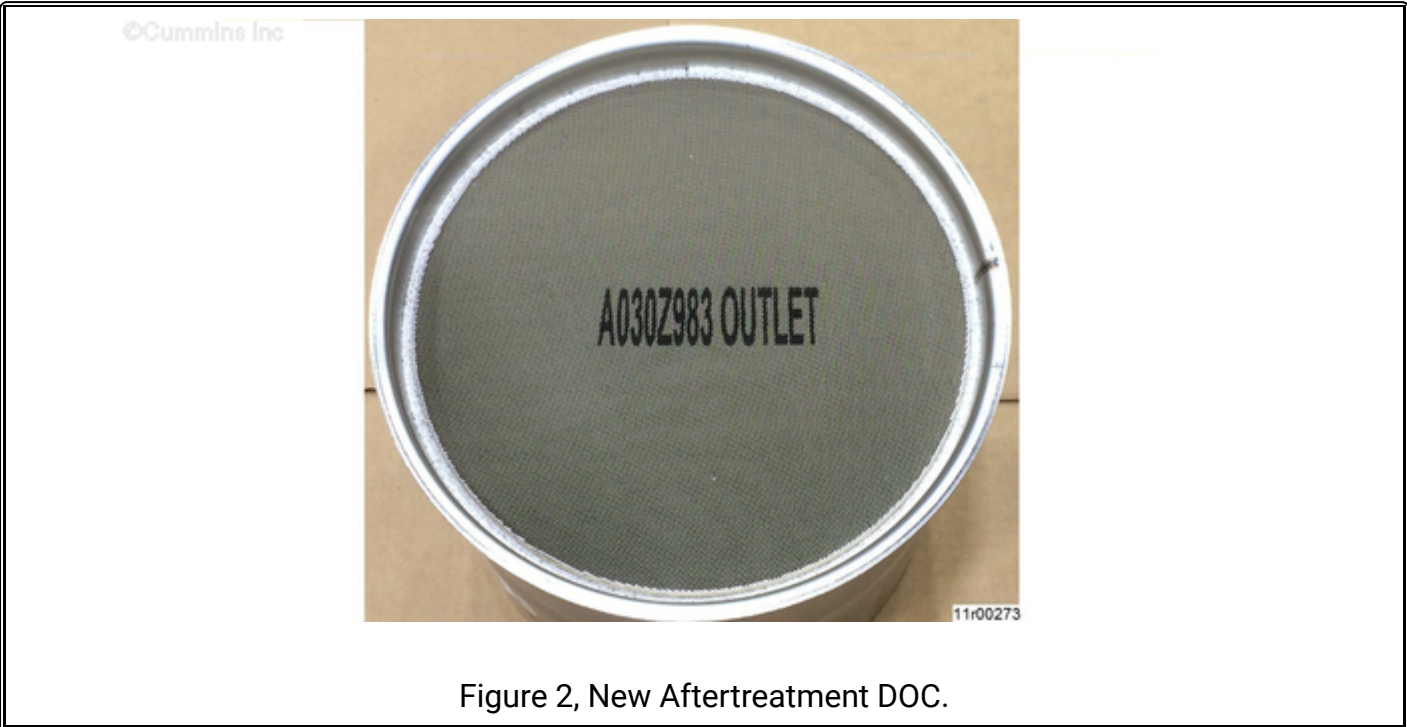
| Table 2, New Aftertreatment Diesel Oxidation Catalyst (DOC) | |

| Table 2, New Aftertreatment Diesel Oxidation Catalyst (DOC) | |
|---|---|
| Appearance | Clean with no dents or gouges and writing on face. |
| Comment | Ready for use. |

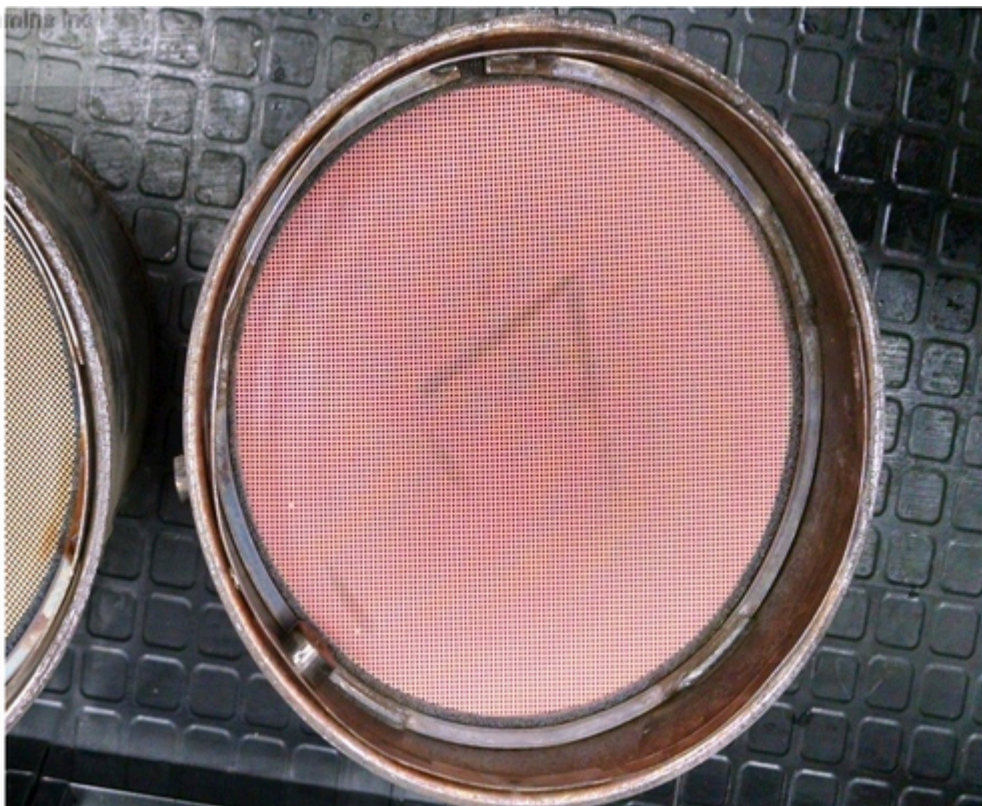
Figure 4, Aftertreatment Diesel Particulate Filter Inlet and Outlet - ReCon® - (Type A).

| Appearance | Clean with pink media. |
| Action | Ready for use. |

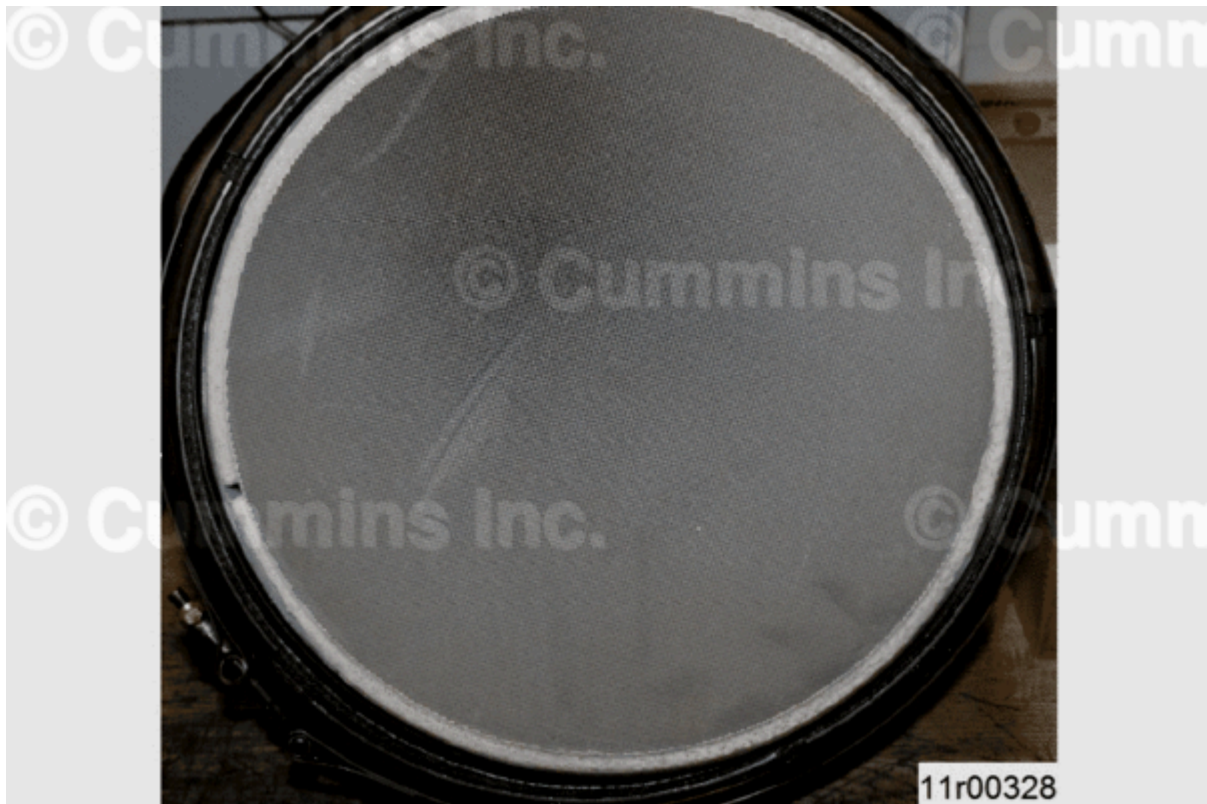
Figure 6, Aftertreatment Diesel Oxidation Catalyst (DOC) Outlet - Used.

| Appearance | Light amounts of soot on outlet face. |
| Cause | Normal engine operation. |

| Action | None. |

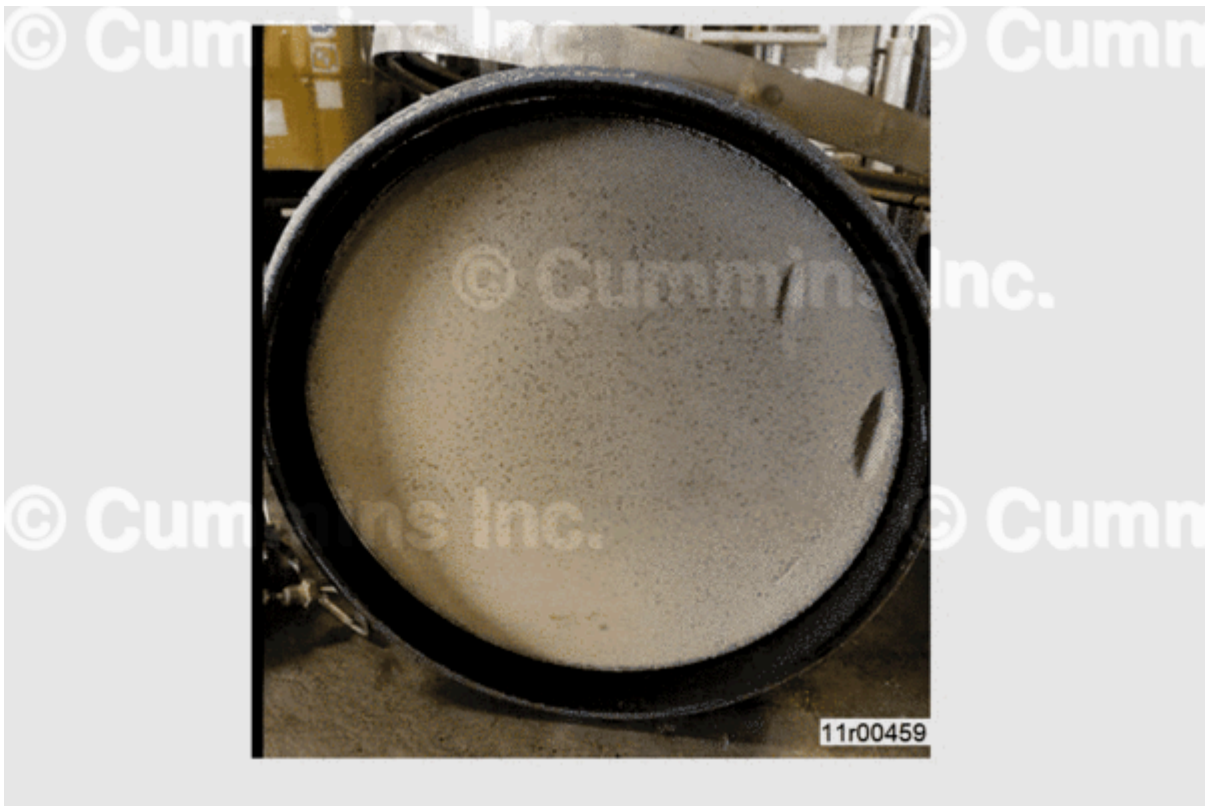
Figure 7, Aftertreatment Diesel Oxidation Catalyst (DOC) Outlet – Dimpling/Chipped Areas.

| Appearance | Small dimple/chipped sections location along DOC outlet face. |
| Cause | Part handling. |

| Action | Confirm section is not melted. Refer to table 9 for reference. |

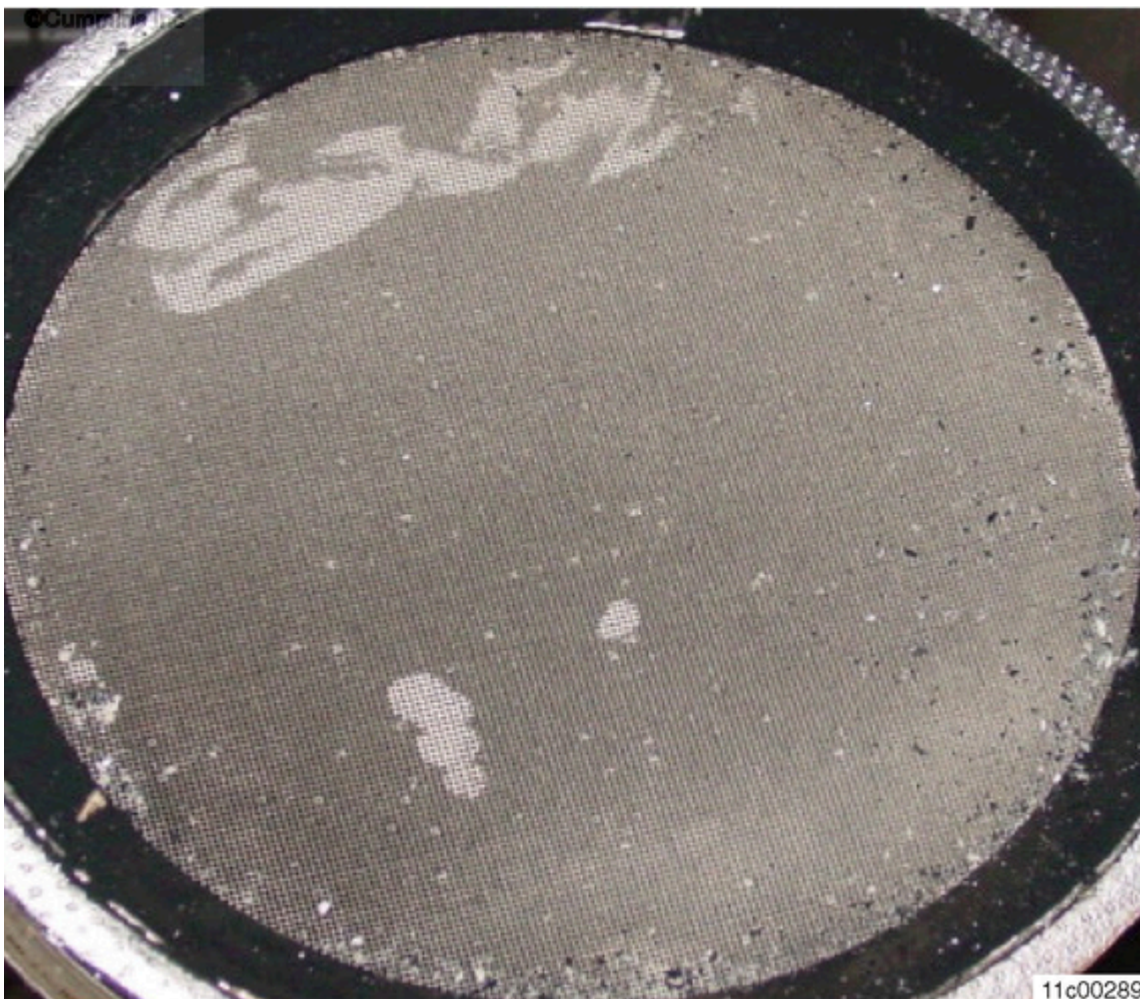
Figure 11, Aftertreatment Diesel Particulate Filter (DPF) Inlet - Light Soot Load.

| Appearance | Light levels of soot (black) or ash (gray) on face and within channels. |
| Cause | Normal engine operation. |

| Action | None, can continue to be used. |

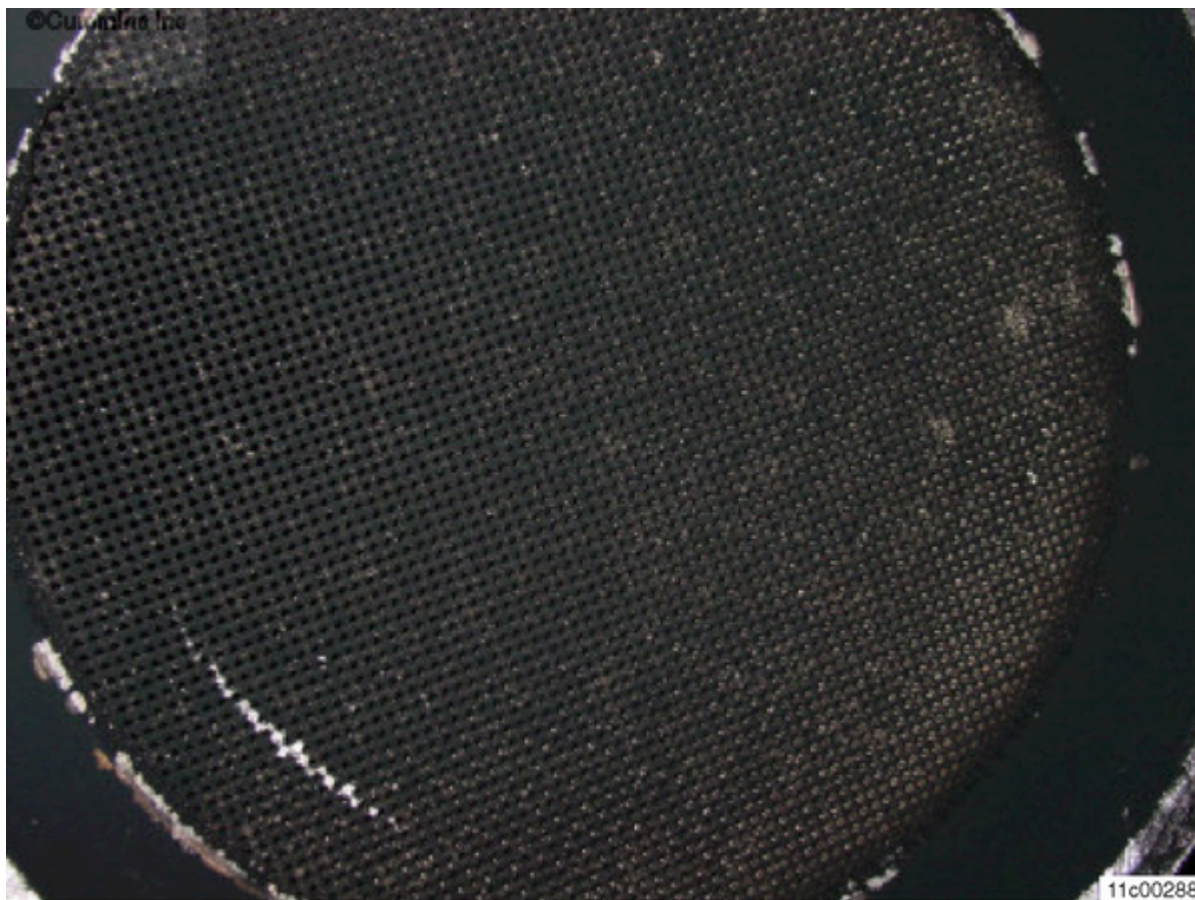
Figure 12, Aftertreatment Diesel Particulate Filter (DPF) Inlet - Moderate Soot Load.

| Appearance | Moderate levels of soot (black) or ash (gray) on face and within channels. |
| Cause | Normal engine operation. |

| Action | None, can continue to be used. |

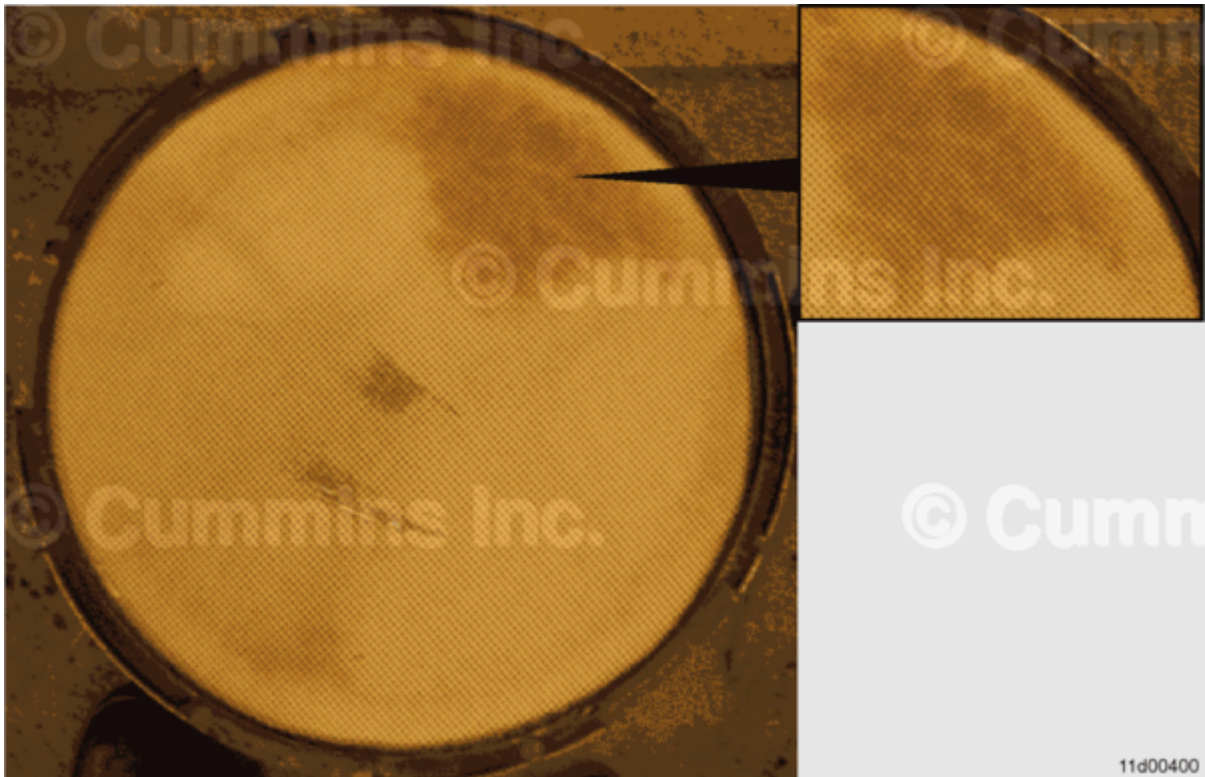
Figure 18, Aftertreatment Diesel Particulate (DPF) Outlet - Coolant Staining.

| Table 18, Aftertreatment Diesel Particulate Filter Outlet - Coolant Staining | |
|---|---|
| Appearance | Dark streaks on face and coolant staining. |
| Cause | Excessive coolant concentration in exhaust gases. |

- Check for active fault codes.
- Investigate coolant consumption.
- Investigate vehicle history for component damage that introduces excessive coolant into exhaust
- Aftertreatment DPF can be recovered.
  - See the corresponding Service Manual. Reference Procedure 014-013 in Section 14.
  - See the corresponding Service Manual. Reference Procedure 014-016 in Section 14.

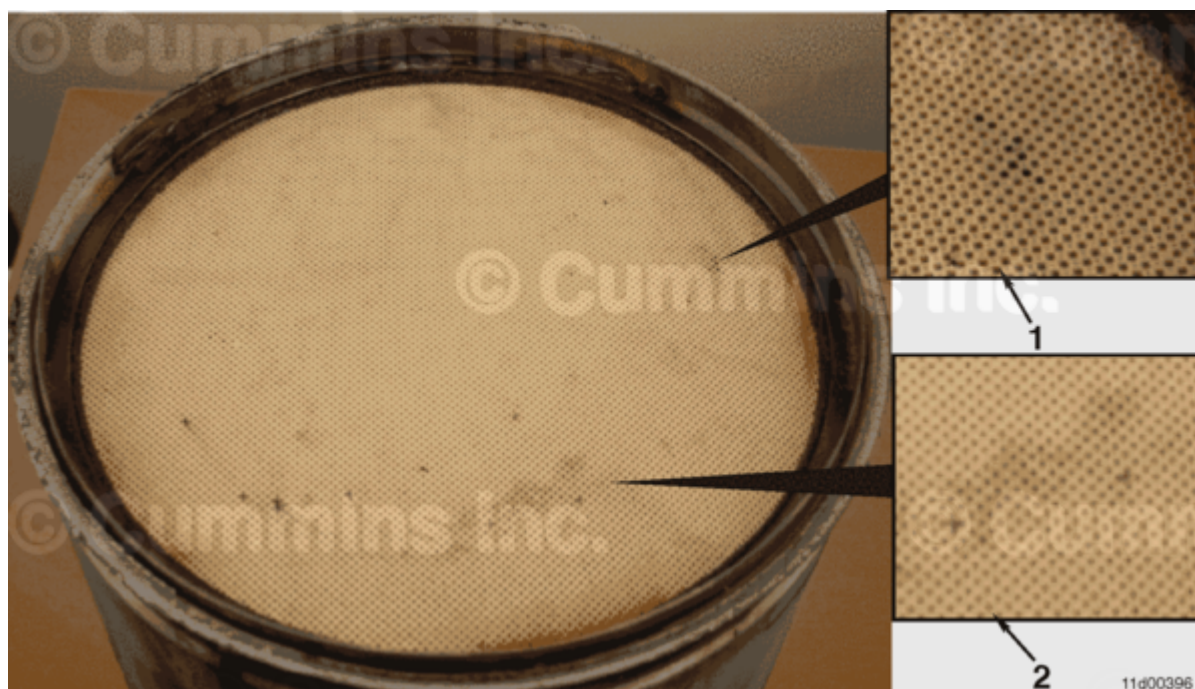
Figure 19, Aftertreatment Diesel Particulate Filter (DPF) Outlet - Soot Stain.

1. Soot staining in channel walls.
2. Soot staining on outlet face.

| Table 19, Aftertreatment Diesel Particulate Filter (DPF) Outlet - Soot Stains | |
|---|---|
| Appearance | <ul style="list-style-type: none"> <li>• Black soot stains on filter outlet and in filter channel walls (Figure 19, Item 1). This indicates the aftertreatment DPF has internal cracking or melting.</li> <li>• Black soot stains on filter outlet (Figure 19, Item 2). This does <b>not</b> indicate a malfunction has occurred.</li> <li>• For more information on identification, see DPF Inspection section below.</li> </ul> |
| Cause | Internal cracking or melting of filter material. |

| Table 19, Aftertreatment Diesel Particulate Filter (DPF) Outlet - Soot Stains | |
|---|---|
| Action | <ul style="list-style-type: none"> <li>• Check for fault codes related to aftertreatment system. Investigate engine service history.</li> <li>• Determine if fuel or lubricating oil has been introduced into exhaust as the result of damage to another engine component.</li> <li>• Inspect turbocharger turbine outlet and aftertreatment inlet for lubricating oil or fuel. See aftertreatment DPF Inspection Section below for additional information.</li> <li>• <b>Only</b> replace aftertreatment DPF after cause of excessive black smoke, fuel, or lubricating oil in exhaust has been corrected.</li> </ul> |

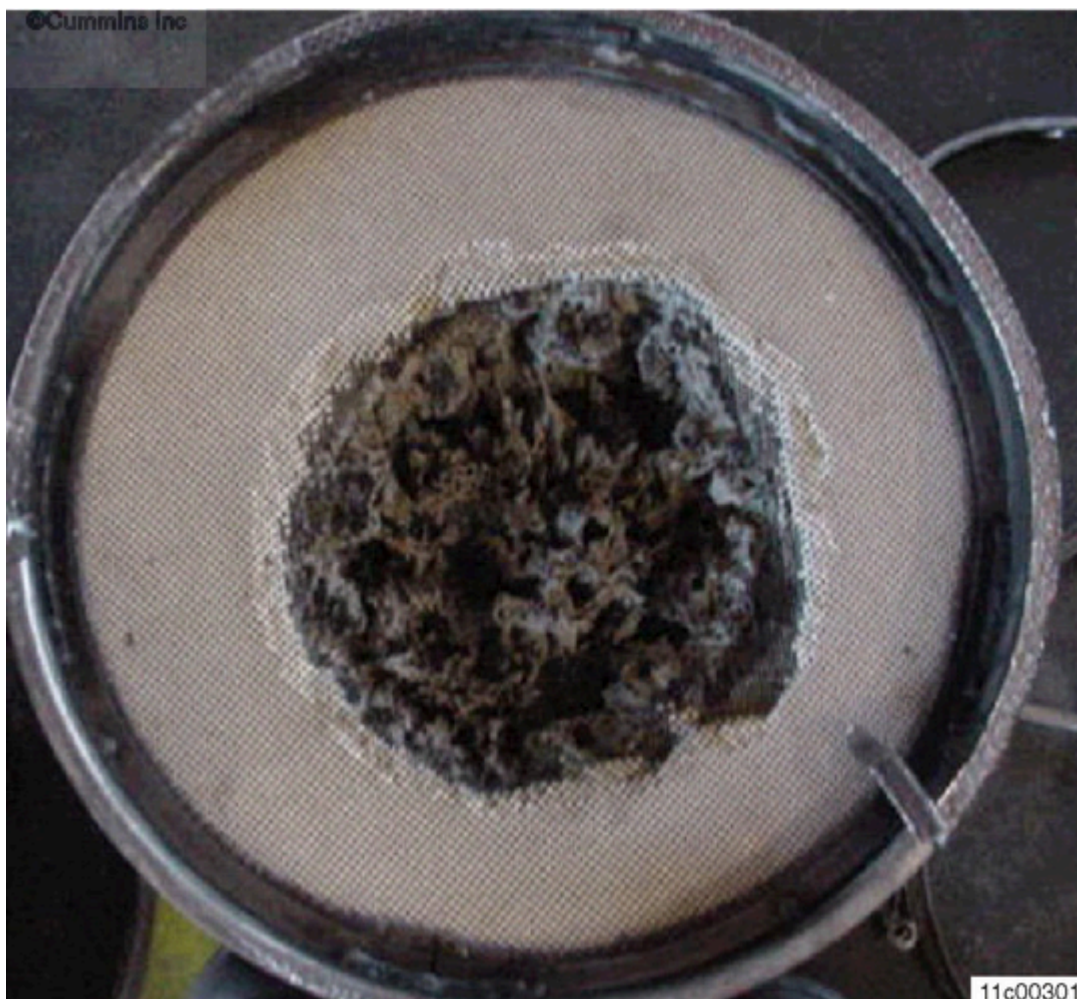
Figure 23, Aftertreatment Diesel Particulate Filter (DPF) Outlet – Melted - (Type A).

| Appearance | Melted or deformed cells. |
| Cause | Excessive fuel or oil in exhaust. |

| Action | <ul style="list-style-type: none"> <li>• Check for fault codes related to aftertreatment system.</li> <li>• Investigate engine service history.</li> <li>• Determine if fuel or oil has been introduced into exhaust from damage of another engine component.</li> <li>• Inspect turbocharger turbine outlet and aftertreatment inlet for oil or fuel.</li> <li>• <b>Only</b> replace aftertreatment DPF after cause of excessive fuel or oil in exhaust has been corrected.</li> </ul> |

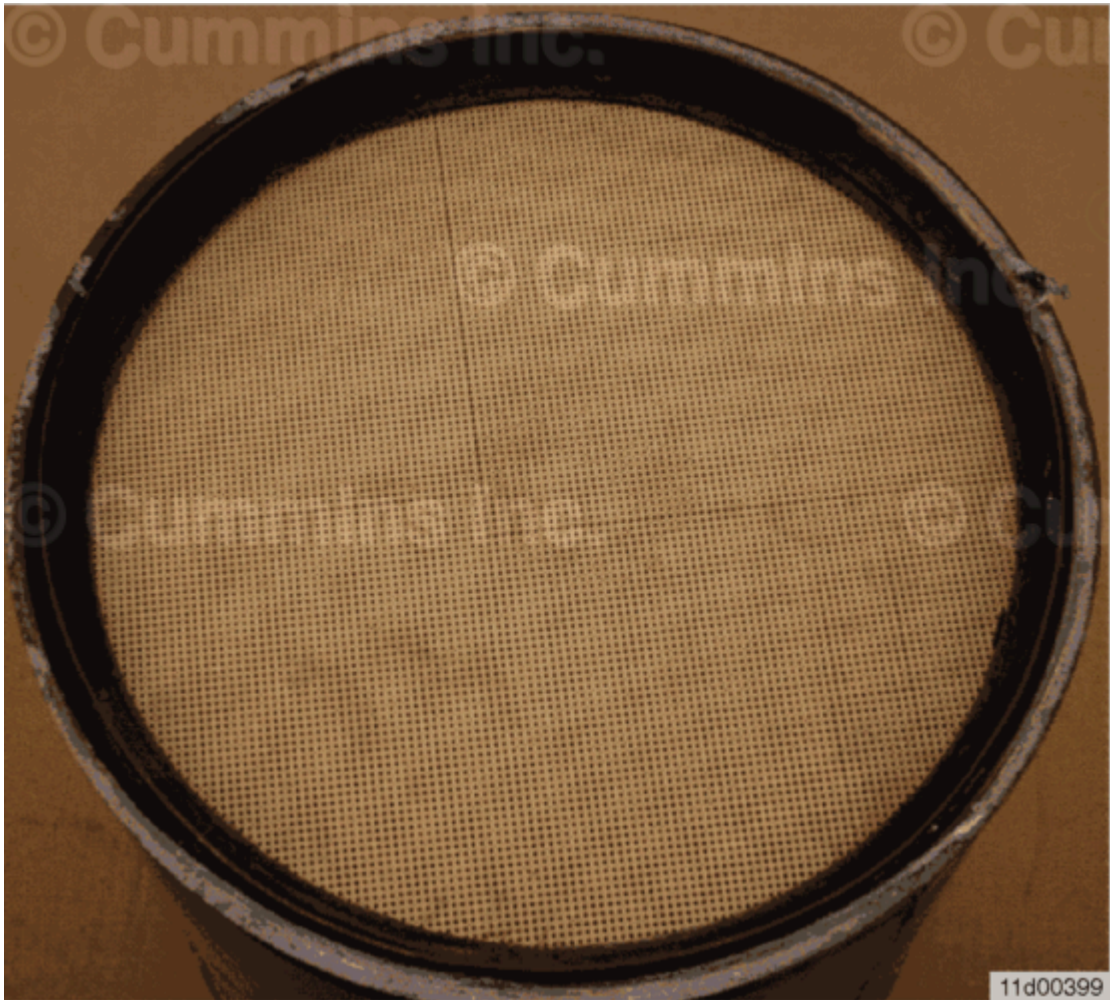
Figure 26, Aftertreatment Diesel Particulate Filter (DPF) Outlet - Face Cracked - (Type A).

| Table 26, Aftertreatment Diesel Particulate Filter (DPF) Outlet - Face Cracked - (Type A) | |
|---|---|
| Appearance | Crack across filter face. |
| Cause | High soot load in aftertreatment DPF reacted rapidly with engine exhaust, creating a high temperature. |

| Table 26, Aftertreatment Diesel Particulate Filter (DPF) Outlet - Face Cracked - (Type A) | |
|---|---|
| Action | Replace aftertreatment DPF. |

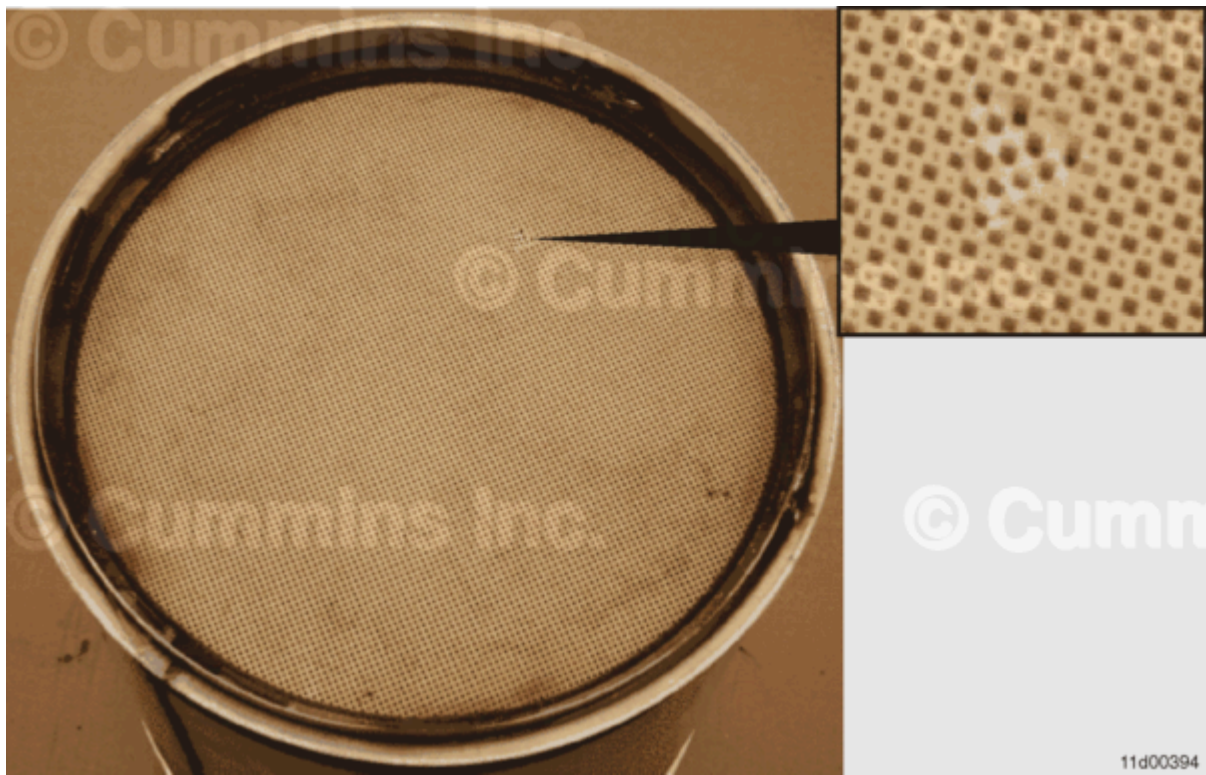
Figure 27, Aftertreatment Diesel Particulate Filter (DPF) Inlet – Gouged.

| Appearance | Gouge in filter face. |
| Cause | Face gouge created during manufacturing of filter, or an object scraped across filter face. |

| Action | <ul style="list-style-type: none"> <li>• Check if gouge(s) in substrate material is more than 3 mm [ 1/8 in ] deep.</li> <li>• If gouge(s) is deeper than 3 mm [ 1/8 in ], more than 20 cell plugs are missing or damaged from gouge(s), replace aftertreatment DPF.</li> </ul> |

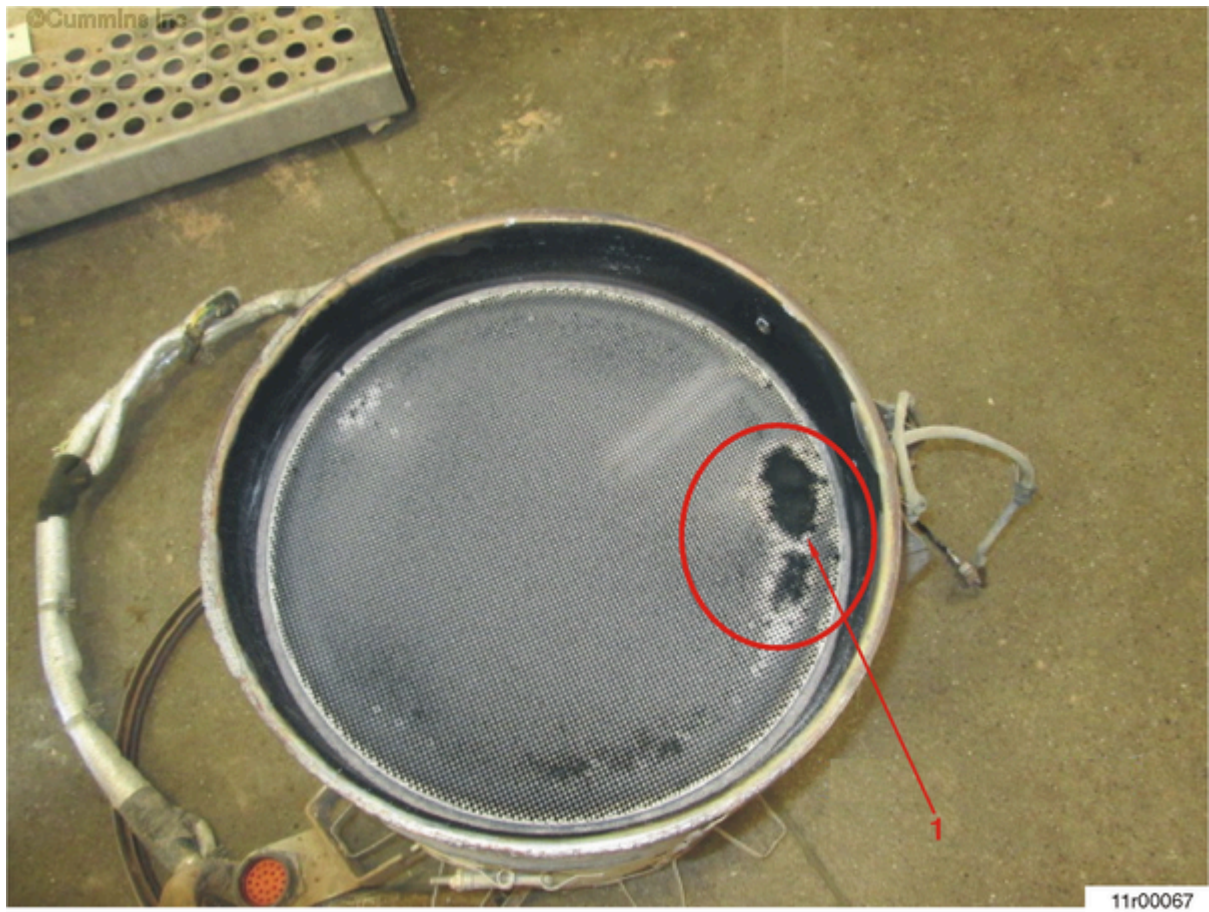
Figure 28, Aftertreatment Diesel Particulate Filter (DPF) Inlet - Fibers from Insulation.

| Appearance | White substance present. |
| Cause | Fibers from upstream component. |

| Action | Aftertreatment DPF needs cleaning through recommended process, if applicable. |
