Service Bulletin Number: 4325971

Released Date: 24-jul-2012

Aftertreatment Diesel Exhaust Fluid (DEF) Dosing and Selective Catalytic Reduction (SCR) System Reuse Guidelines

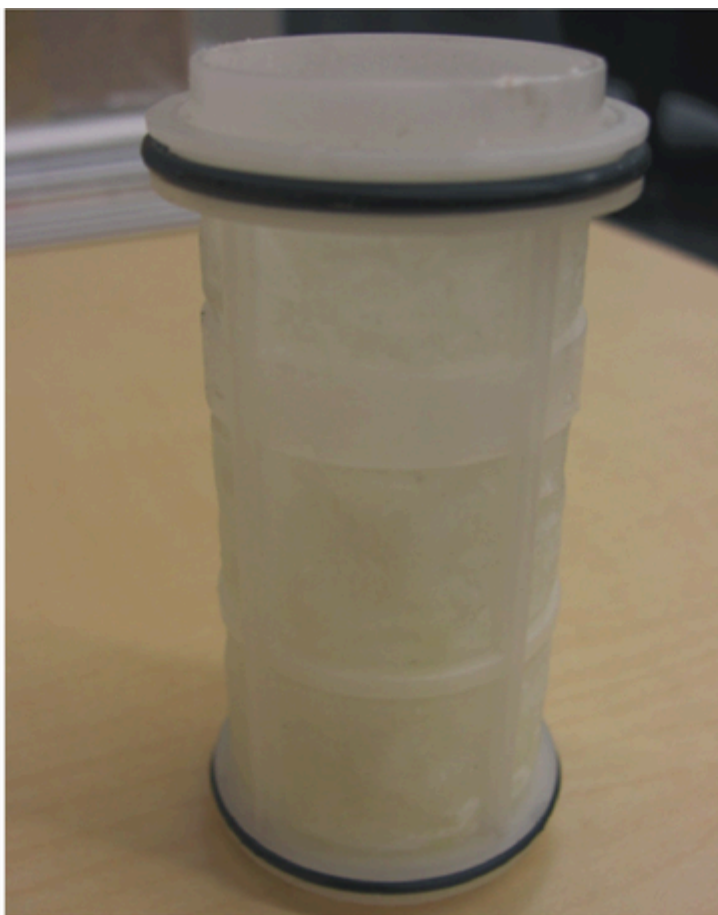
11b00111

Obsolete Filter

**Aftertreatment DEF Dosing Unit Main Filter - New**

Clean filter element

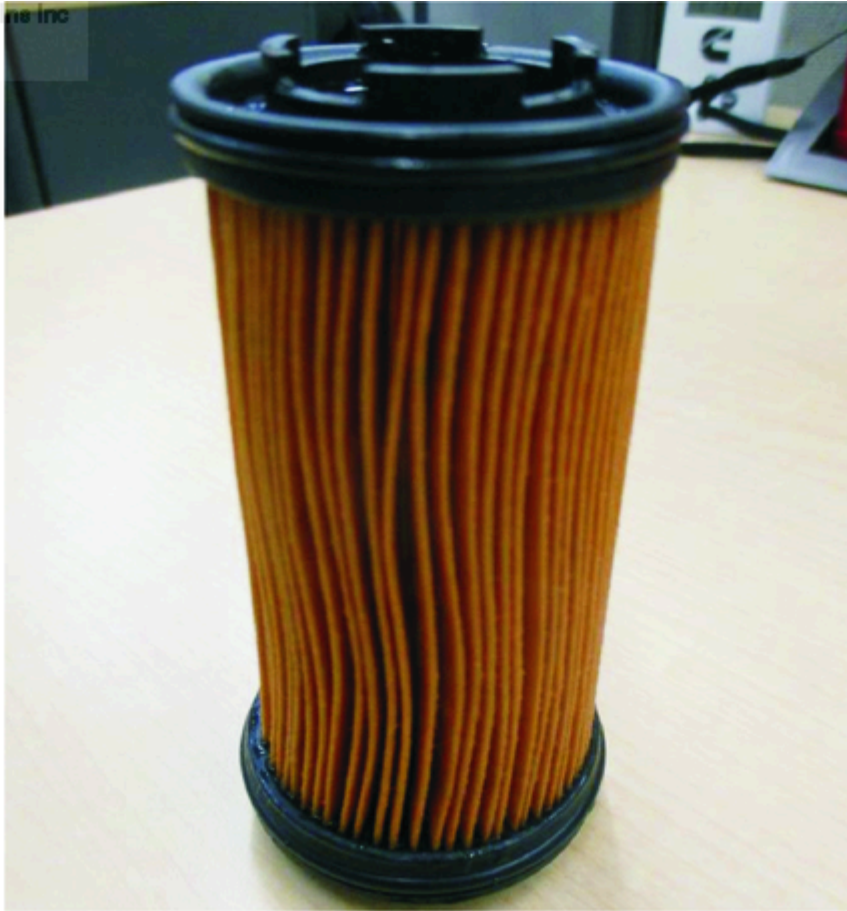
07900597

Current Pleated Filter

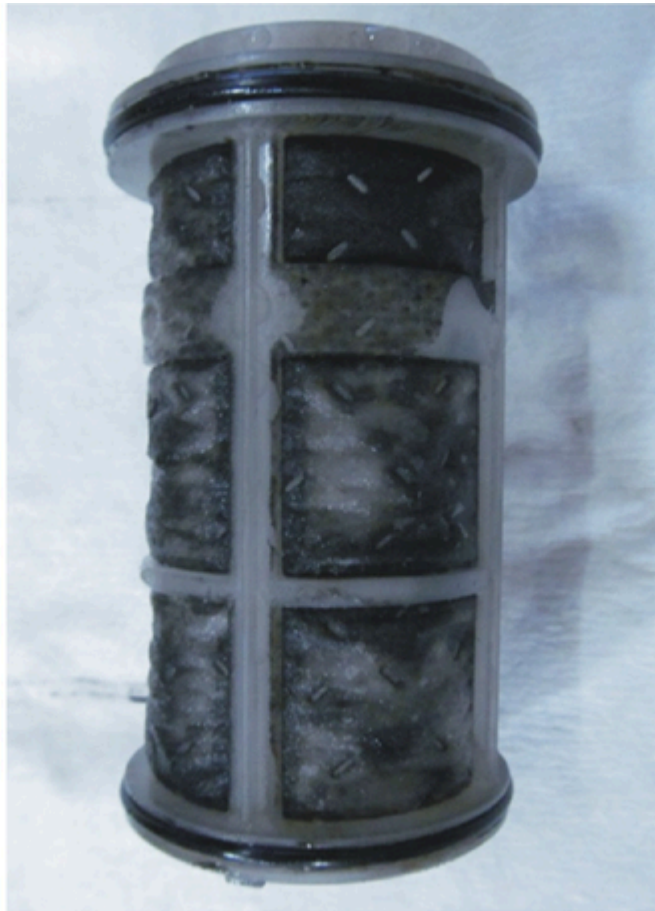
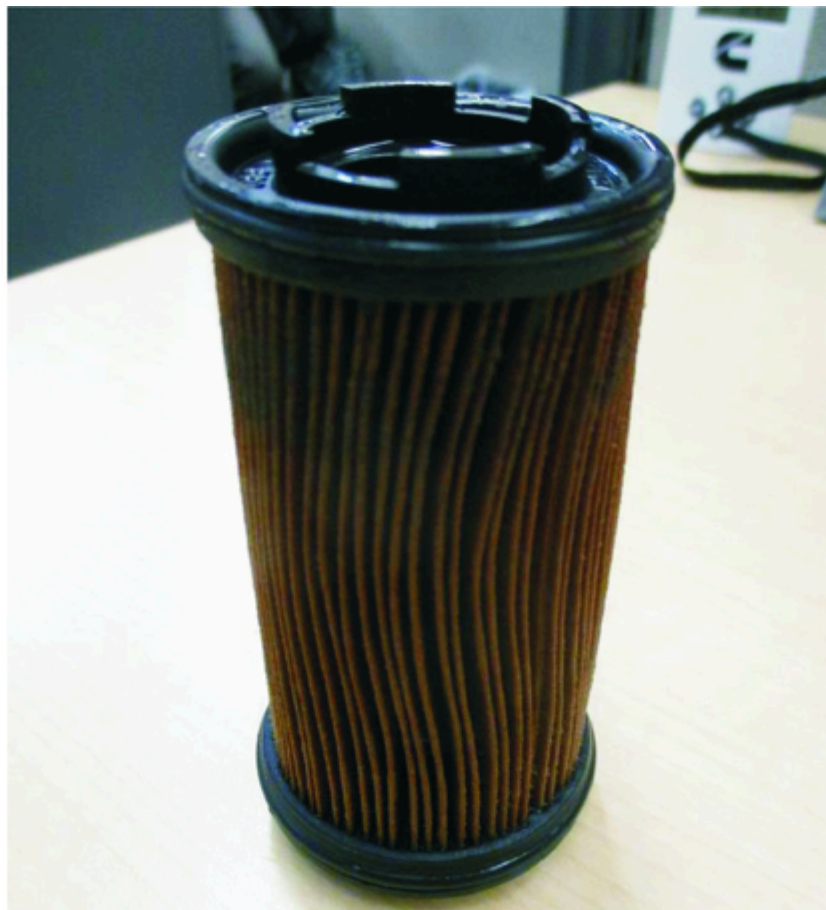
| Aftertreatment DEF Dosing Unit Filter - Normal Use - Approximately 200k Miles | |
| Appearance: | Darkened filter element, urea odor, absence of large particles, absence of hydrocarbon odor |
| Cause: | Normal dirt and dust intrusion into DEF system |

| Aftertreatment DEF Dosing Unit Filter - Normal Use - Approximately 200k Miles | |
|---|---|
| Action: | Replace DEF dosing filter at normal maintenance interval. |

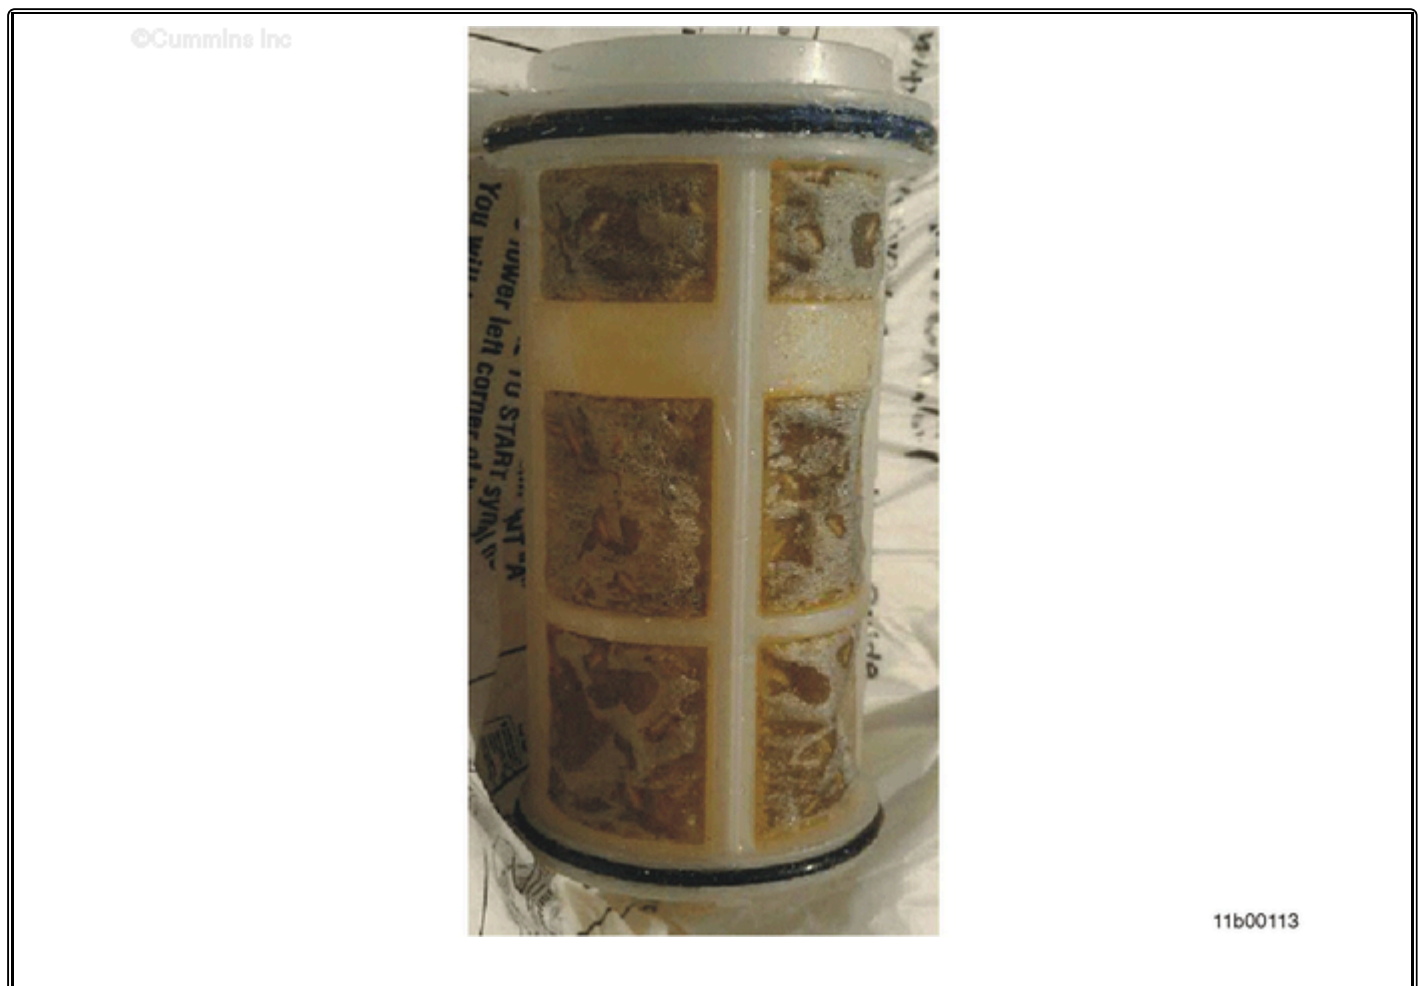
| Aftertreatment DEF Dosing Unit Filter - Contaminated | |
| Appearance: | Dark yellow filter element (similar appearance on both style filters) |
| Cause: | Likely diesel fuel in the DEF tank |

Remove and clean DEF tank, flush DEF lines, and replace DEF dosing unit filter. Reference the following procedure for contamination/incorrect fluid:

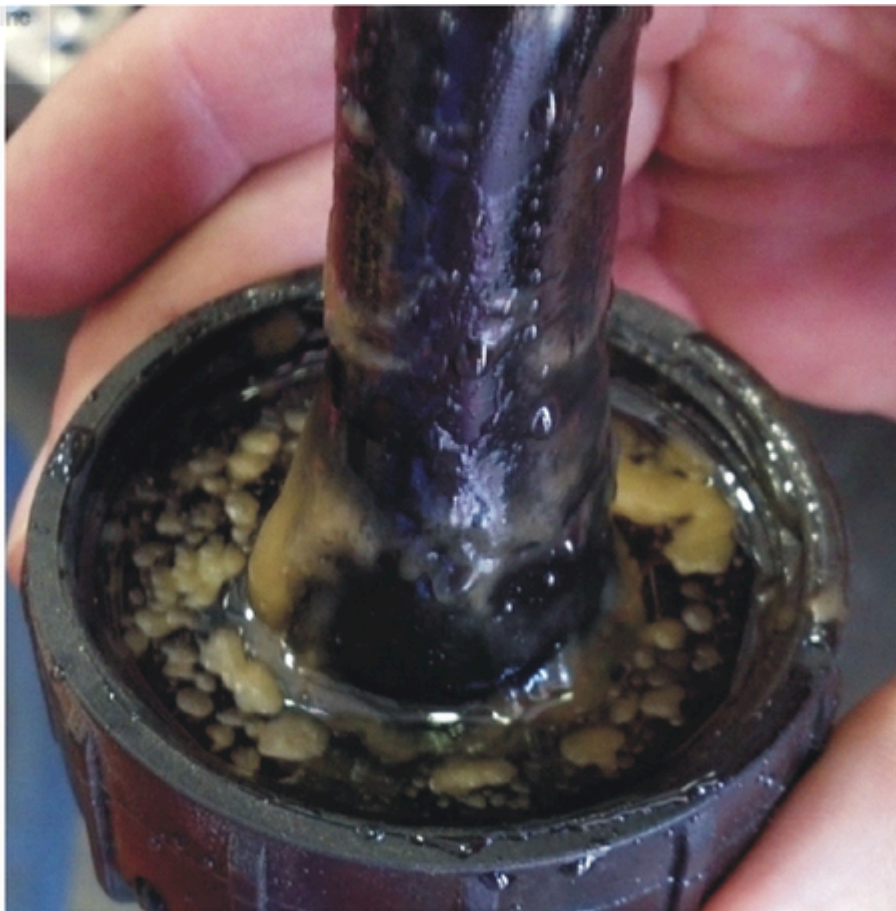
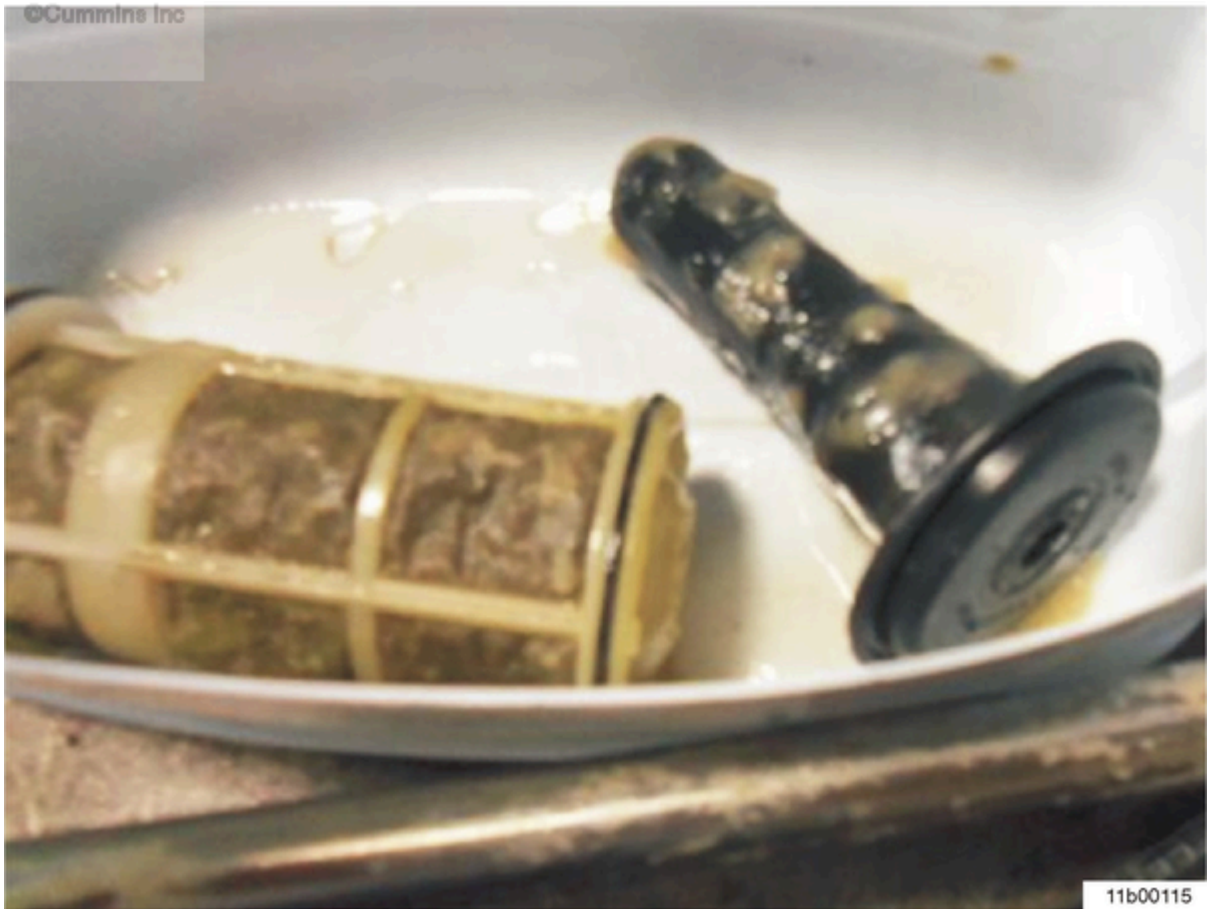
11b00114

#### **Aftertreatment DEF Dosing Unit Filter - Contaminated**

Grease-like substance separated from DEF  
(similar appearance on both filters)

Contaminant in DEF tank

Remove and clean DEF tank, flush DEF lines, and replace DEF dosing unit filter. Reference the following procedures for contamination/incorrect fluid:
