Service Bulletin Number: 4326040

Prevention of Turbocharger Damage After Engine Mechanical Issue

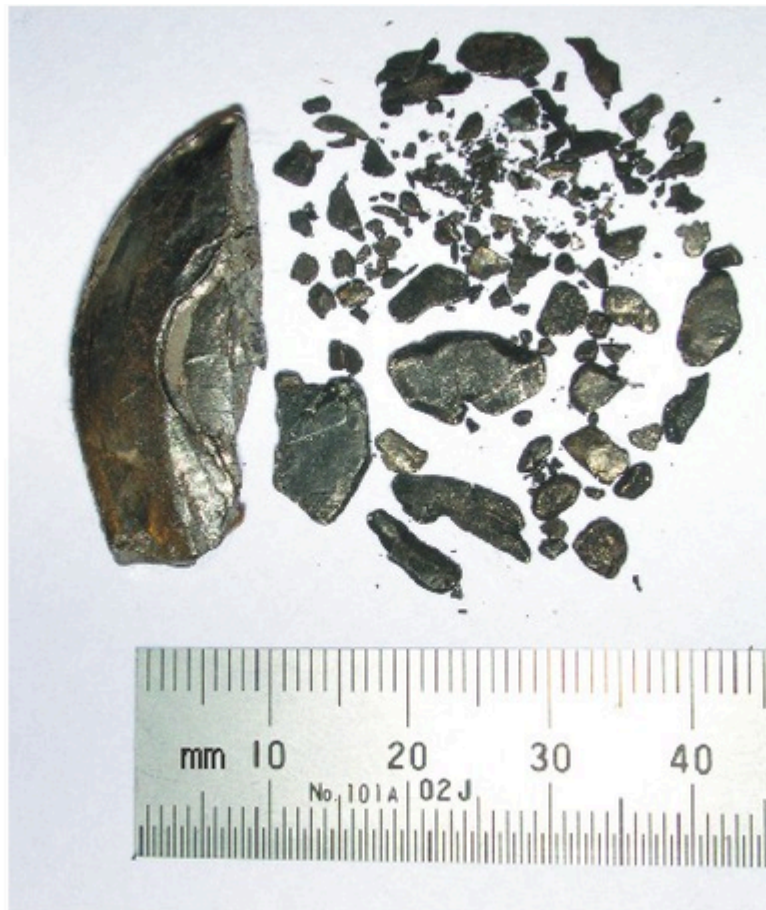
Figure 1 - Example of exhaust valve debris

Debris particles as small as 0.70 mm [0.030 in] caught in the air handling system are difficult to clean out. This debris can travel through the EGR system, back into the intake, and out the exhaust manifold to the turbocharger, where it causes damage that prevents motion of the variable geometry turbocharger (VGT) mechanism.

If an engine experiences a piston, intake valve, or exhaust valve mechanical issue, it is important to understand that the small size of the debris particles could possibly allow them to travel through the air handling system and become lodged in various components (See Figure 1).

**Note :** Some debris pieces are large, however, particles as small as 0.70 mm [0.030 in] could damage a turbocharger.

1. Replace the EGR cooler.
2. Inspect the interior of the following components. Flush the air passages in these components using safety solvent. Rinse and dry with compressed air. See corresponding Service Manual. Reference procedure 200-004 in Section F for the air intake system component location on the engine. Reference procedure 200-005 in Section F for the exhaust system component location on the engine.

3. Operate the engine without the turbocharger installed at low idle for approximately 3-5 minutes to be sure the system is free of debris.

4. After Step 1, 2, and 3 are completed and the engine is assembled with the turbocharger installed, operate the engine at low idle for 2 minutes while deaerating the cooling system. Use low idle for this procedure, to keep the turbocharger speed low while any residual debris is blown out of the system.
