# Service Bulletin

Service Bulletin Number: 4383578

Spark Plug Reuse Guidelines

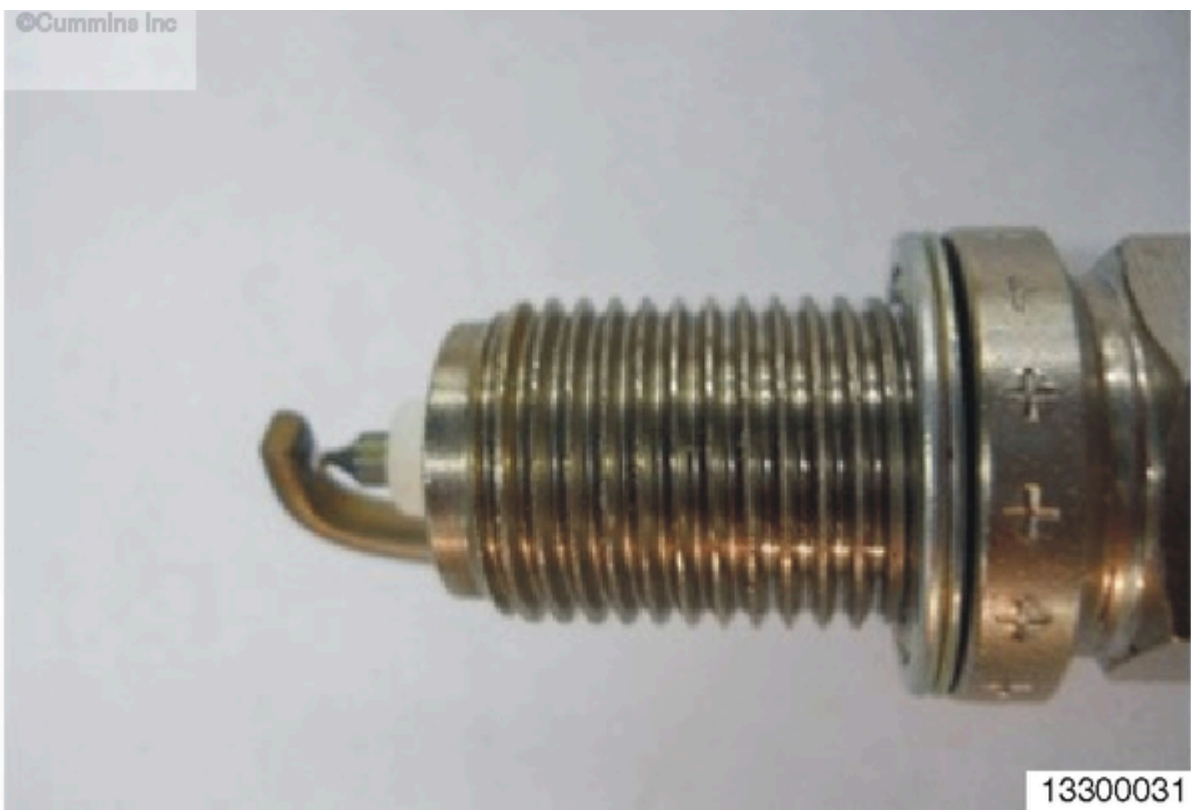
### Spark Plugs - New

Clean, without any signs of use.

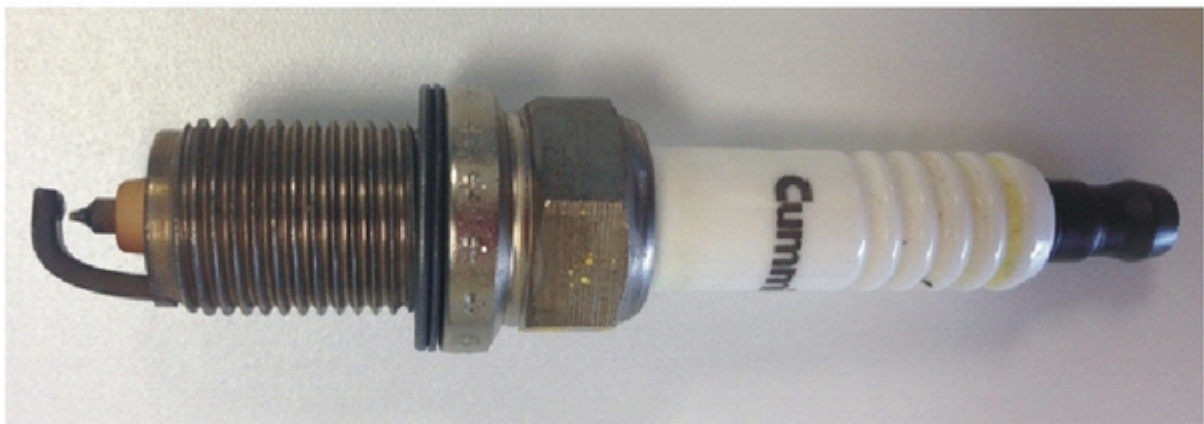
13300033

**Spark Plug - Good Used Plug**

| Appearance | Clean, without any defects; minor signs of use. |

| Action | Reuse |

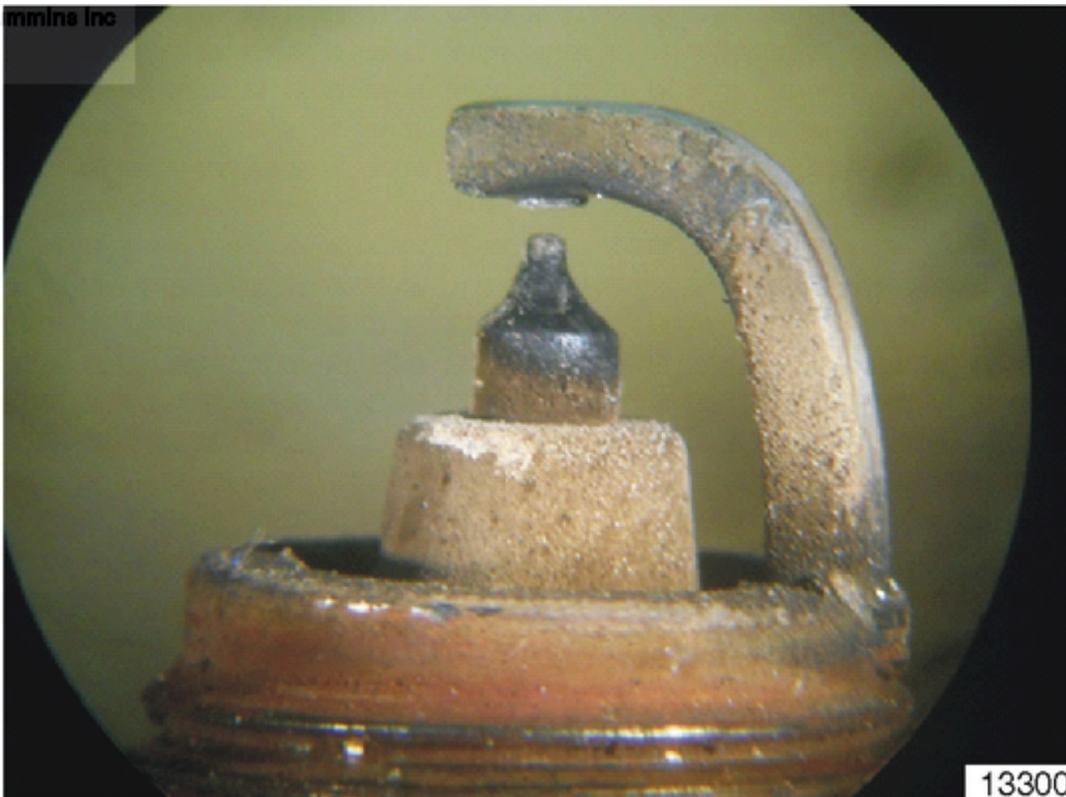
13300034

### Spark Plug - Acceptable Deposits

| Appearance | Slightly discolored. |
| Cause | Deposits from normal combustion. |

| Action | Reuse |

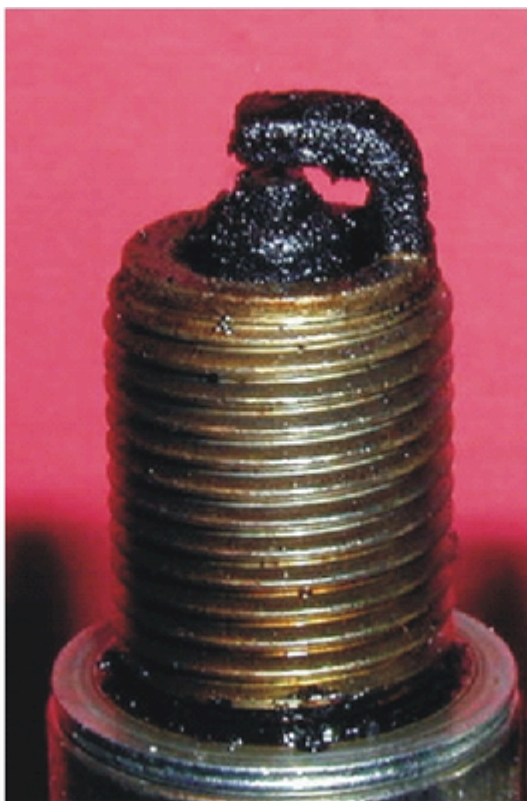
13300035

### Spark Plug - Oil Deposits

| Appearance | Coated with black, oily sludge. |
| Cause | Oil Deposits, leaking valve stem seals, piston malfunction, piston ring malfunction. |

| Action | Compare with spark plugs from the other cylinders to determine if the issue is isolated to one cylinder or across all cylinders.<br>Investigate possible causes of internal oil leaks and complaints of oil consumption.<br>Replace all spark plugs with the appearance of the above deposits. |

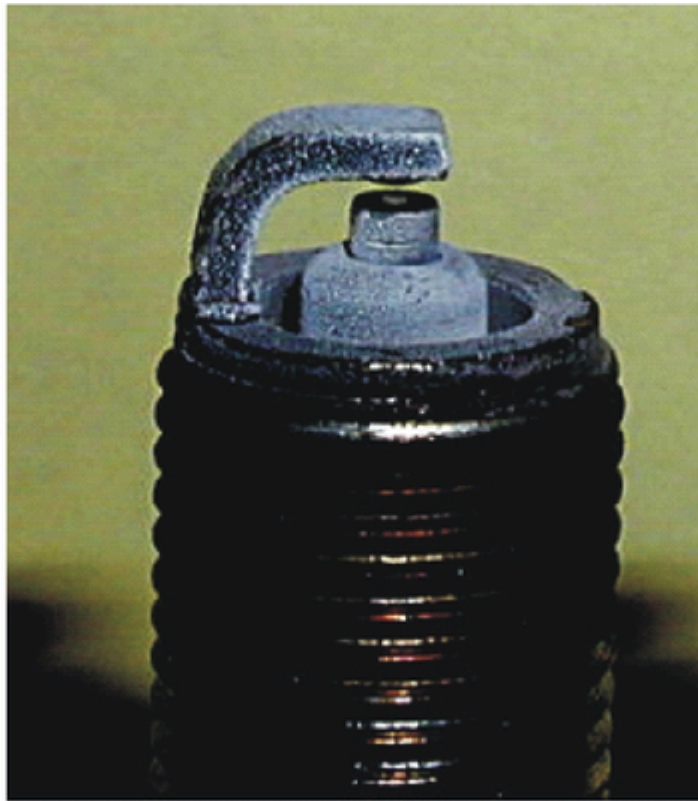
13300037

**Spark Plug - Unacceptable Deposits**

| Appearance | Exceedingly discolored, or coated with ash. |
| Cause | Deposits from oil consumption, coolant consumption, or poor fuel quality. |

Check for excessive coolant consumption.  
Check for excessive oil consumption.  
Compare with spark plugs from the other cylinders to determine if the issue is isolated to one cylinder or across all cylinders. Replace all spark plugs with the appearance of the above deposits.

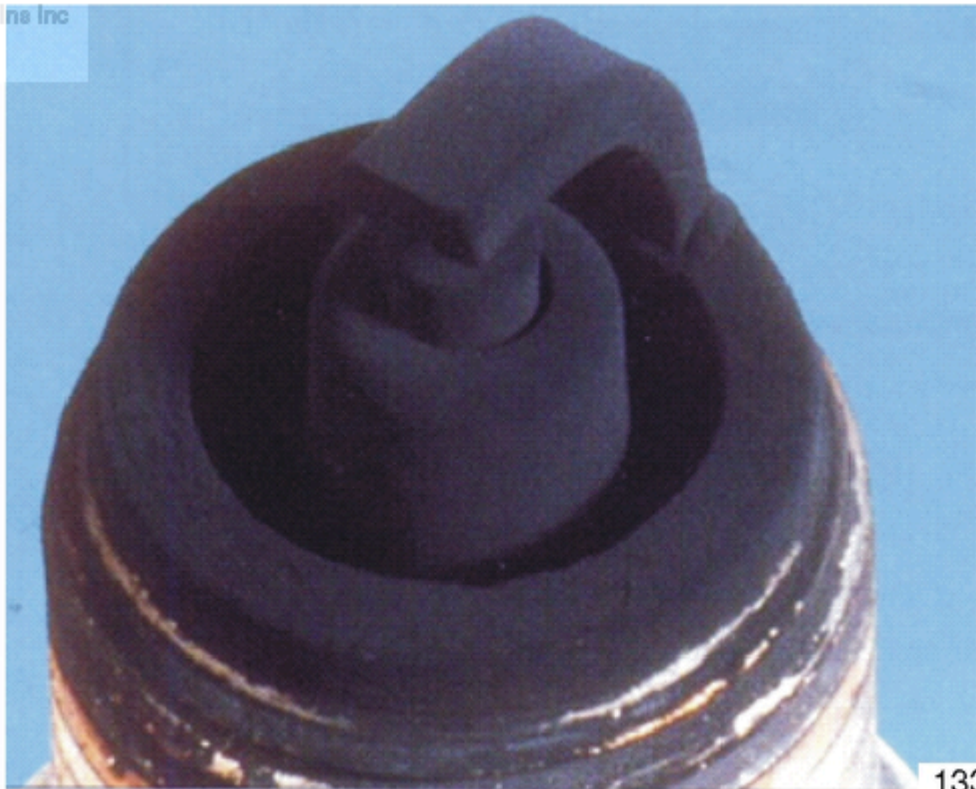
13300038

### Spark Plug - Dry Fouling

Dry, black deposits on electrodes and core nose.

Running rich for a prolonged period of time.

Compare with spark plugs from the other cylinders to determine if the issue is isolated to one cylinder or across all cylinders. Investigate possible causes of rich running condition. Replace all spark plugs with the appearance of the above deposits.

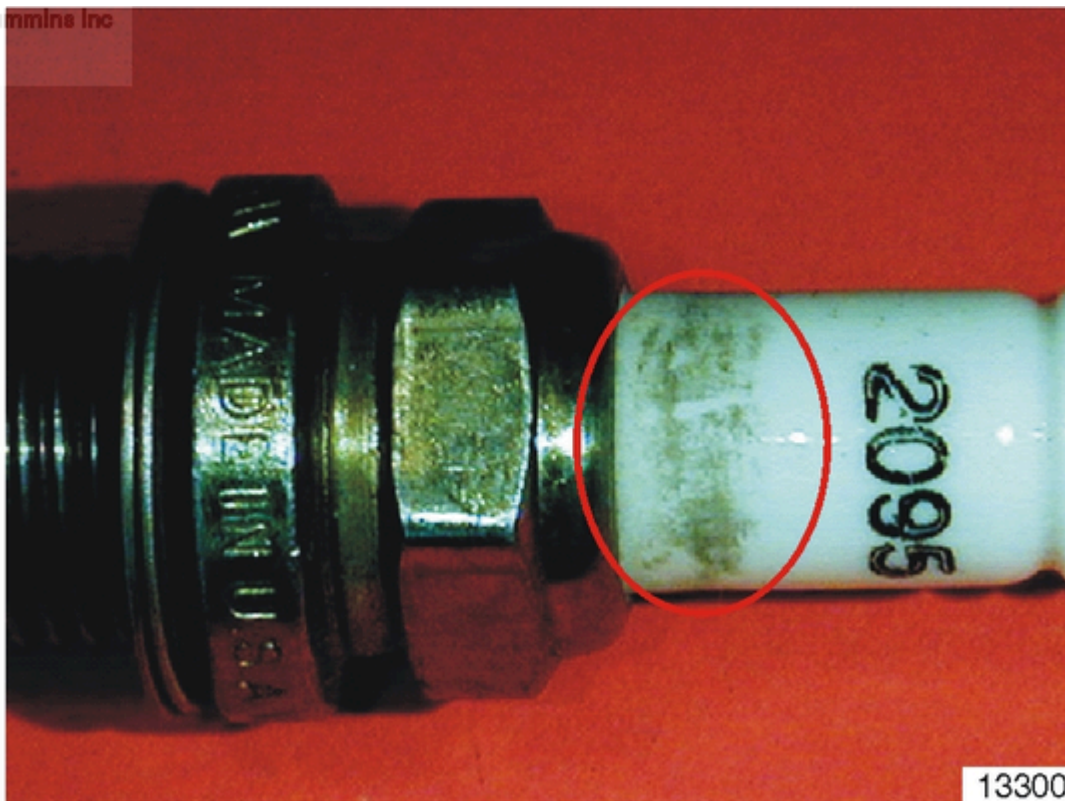
| Spark Plug - Corona Staining | |
| Appearance | Normal brown discoloration of the insulator. |
| Cause | Electrically charged particles or dirt. |

| Spark Plug - Corona Staining | |
|---|---|
| Action | Reuse |

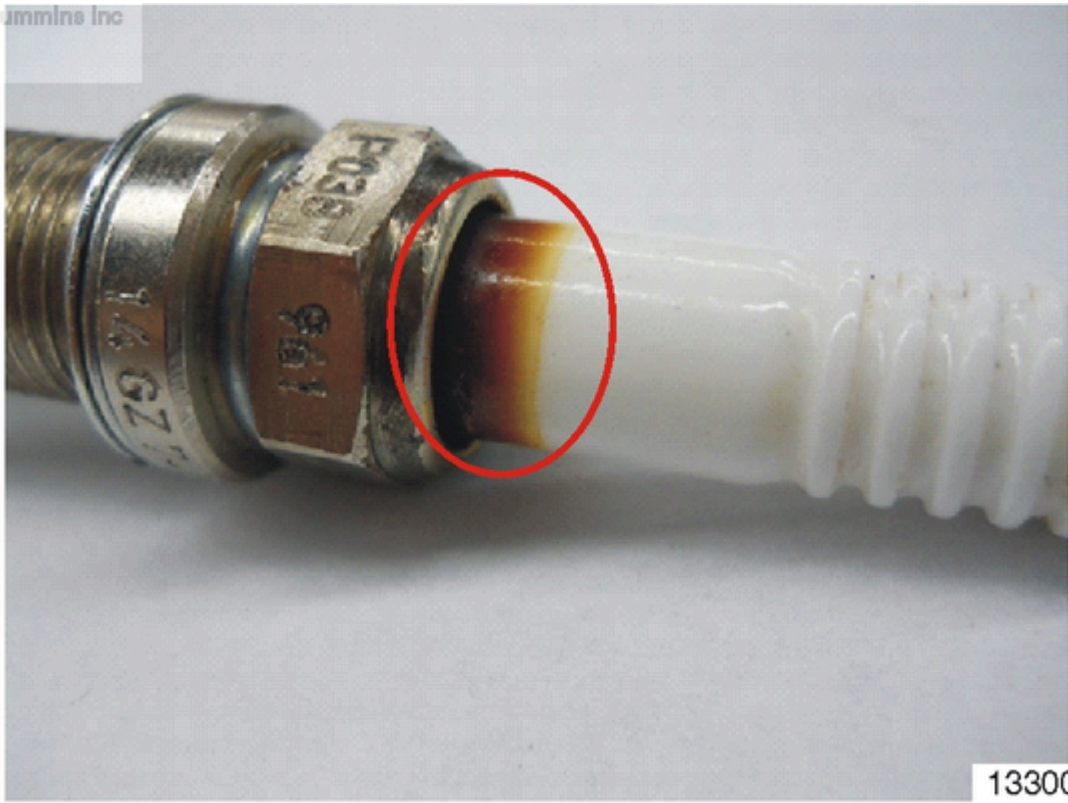
13300046

**Spark Plug - Gasket Leak/Internal Seal Malfunction**

| Appearance | Burnt oil around insulator. |
| Cause | Over-torqued. |

| Action | Replace the spark plug <b>only</b> if the insulator rotates relative to the metal shell or shows heat damage. |

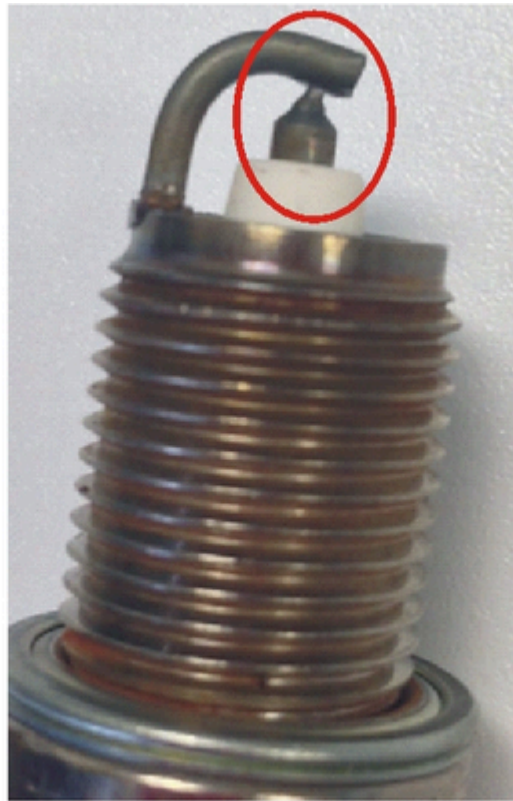
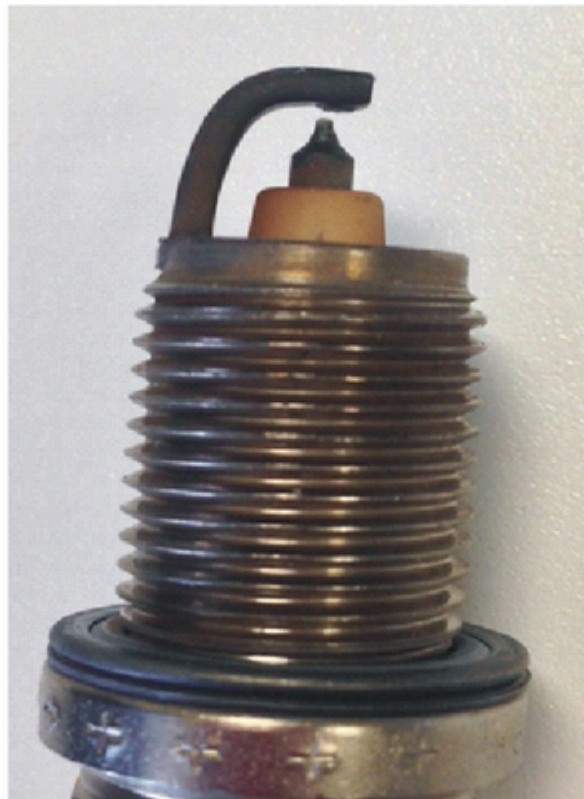
**Spark Plug - Closed Gap**

Ground electrode and center electrode touching; Figure 1 - Closed gap, Figure 2 - Meets reuse guidelines.

Mishandling or knock.

Check for possible engine knock. Replace spark plug.

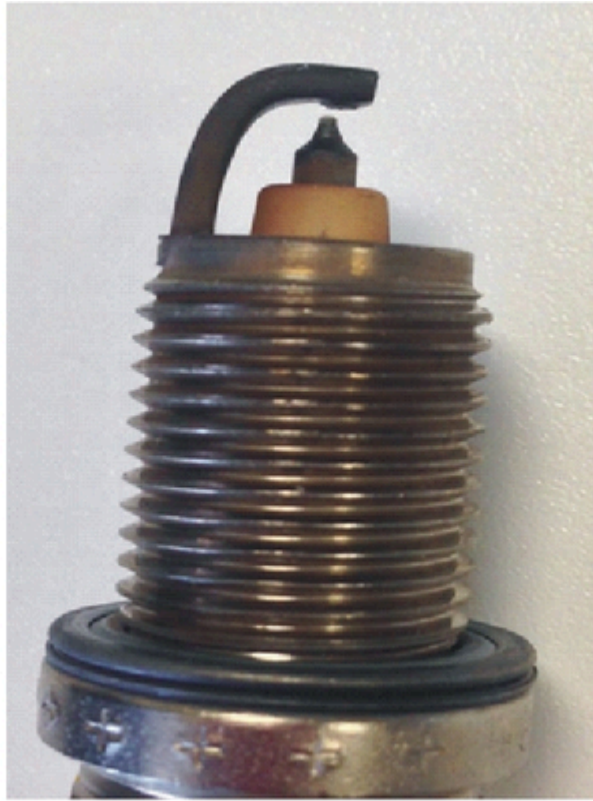
**End of Life Spark Plug - Excessive Gap**

| Appearance | Gap between the center electrode and ground electrode are out of specification. Figures 1 - Excessive gap. Figure 2 - Meets reuse guidelines. |
| Cause | Spark plug at or beyond its end of life. |

| Action | Replace all the spark plugs. |

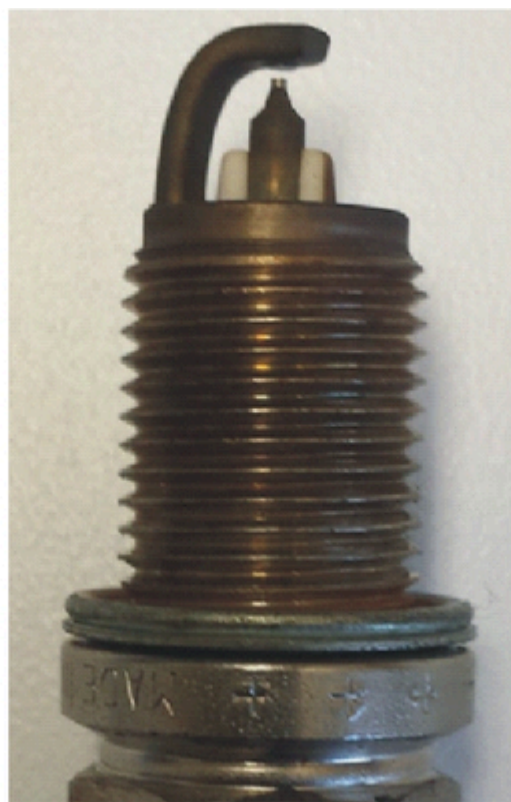
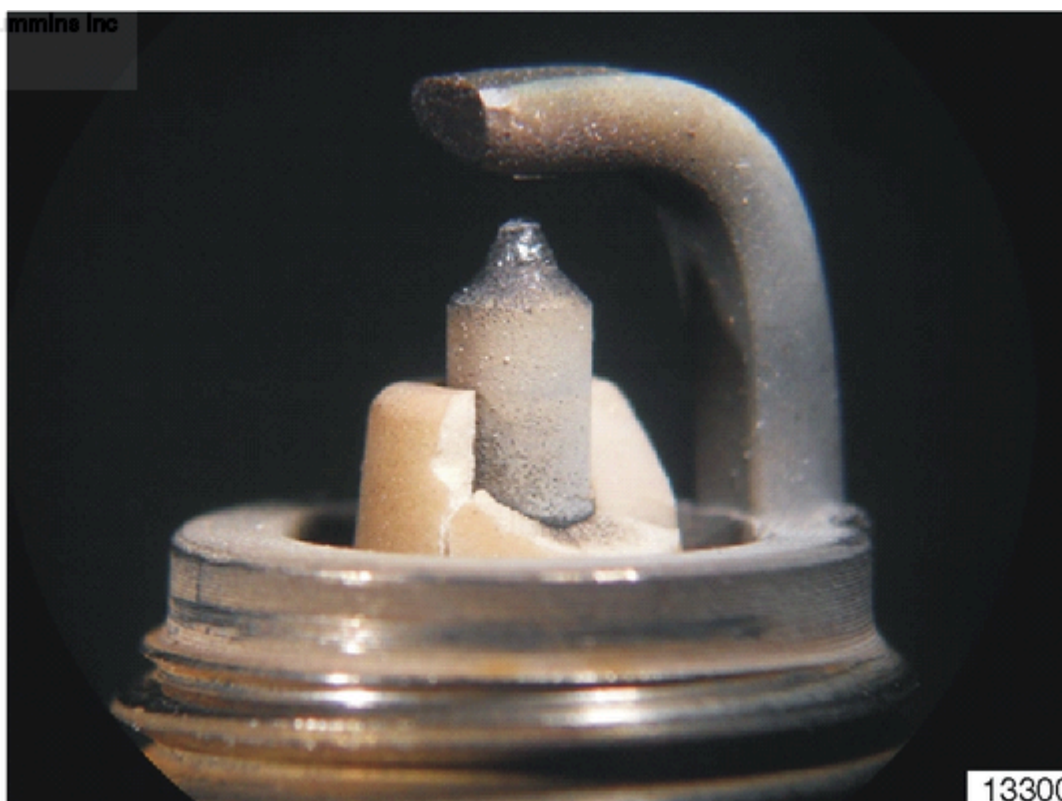
**Spark Plug - Core Nose Damage**

| Appearance | Cracked, chipped, or missing core nose ceramic. |
| Cause | Mishandling, knock. |

| Action | Compare with spark plugs from the other cylinders to determine if the issue is isolated to one cylinder or across all cylinders. Replace all spark plugs with a cracked core nose. |

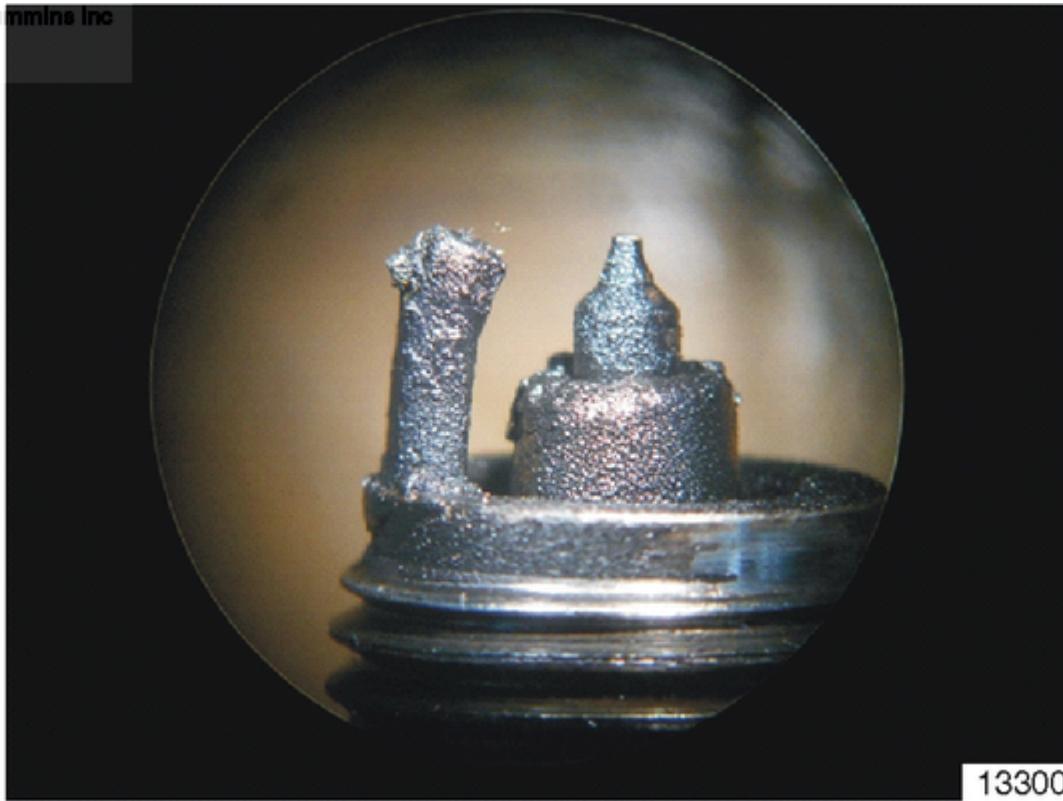
13300055

**Spark Plug - Melted Ground Electrode**

| Appearance | Ground electrode melted and/or partially missing. |
| Cause | Excessive temperatures or knock. |

| Action | Compare with spark plugs from the other cylinders to determine if the issue is isolated to one cylinder or across all cylinders. Check for in-cylinder damage or causes of knock. Replace all spark plugs with a melted ground electrode. |

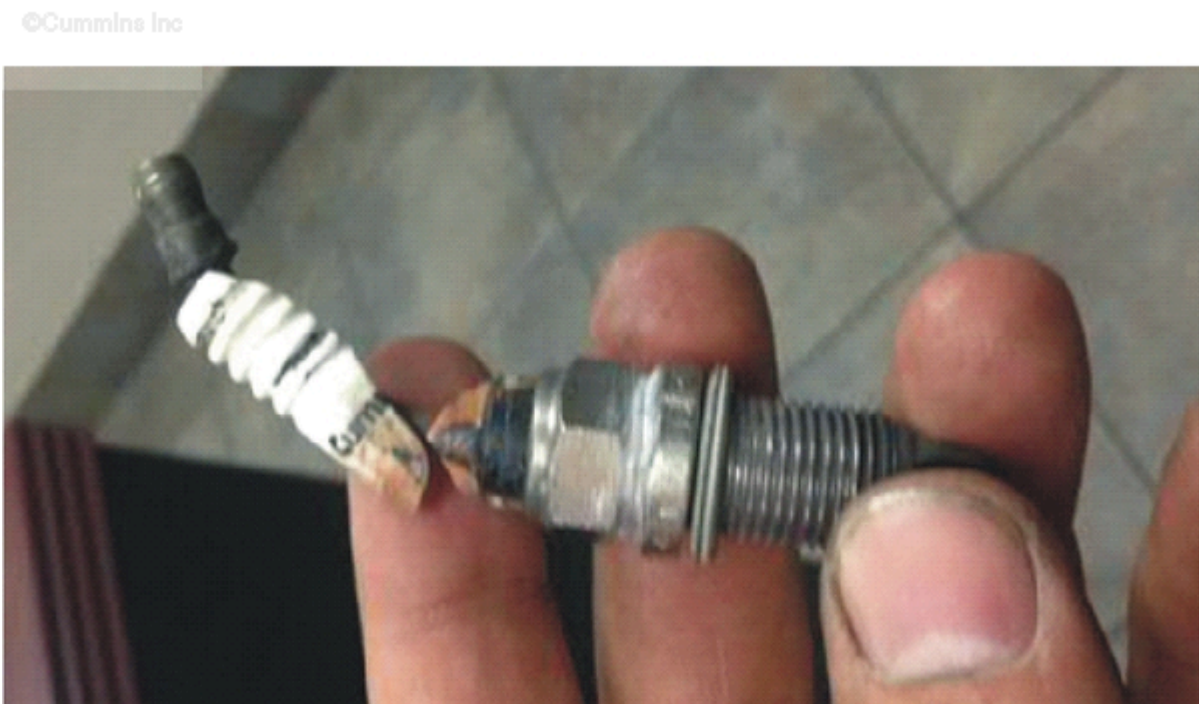
### Spark Plug - Cracked Insulator

Cracked insulator.

Mishandling or over-torqued.

Compare with spark plugs from the other cylinders to determine if the issue is isolated to one cylinder or across all cylinders. Replace all spark plugs with cracked insulators.

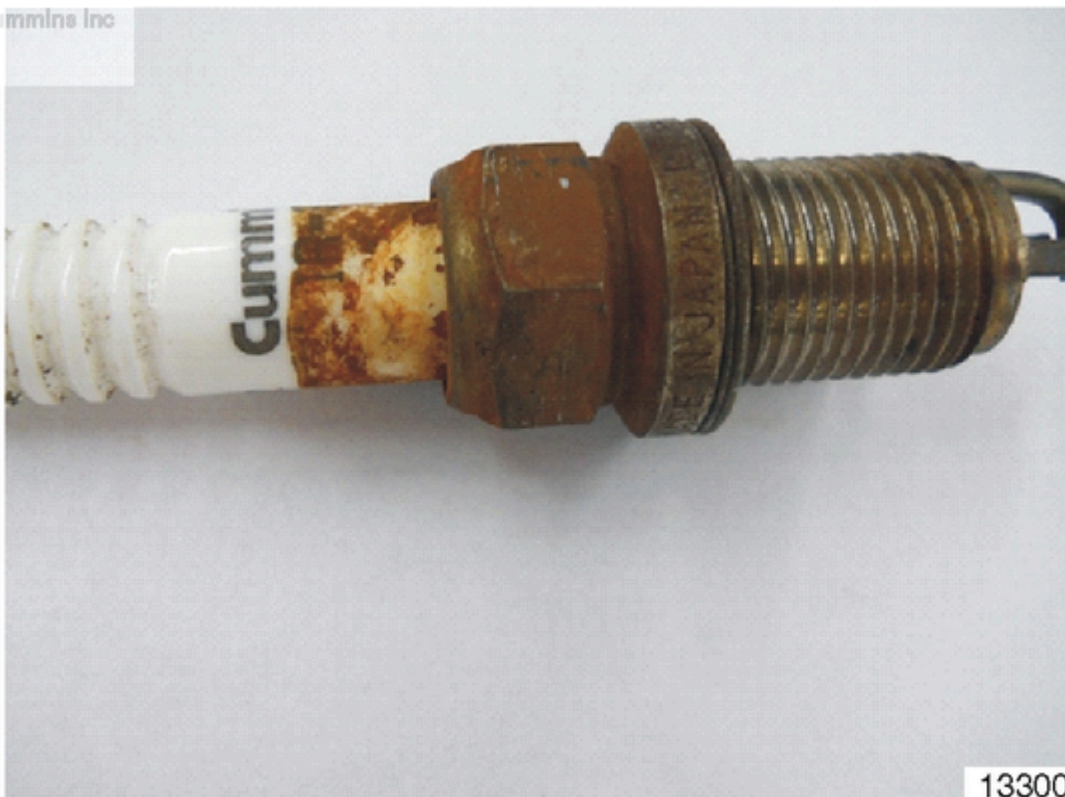
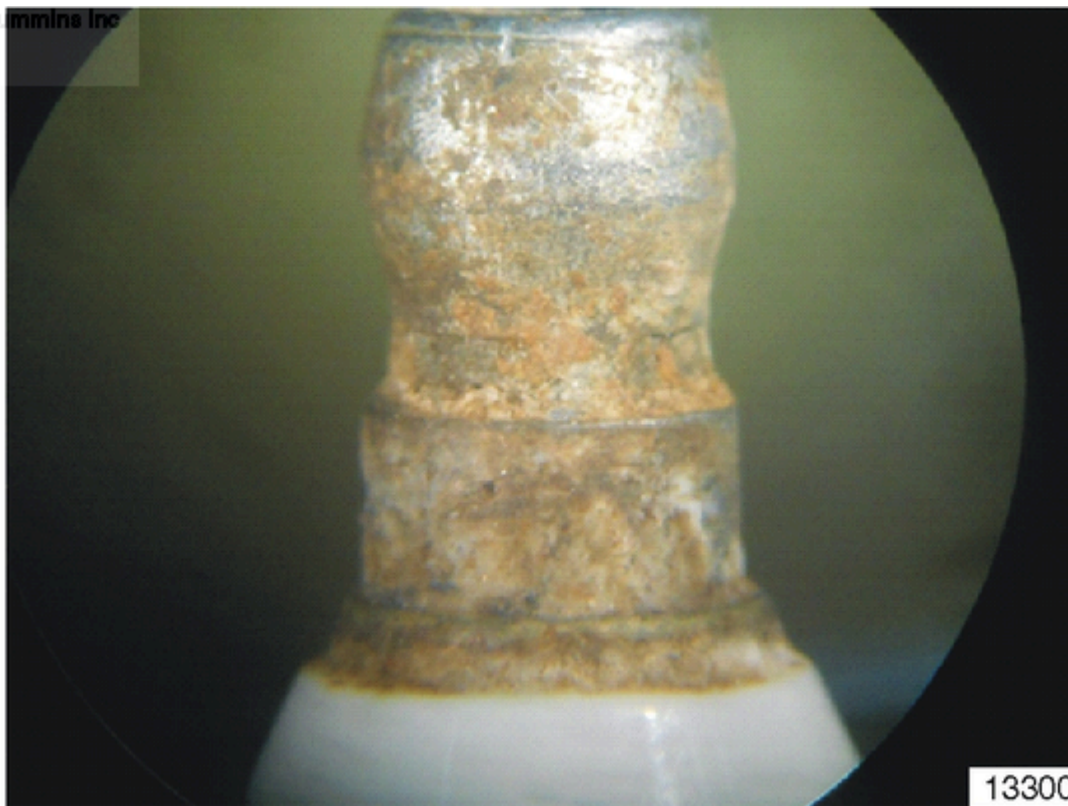
13300060

**Spark Plug - Corrosion**

| Appearance | Discolored and/or rusted. |
| Cause | Moisture in the spark plug well and/or leaking seal or boot. |

| Action | Check the seal on ignition coil and spark plug boot. Investigate for the source of moisture. Compare with spark plugs from the other cylinders to determine if the issue is isolated to one cylinder or across all cylinders. Replace all spark plugs with corrosion that will <b>not</b> wipe off. |

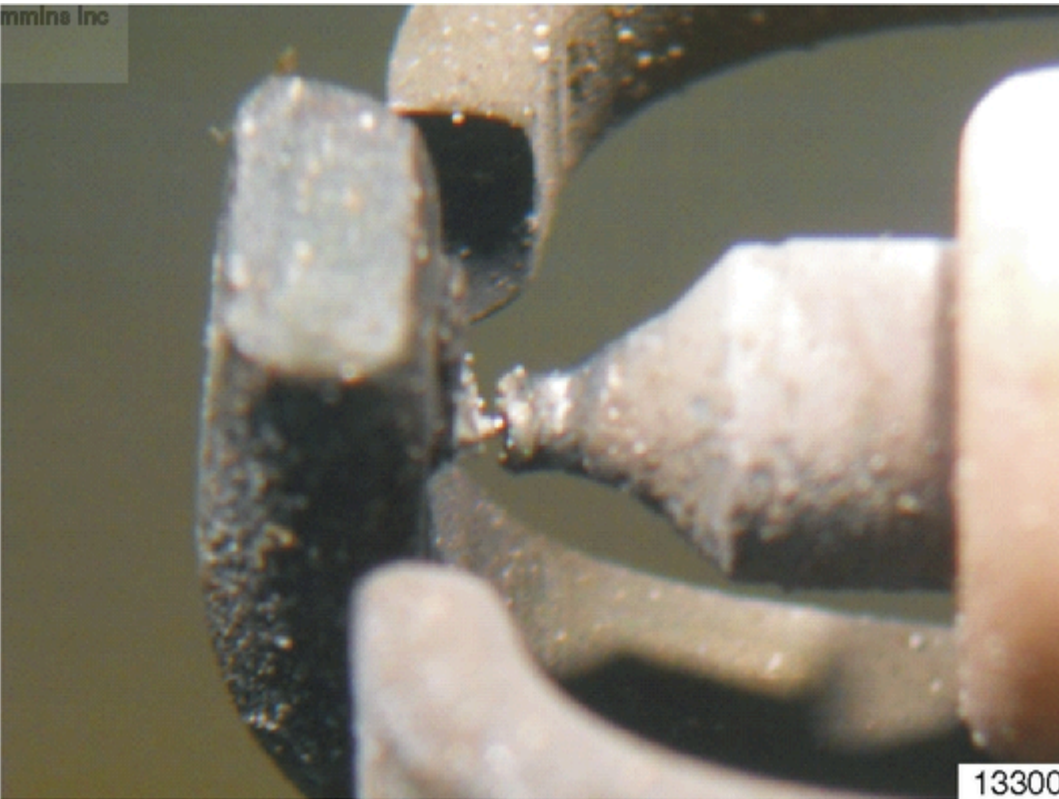
**Spark Plug - Beading**

Small beads on the electrodes, bridging the gap.

Excessive temperatures and/or fuel which does **not** meet Cummins® specifications.

Compare with spark plugs from the other cylinders to determine if the issue is isolated to one cylinder or across all cylinders. Replace spark plug **only** if the gap is out of specification. Verify fuel quality and investigate source of excessive in-cylinder temperature.

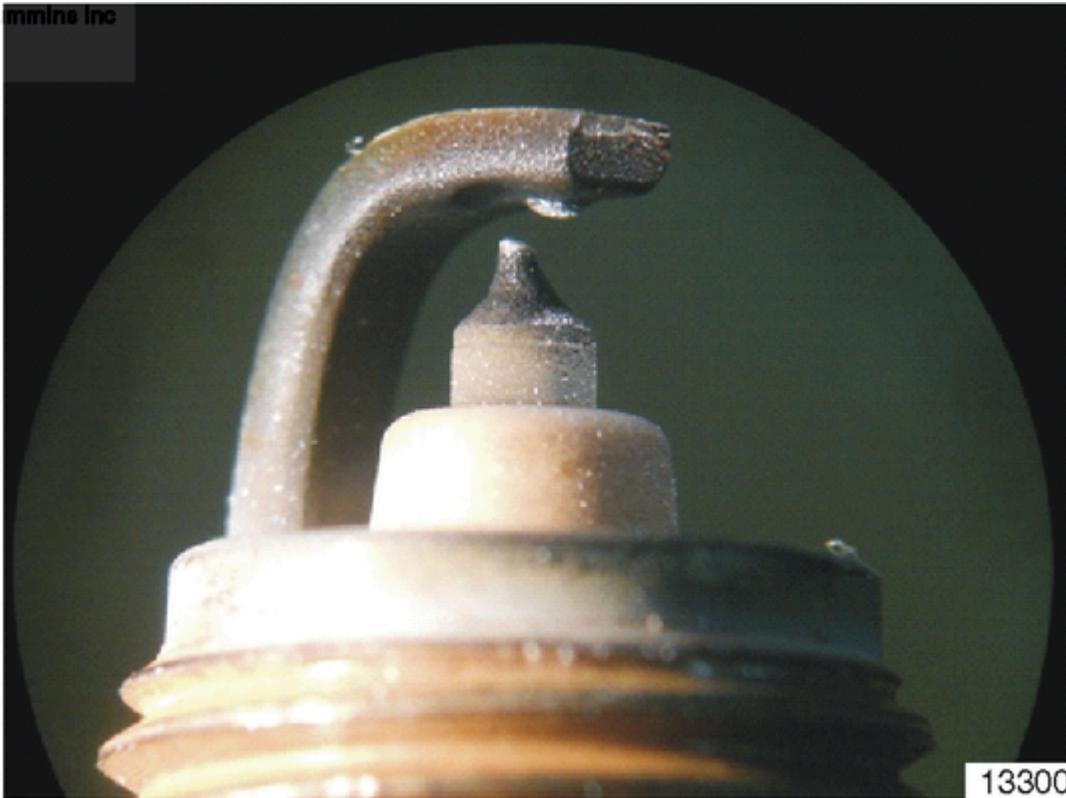
**Spark Plug - Uneven Wear on Ground Electrode**

| Appearance | Erosion to one side of the ground electrode. |
| Cause | Normal wear in response to severe duty cycle applications. |

| Action | Measure the gap. Replace the spark plug if the gap is out of specification. |

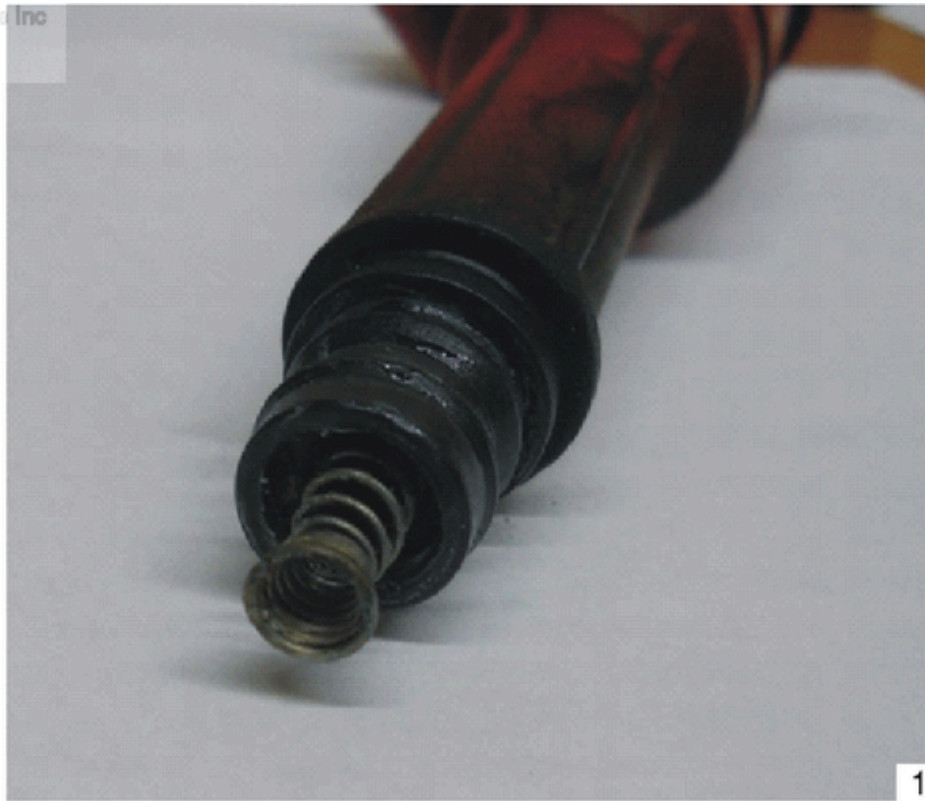
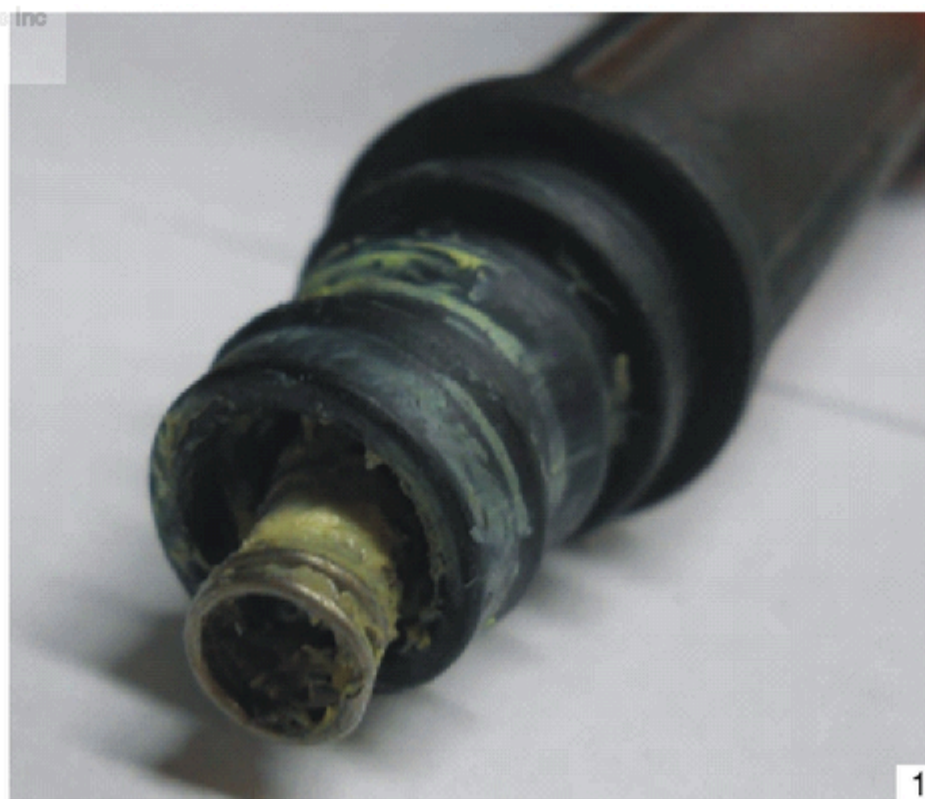
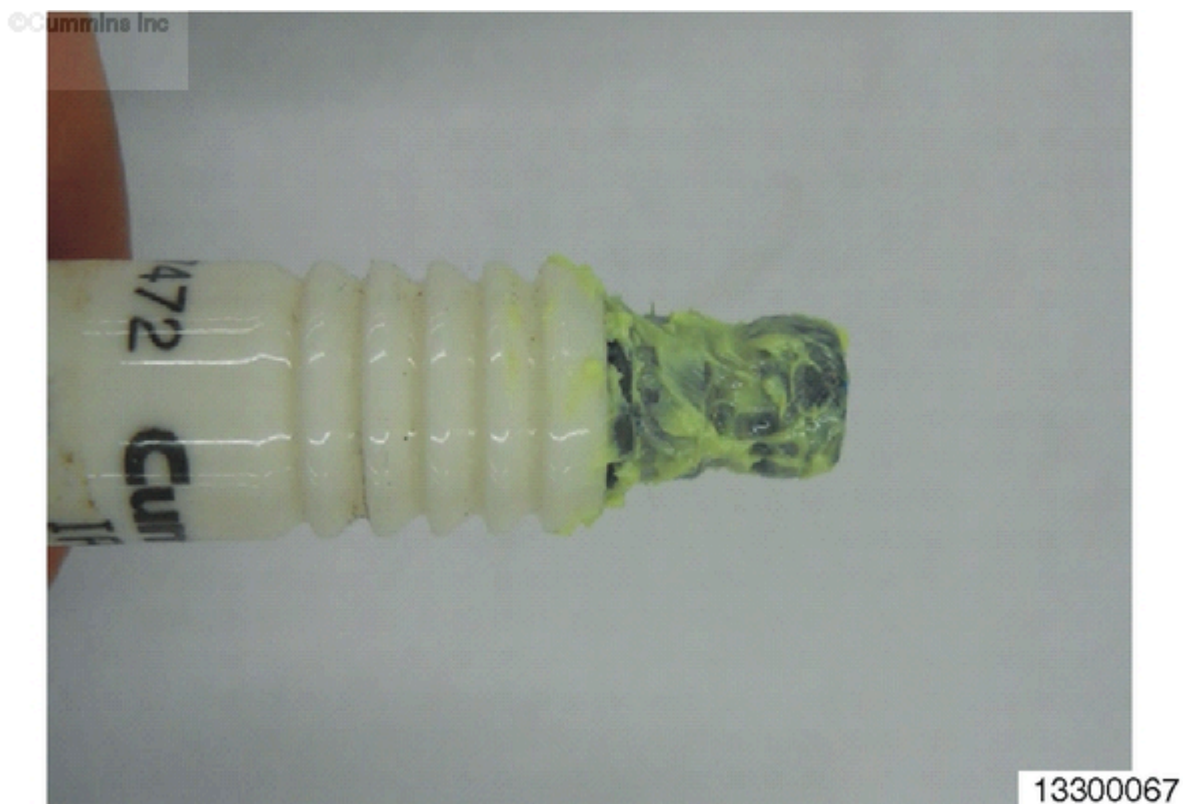
#### Excessive Dielectric Grease on Spark Plug

| Appearance | Excessive dielectric grease on the spark plug terminal or insulator. Figure 1 - Normal, Figure 2A and 2B - excessive dielectric grease. |
| Cause | Use of additional dielectric grease. Grease buildup in the ignition coil. |

| Action | Compare with spark plugs from the other cylinders to determine if the issue is isolated to one cylinder or across all cylinders. Remove the grease deposits and reuse spark plug. Replace the old boot with new, pre-greased, boot when replacing spark plug. |

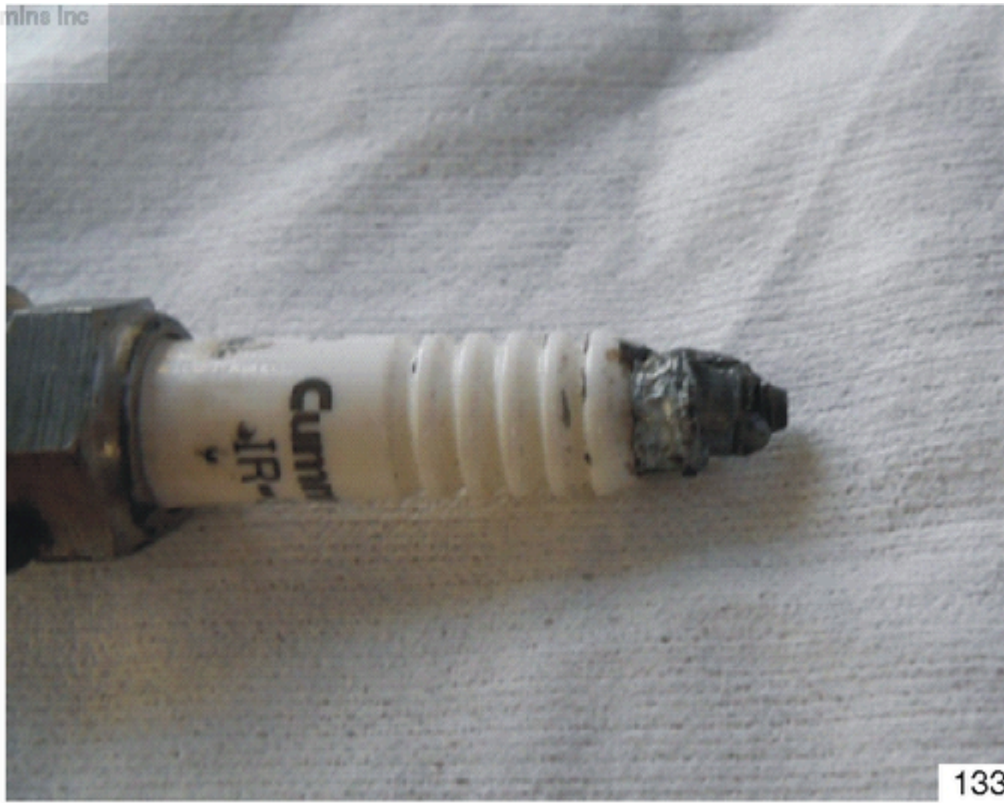
13300069

**Spark Plug - Melted Terminal**

| Appearance | Top of the spark plug is melted. |
| Cause | Excessive temperatures or knock. |

| Action | Compare with the other spark plugs. Check for knock and/or possible in-cylinder damage. Replace all the spark plugs. |

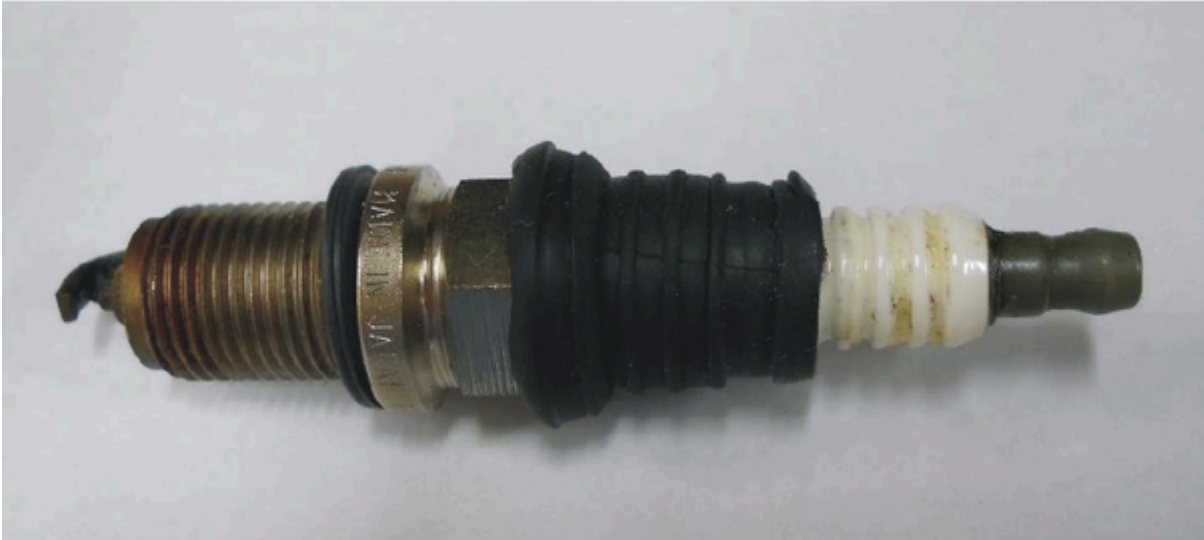
13300070

| Boot Stuck on Spark Plug | |
| Appearance | Coil boot covering the spark plug with metal shell. |
| Cause | Coil installed with the boot from the previous coil still on spark plug, Normal wear. |

| Boot Stuck on Spark Plug | |
|---|---|
| Action | Replace all the spark plugs with damaged boots. |

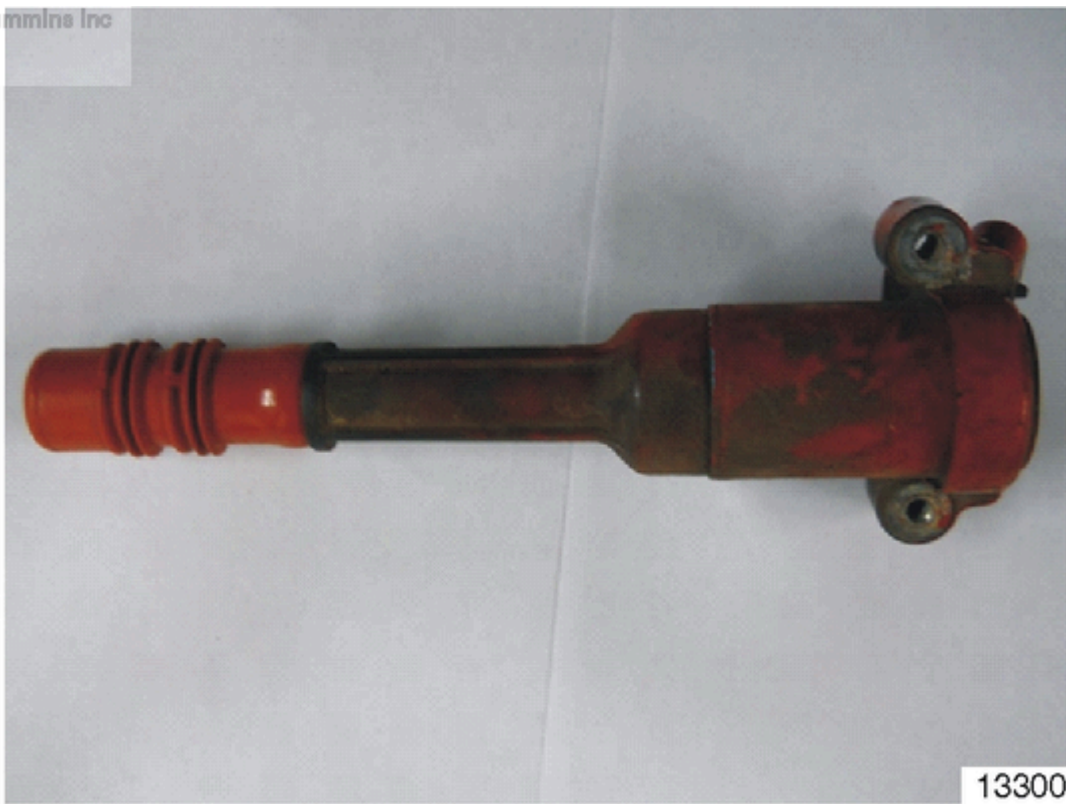
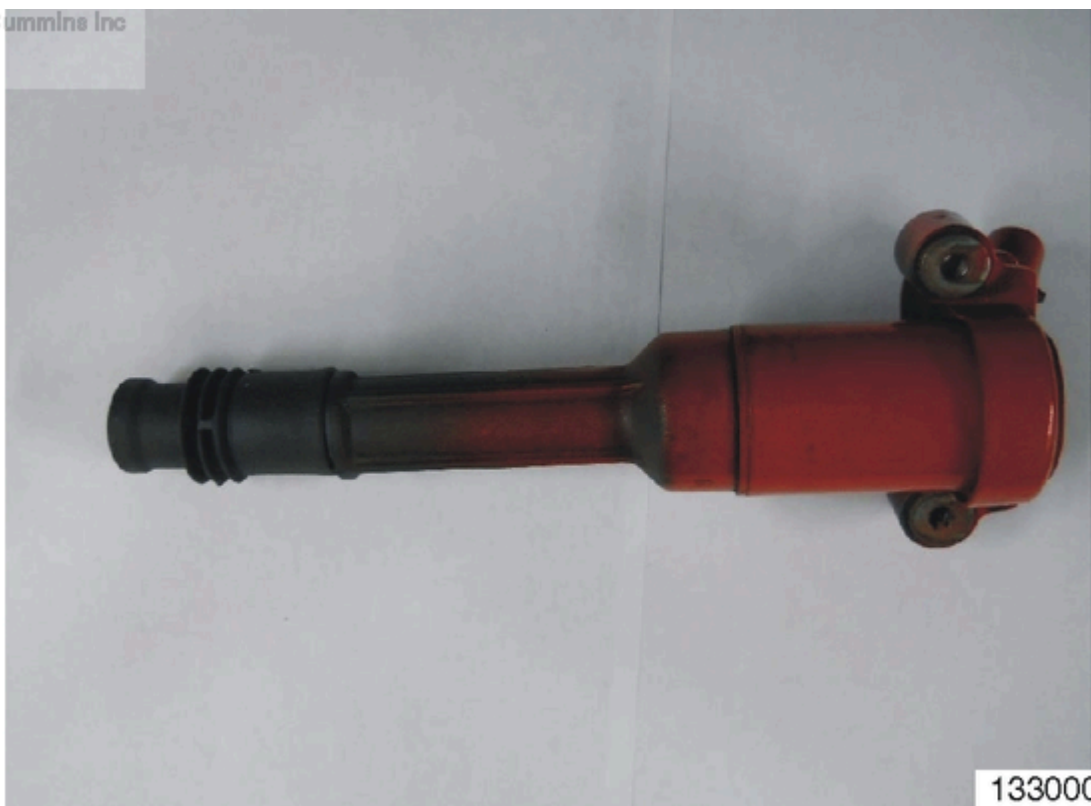
**Wrong Boot on Coil, Causing Short Spark Plug Life - ISL G**

Larger, orange boot. Figure 1 - Wrong boot.  
Figure 2 - Correct boot.

Spark plug kit ordered for the C Gas engine.

| Action | Replace with the spark plug kit for ISL G. |
